Fatality #2 - January 22, 2010
Fall of Face/Rib/Highwall - Underground - Kentucky
Bledsoe Coal Corporation - Abner Branch Rider

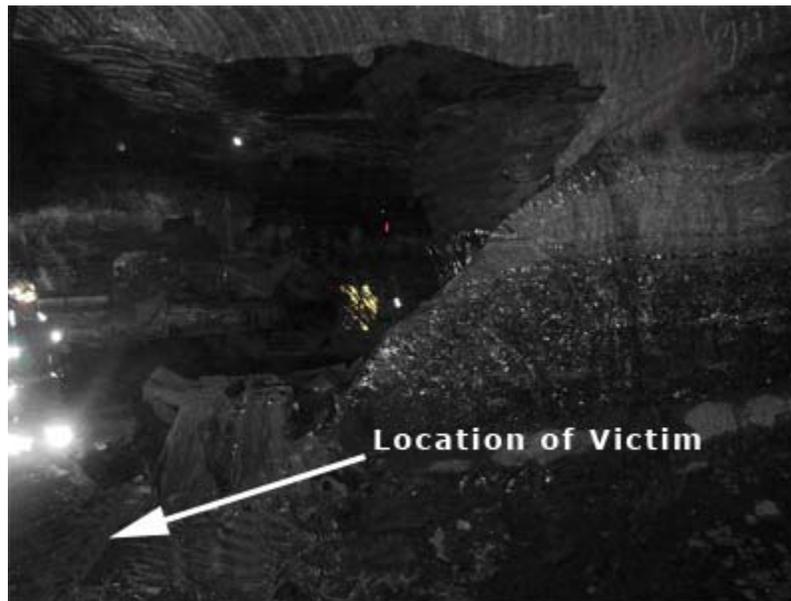
COAL MINE FATALITY - On Friday, January 22, 2010, at approximately 9:15 a.m., a 29 year old continuous miner operator with 12 years of mining experience was fatally injured when a rib roll, approximately 70 inches high, 63 inches long, and 103 inches wide, occurred. The victim was operating a remote control continuous mining machine to clean a previously bolted crosscut when he was struck by the coal rib and pinned against the mine floor.

- Conduct a thorough visual examination of the roof, face, and ribs immediately before any work or travel is started in an area and thereafter as conditions warrant.
- Adequately support or scale any loose rib or roof material before beginning work.
- Perform careful examinations of pillar corners, particularly where the angles formed between entries and crosscuts are less than 90 degrees.
- Permanently support openings that create an intersection before any work or travel in the intersection.
- Be alert to changing geologic conditions which may affect roof/rib conditions.
