**Fatality #24 - December 29, 2010**  
**Falling Material - Texas - Dimension Sandstone**  
**Martinez Stone - Martinez Stone**

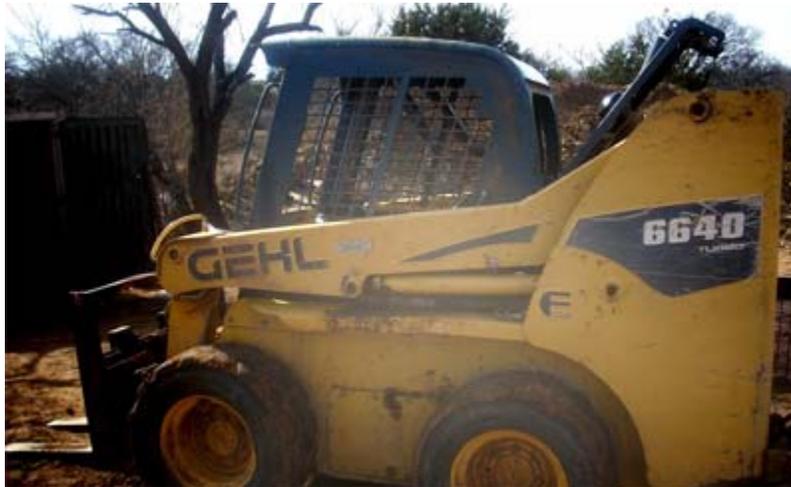
**METAL/NONMETAL MINE FATALITY** - On December 29, 2010, a 41 year- old laborer with 4 years of experience died at a dimension stone operation. The victim was replacing a hydraulic lift arm cylinder on a skid steer loader. The lift arms suddenly lowered, pinning him against the frame of the machine.

- Establish safe work procedures and identify and remove hazards before beginning repair or maintenance tasks. Follow the equipment manufacturer's procedures for the work being performed to ensure that all hazards have been addressed.
- Train persons to recognize the hazards associated with performing repair or maintenance tasks.
- Prior to performing repair or maintenance tasks, turn the power off and block any raised component against accidentally lowering.
- Assign a sufficient number of persons to repair or maintenance tasks to ensure the tasks can be safely performed.
- Do not place yourself in a position that will expose you to hazards while performing repair or maintenance tasks.
- Monitor personnel routinely to determine that safe work procedures are followed.
