**Fatality #14 - August 15, 2011**  
**Fall of Roof or Back - Underground - West Virginia**  
**Mingo Logan Coal Company - Mountaineer II Mine**

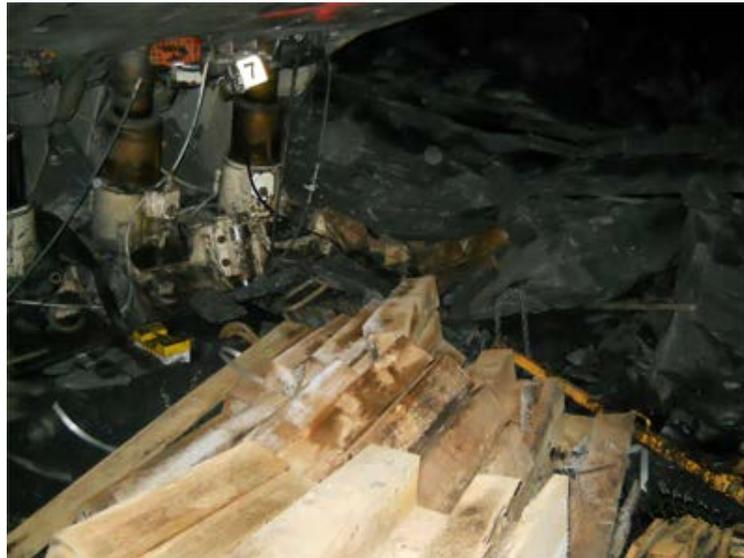
**COAL MINE FATALITY - COAL MINE FATALITY** - On Monday, August 15, 2011, a 46 year old miner was killed when he was struck by a portion of the mine roof that fell from an area adjacent to a longwall shield. The accident occurred during a longwall move, while the victim was installing a wooden crib in an area where a longwall face shield had been removed previously. The victim had approximately five years experience with this activity.

- Assure that roof control plans are suitable to the prevailing geological conditions. If roof geology changes affect roof stability, reevaluate roof support techniques.
- Share and discuss roof control plans with the miners on a regular basis. For miner safety, assure that the roof control plan safety precautions are followed.
- Provide additional training for specialized work, such as longwall moves, emphasizing best practices for a specific task.
- Conduct examinations of roof conditions frequently to prevent exposure to poor roof conditions. Remain vigilant for changing roof conditions.
- When hazardous roof conditions are detected, danger off areas until they are made safe.
