Fatality #16 - December 15, 2011
Machinery - Pennsylvania - Crushed, Broken Stone NEC
Damascus 535 Crushing - Damascus 535 Crushing

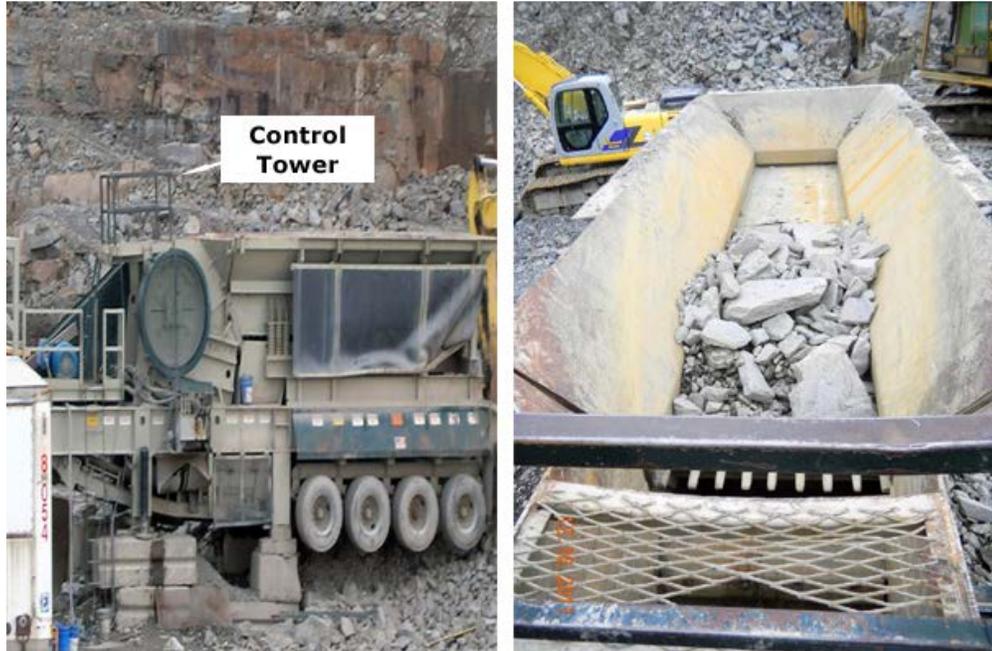
METAL/NONMETAL MINE FATALITY - On December 15, 2011, a 22 year-old laborer with 3 months of experience was killed at a surface stone operation. The victim, who was last seen on a control tower, fell into an operating jaw crusher.

- Always use fall protection when working where a fall hazard exists.
- Establish policies and procedures for safely clearing plugged material in a jaw crusher.
- Ensure that persons are task trained and understand the hazards associated with the work being performed.
- Deenergize and Lock-out/tag-out all power sources before working on crushers.
- Do not place yourself in a position that will expose you to hazards.
- Monitor personnel routinely to determine that safe work procedures are followed.
