**Fatality #15 - September 13, 2012**  
**Fall of Roof or Back - Underground - West Virginia**  
**Consolidation Coal Company - Blacksville No 2**

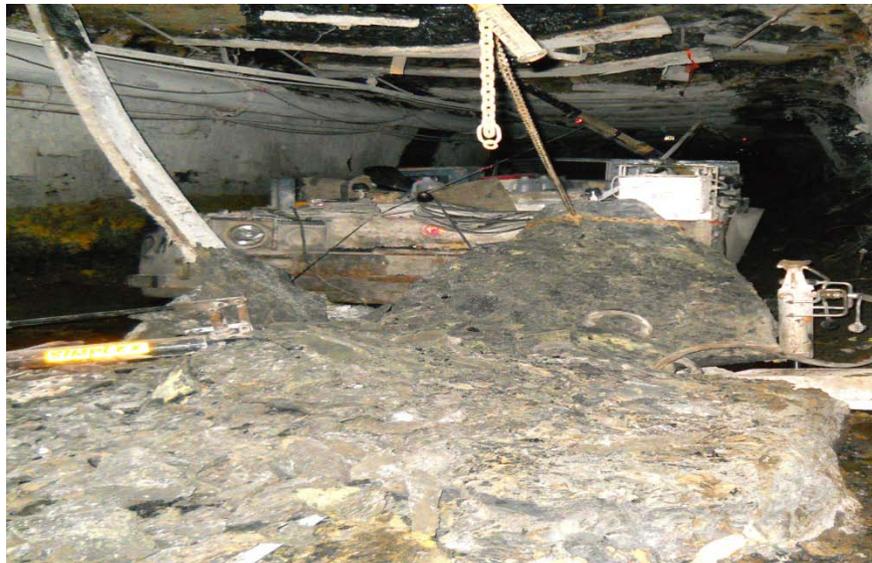
**COAL MINE FATALITY** - On Thursday, September 13, 2012, a 61-year-old general inside laborer with 38 years of mining experience was killed when he was struck by a section of mine roof. The victim was removing a roof bolt from an older area of the mine which was no longer in contact with the mine roof. A section of mine roof fell, striking the victim.

- Before performing work in any area of the mine, observe the roof and ribs for hazardous conditions and correct hazards immediately.
- Install additional roof supports prior to removing old supports.
- Perform sound and vibration testing before installing or removing permanent roof supports.
- Only remove roof supports under the direction of a manager or foreman.
- Use roof screen (wire mesh) to control loose roof in long-term travel roads.
- Take extra precautions when working or traveling in older areas of the mine, paying particular attention to deteriorating roof conditions.
- Make frequent roof examinations and be alert to changing roof conditions at all times. Give extra attention to the roof after activities occur that could cause roof disturbance.
