CRANDALL CANYON MINE- MAINS WEST SECTION

08/28/2007

UtahAmerican
 Energy, Inc.
 Crandall Canyon Mines

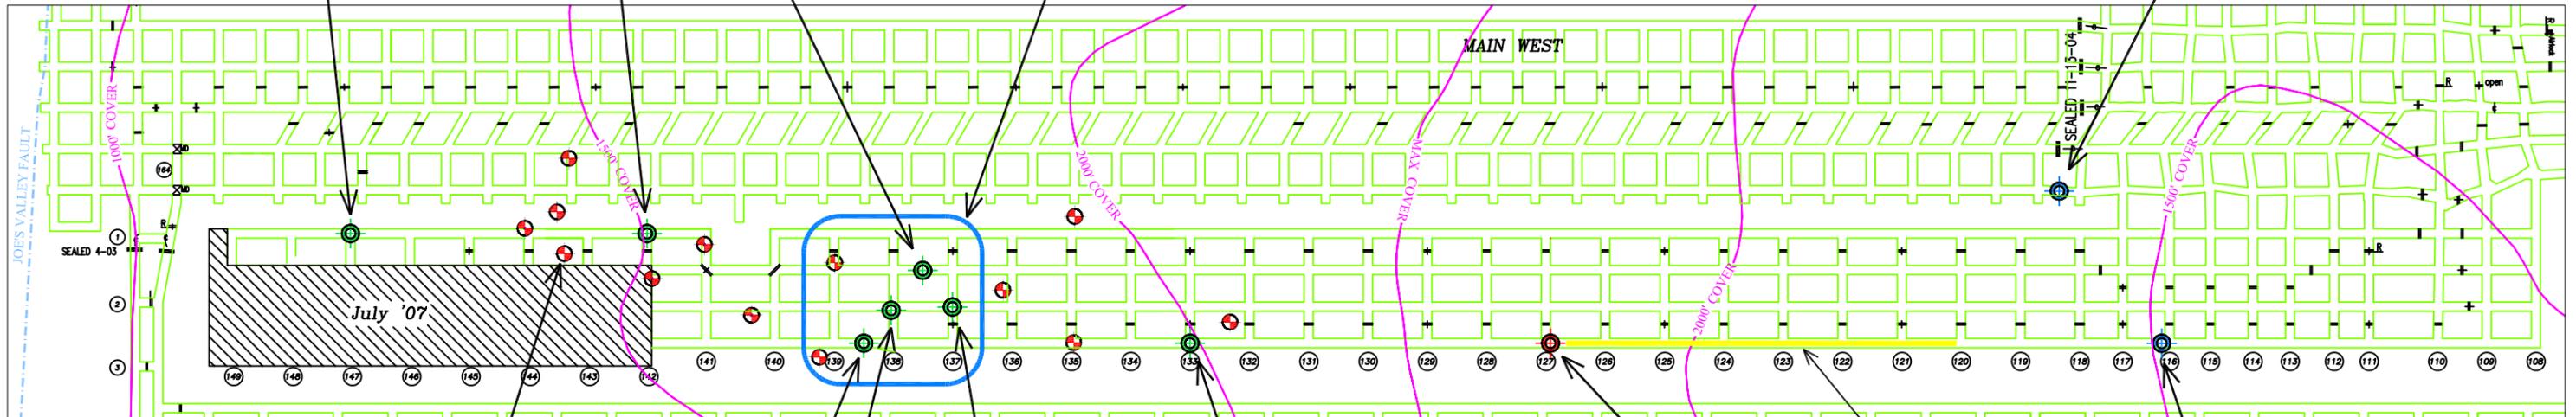
DRILL HOLE #3 8-7/8"
 DEPTH- 1,414 FT.
 16.2% Oxygen
 0.0% Methane
 22 ppm Carbon Monoxide
 as per MSHA Log 8/16/07
 Drilling Started: 8/13/07 17:00pm
 Breached Mine: 8/15/07 10:00am
 Total Drill Time: 41 Hours
 Avg Drill Speed: 34.5 Feet Per Hour

DRILL HOLE #4 8-7/8"
 DEPTH- 1,587 FT.
 13.8% Oxygen
 0.0% Methane
 19 ppm Carbon Monoxide
 as per MSHA Log 8/19/07
 Drilling Started: 8/16/07 12:00pm (noon)
 Breached Mine: 8/18/07 09:00am
 Total Drill Time: 45 Hours
 Avg Drill Speed: 35.3 Feet Per Hour

DRILL HOLE #7 8-7/8"
 DEPTH- 1,865 FT.
 % Oxygen
 % Methane
 ppm Carbon Monoxide
 as per MSHA Log 8/ /07
 Drilling Started: 8/28/07 04:00am
 Breached Mine:
 Total Drill Time: Hours
 Avg Drill Speed: Feet Per Hour

LAST KNOWN
 LOCATION
 OF MINERS

1 SEAL BREACH 8/06/07
 6.8% Oxygen
 0.0% Methane
 57 ppm Carbon Monoxide
 as per MSHA Log 8/6/07

DRILL HOLE #6 8-7/8"
 DEPTH- 1,783 FT.
 No Air Samples Available
 Hole Plugged
 Drilling Started: 8/23/07 15:40pm
 Breached Mine: 8/25/07 16:30pm
 Total Drill Time: 49 Hours
 Avg Drill Speed: 36.4 Feet Per Hour

DRILL HOLE #2 8-7/8"
 DEPTH- 1,866 FT.
 Air Quality Readings
 Not Available
 Drilling Started: 8/8/07 19:00pm
 Breached Mine: 8/11/07 01:00am
 Total Drill Time: 53 Hours
 Avg Drill Speed: 35.2 Feet Per Hour

DRILL HOLE #5 8-7/8"
 DEPTH- 2033 FT.
 No Air Samples Available
 Hole Plugged
 Drilling Started: 8/19/07 22:00pm
 Breached Mine: 8/22/07 08:30am
 Total Drill Time: 58.5 Hours
 Avg Drill Speed: 34.9 Feet Per Hour

**ADVANCEMENT
 UP TO 8/16/07**
MUCKING: 940'
PROPS: 870'
 MINING HALTED AT 6:38 P.M. MST
 DUE TO PILLAR BURST AND
 INJURY TO MINERS

AIR QUANTITIES AFTER
 SEISMIC EVENT on 08/06/2007
 XC 116 ENTRY #1
 38,969 CFM
 21.0% Oxygen
 0.0% Methane
 0 ppm Carbon Monoxide
 as per MSHA Log 8/6/07

DRILL HOLE #1 2-1/2"
 DEPTH- 1,871 FT.
 7.4% Oxygen
 0.0% Methane
 172 ppm Carbon Monoxide
 as per MSHA Log 8/10/07
 Drilling Started: 8/7/07 22:00pm
 Breached Mine: 8/09/07 22:00pm
 Total Drill Time: 48 Hours
 Avg Drill Speed: 39.0 Feet Per Hour
