U.S. Department of Labor
Mine Safety and Health Administration
Protecting Miners' Safety and Health Since 1978

CRANE TURRET BEARING FASTENER SAFETY

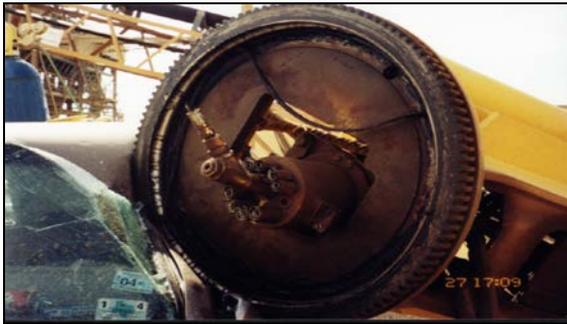
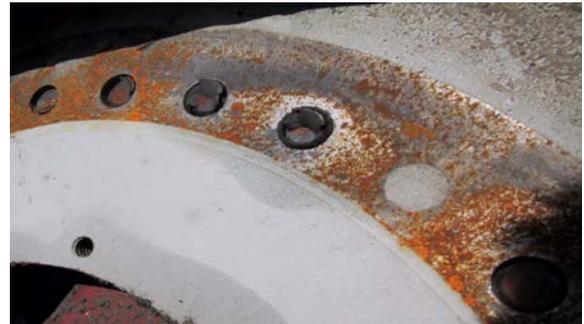
Mobile crane accidents have occurred in the mining industry when the turret or slew bearing suddenly detached from the base of the crane as a result of bolt fastener and bearing race failures. These mounting fasteners typically consist of high strength bolts, hardened flat-washers and/or high strength nuts when through-bolts are used. Proper torque on the fasteners must be maintained to prevent possible bolt fatigue and bearing deflections, which could cause the bolts or bearing to fail unexpectedly. Failure to maintain these fasteners can lead to catastrophic fastener or bearing failure resulting in loss of life, bodily injury and equipment destruction.

- Consult the equipment manuals to identify the specified mounting fasteners, fastener re-torque values, and fastener re-torque intervals.
- Periodically inspect the bearing and mounting fasteners for damage and re-torque the fasteners as specified by the equipment manufacturer. Maintain proper torque on the fasteners to prevent possible bolt fatigue and bearing deflections, which could cause the bolts or bearing to fail unexpectedly and catastrophically.
- Document fastener inspection and any maintenance performed.
- Replace any damaged fasteners with fasteners that meet the equipment manufacturer's specifications.
- If the equipment has been involved in an overloaded condition or damaged in an accident, before returning the equipment to service thoroughly examine the machine and fasteners. Check the fasteners for proper torque.
