SUPPRESSION OF FIRES ON UNDERGROUND  
COAL MINE CONVEYOR BELTS

WALTER KIDDE & COMPANY, INC.  
BELLEVILLE, N.J.

USBM CONTRACT FINAL REPORT (Contract No. H0122086)

September 13, 1974

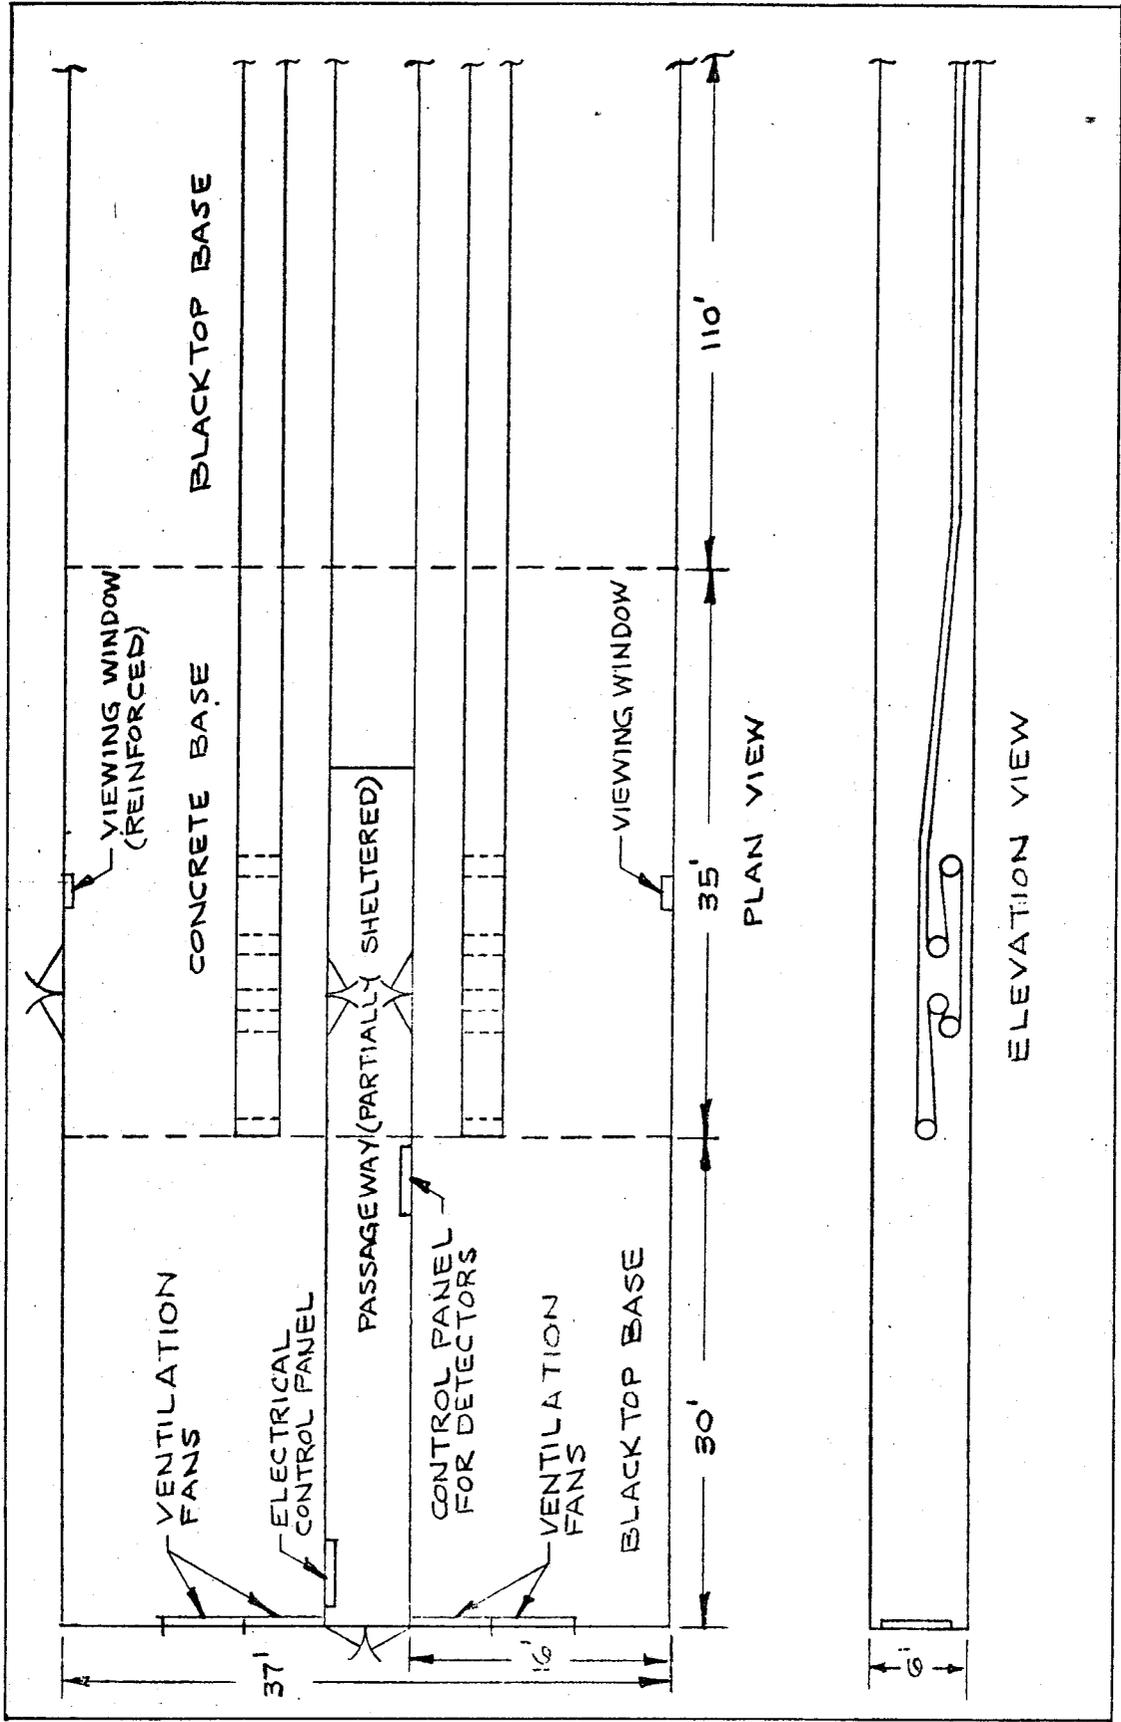
Figure 1  
Test Galleries

The galleries were constructed of galvanized metal with external wood support members to minimize fire damage. The roofs had a six inch pitch for water run off. Access doors and viewing windows were provided in the gallery sides at convenient locations. The base of the gallery was blacktop, except for a 35 foot section under the conveyor head piece and take-up assembly, which was concrete.

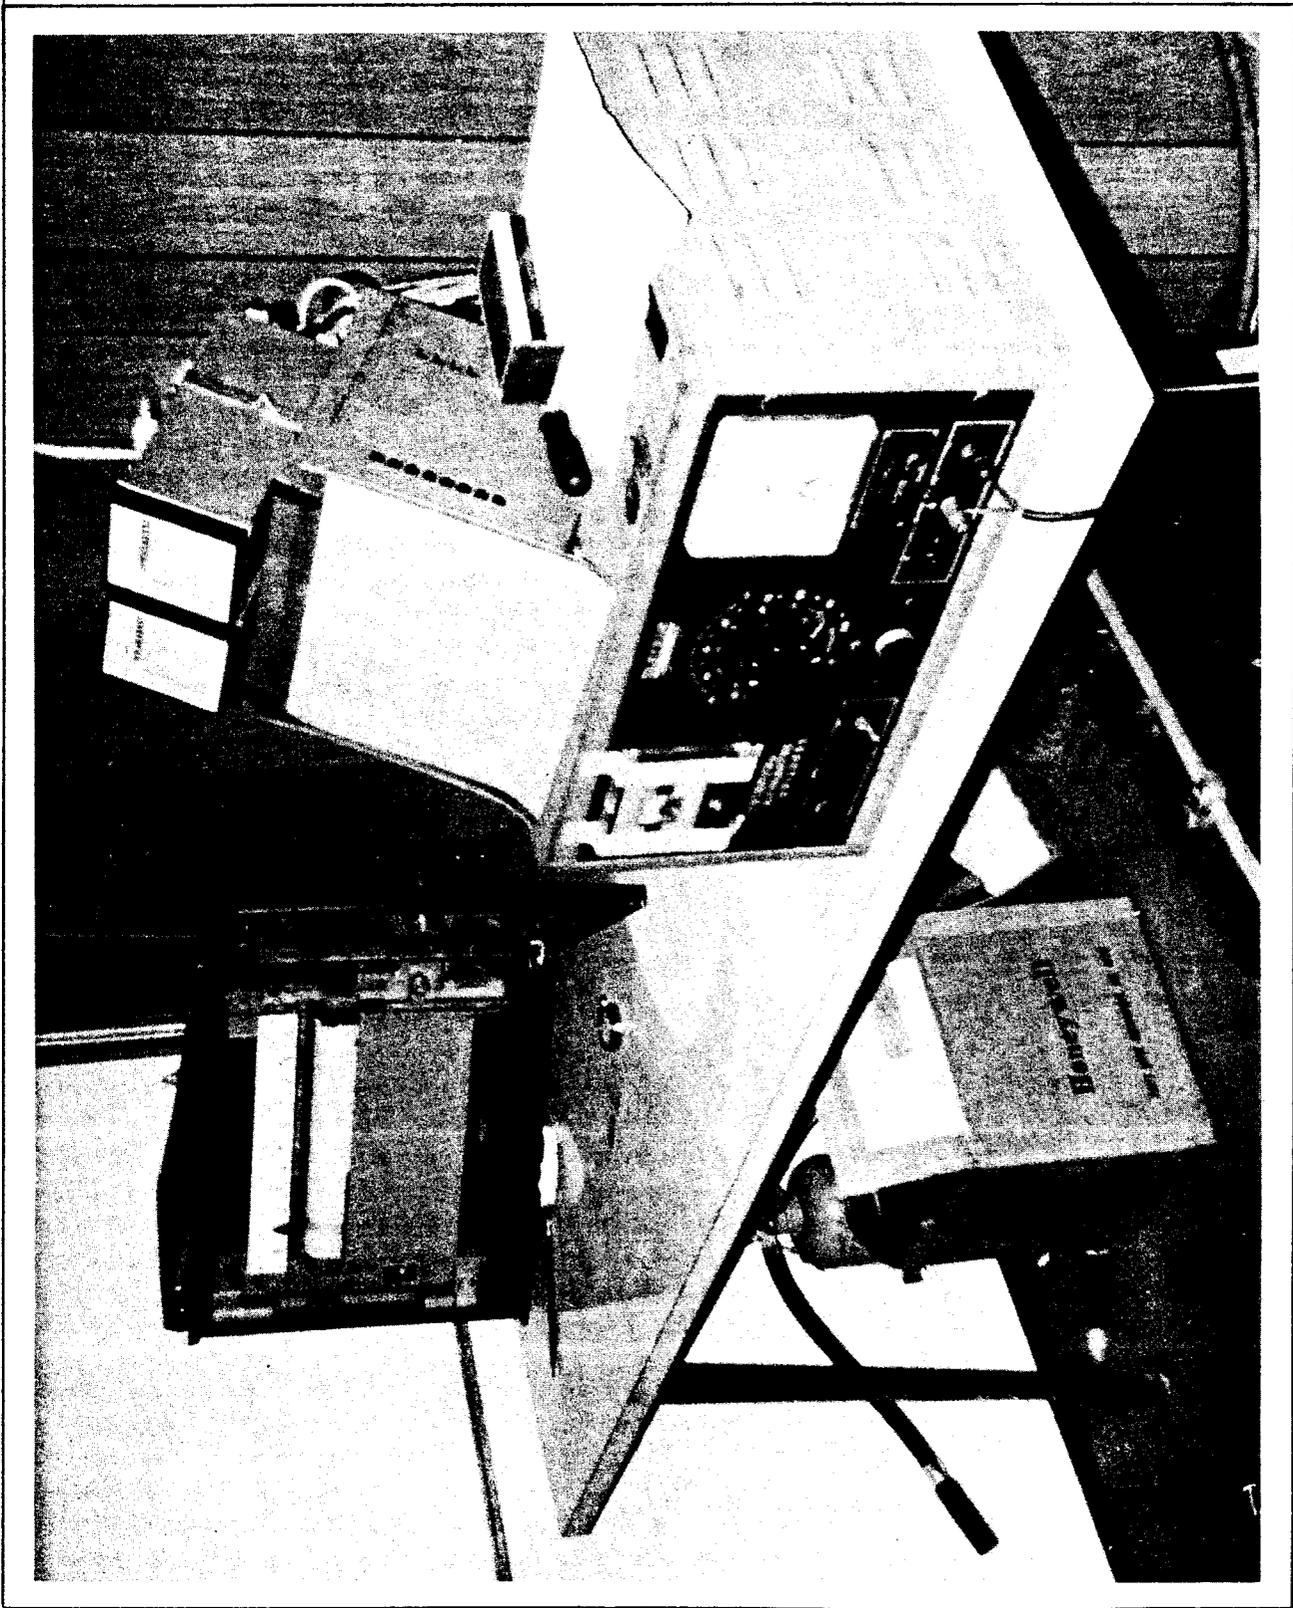
Figure 3

Instrumentation room, showing 12 point temperature recorder (left) and multipoint event recorders (upper right), used for recording the actuation of detection devices.

Actuations of the detector devices were monitored by means of two ten channel event recorders. A reference marker was used to denote the time of ignition so that actuation times could be determined. Both the temperature and the detector event recorders were located in a mobile van which served as a combination office and instrumentation room. (See Figure 3.)

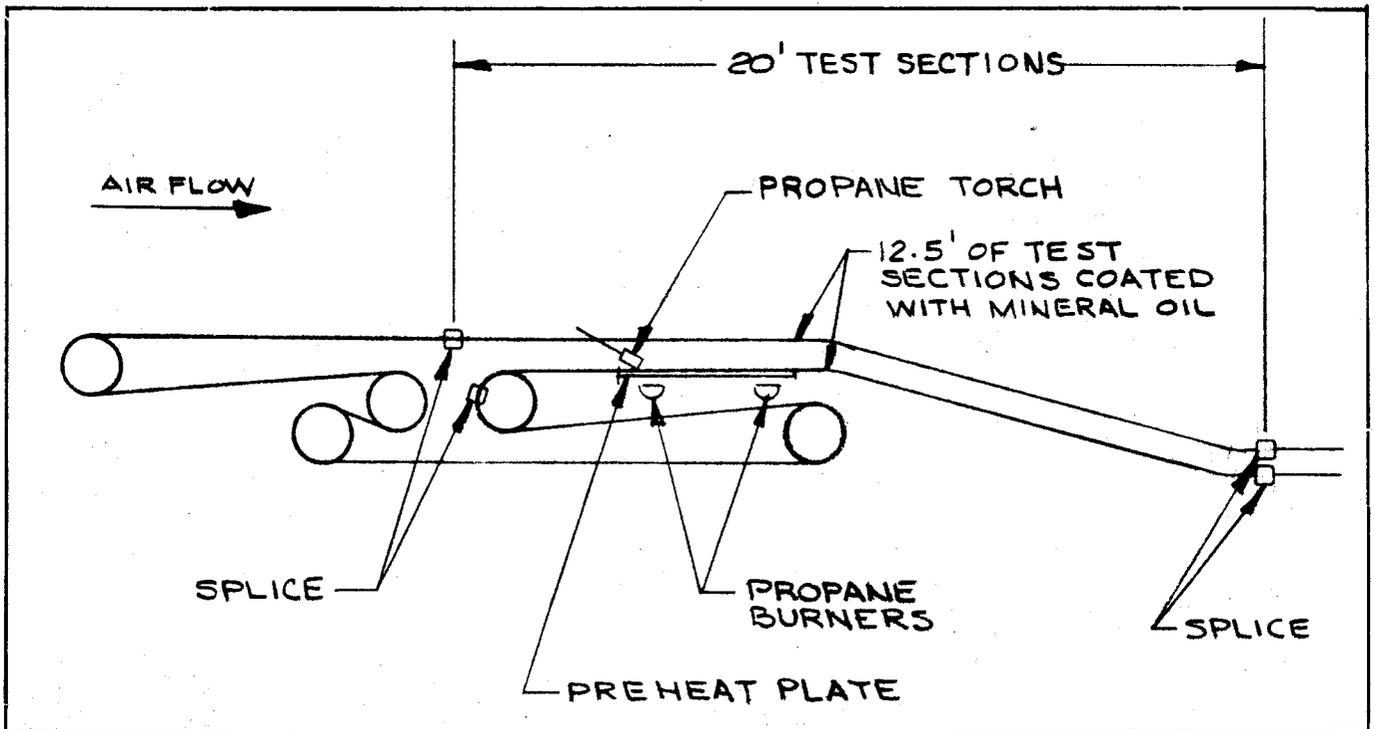
Figure 4  
Method of Ignition

The method of ignition used for the evaluation tests consisted of a 15 minute preheat using the 5 foot long by 30 inch wide by 1/2 inch thick aluminum plate heated by two propane gas burners. The gas pressure was adjusted as necessary to achieve a temperature of approximately 500°F between the plate and the belt surface, which required a heat release rate of approximately 8,000 Btu/min. This temperature was measured by two thermocouples, one at the center of the plate over one of the burners, and the other at the edge of the plate. The preheat temperature was considered to be the average of the two thermocouples.

Ignition was achieved by applying a propane torch to the top surface of the preheated belt section. The torch liberated heat at a rate of approximately 3,500 Btu/min, and produced a flame approximately 3 inches in diameter by nine inches long. (The total heat input to the ignition zone was 11,500 Btu/min.) The point of ignition was on the return belt in the take-up section. (See Figure 4.) Twenty foot test sections were spliced into the load bearing and return belts and were changed for each test. This minimized the amount of belt consumed in each test, and also simplified replacement of belt for the next test. The first 12.5 feet of both test sections were coated with mineral oil. The conveyor belting was also clamped to the take-up pulley to prevent the belt from falling away from the point of ignition after it had burned through and separated. The gas burners and torch were turned off after the fire had become obviously self-sustaining and the propane gas was no longer a contributing factor to the fire. Application of the ventilation air flow was withheld until one minute after turn-on of the ignition torch, so as to allow more rapid ignition of the belt test section.

Table II lists the test condition variables. As previously mentioned, the belt test sections were 20 feet long and were spliced into the two top belt layers as illustrated in Figure 4. New test sections were installed for each test.

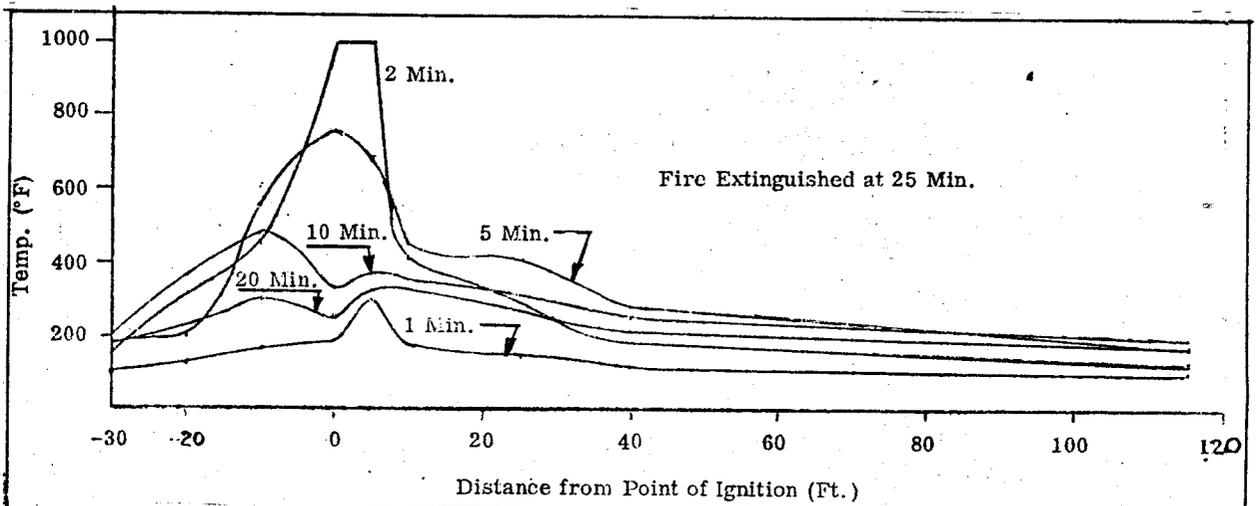
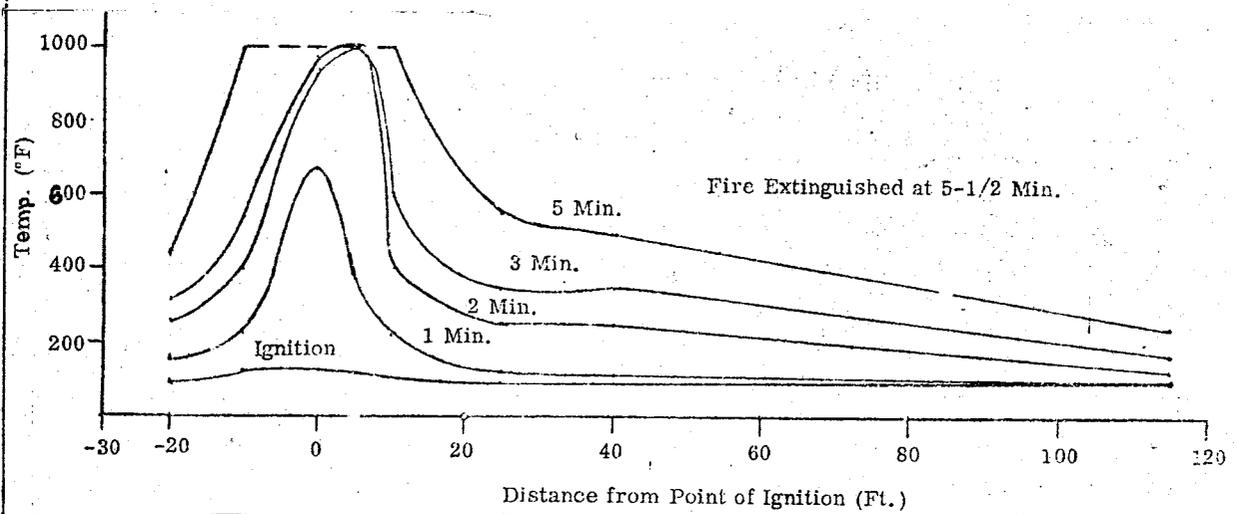
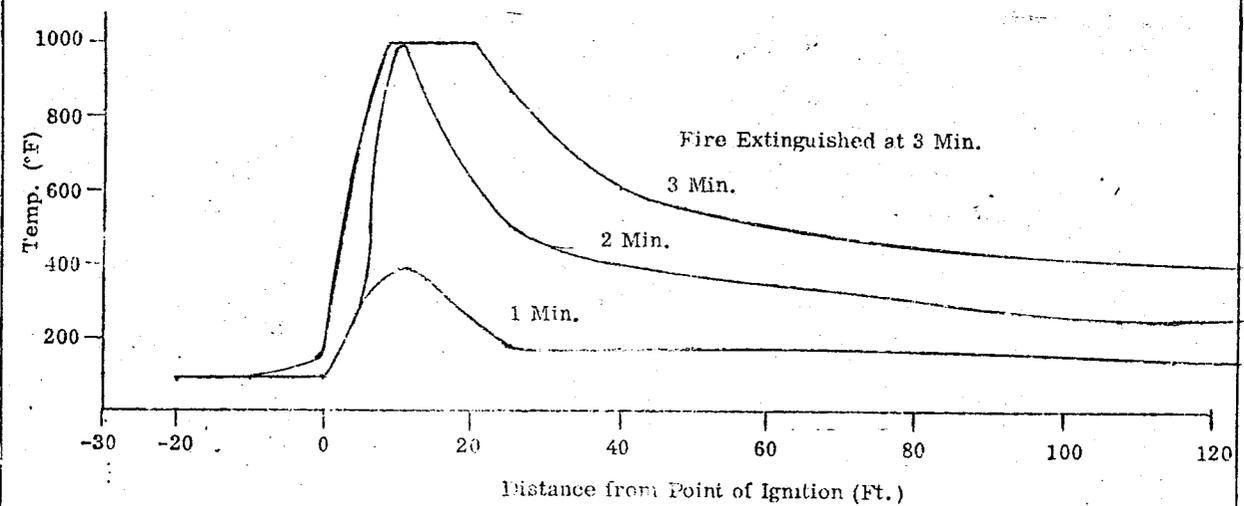
Figure 6  
Temperature Profiles

Test No. 37 (Neutral Air Flow)

Test No. 33 (125 fpm Air Flow)

Test No. 38 (350 fpm Air Flow)

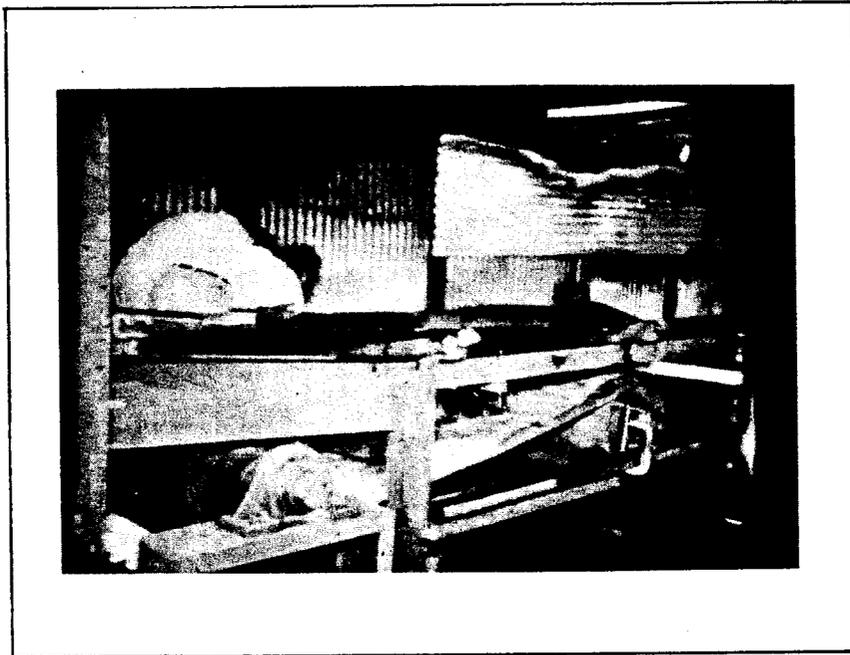
Figure 7  
Test Setup for Automatic Sprinklers (Test No. 112)

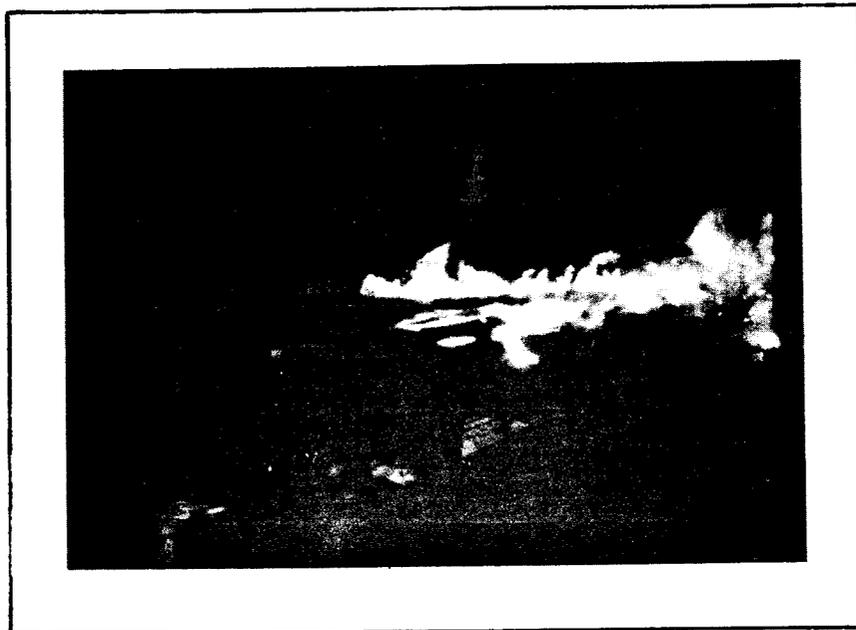
Figure 8  
Test Fire at Approximately One Minute

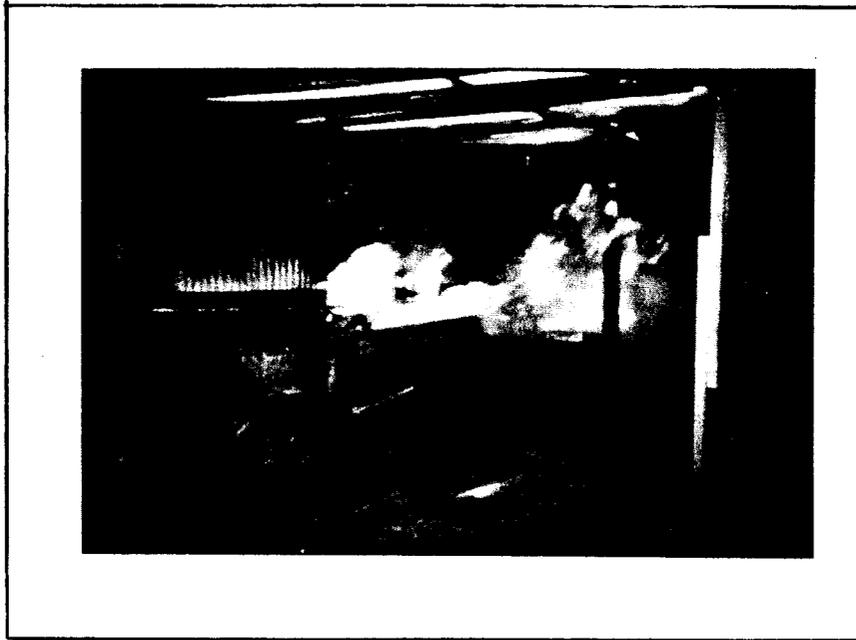
Figure 9  
Test Fire Just Prior to Sprinkler Actuation

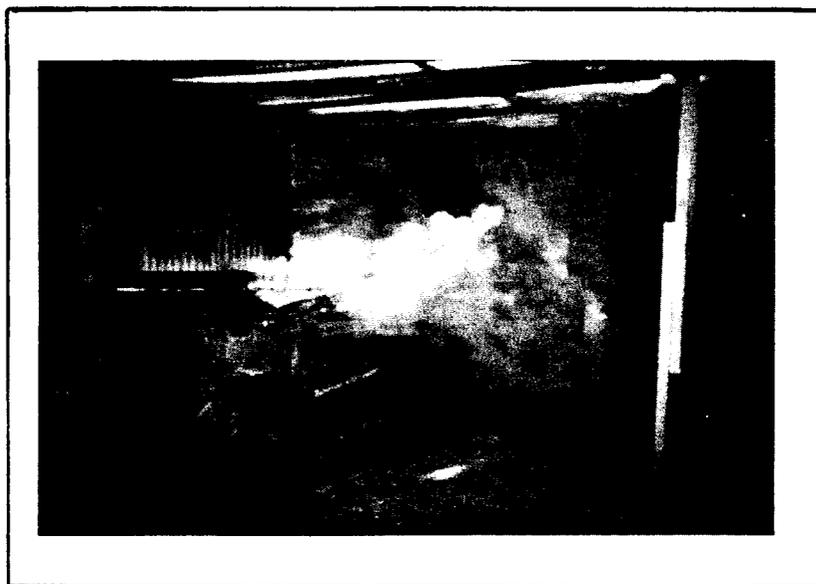
Figure 10  
Test Fire at the Time of Sprinkler Actuation (2 min.)

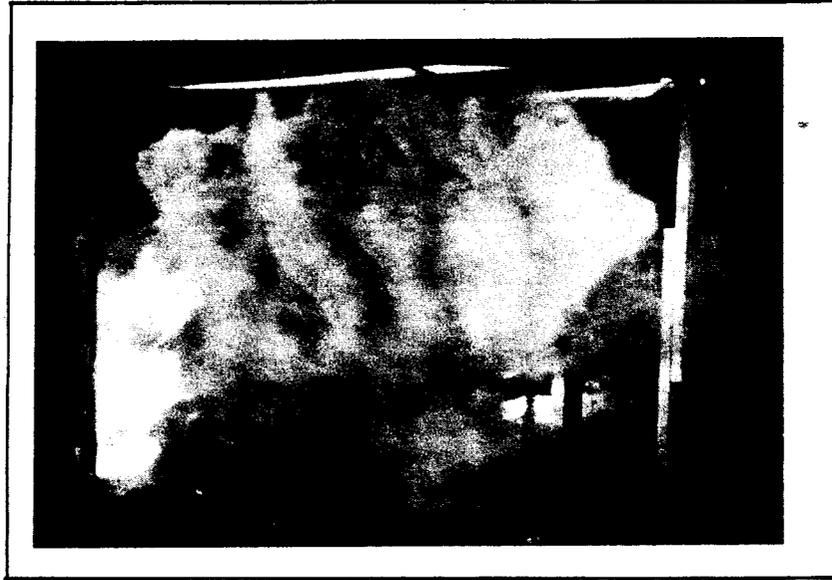
Figure 11  
Action of Automatic Sprinkler

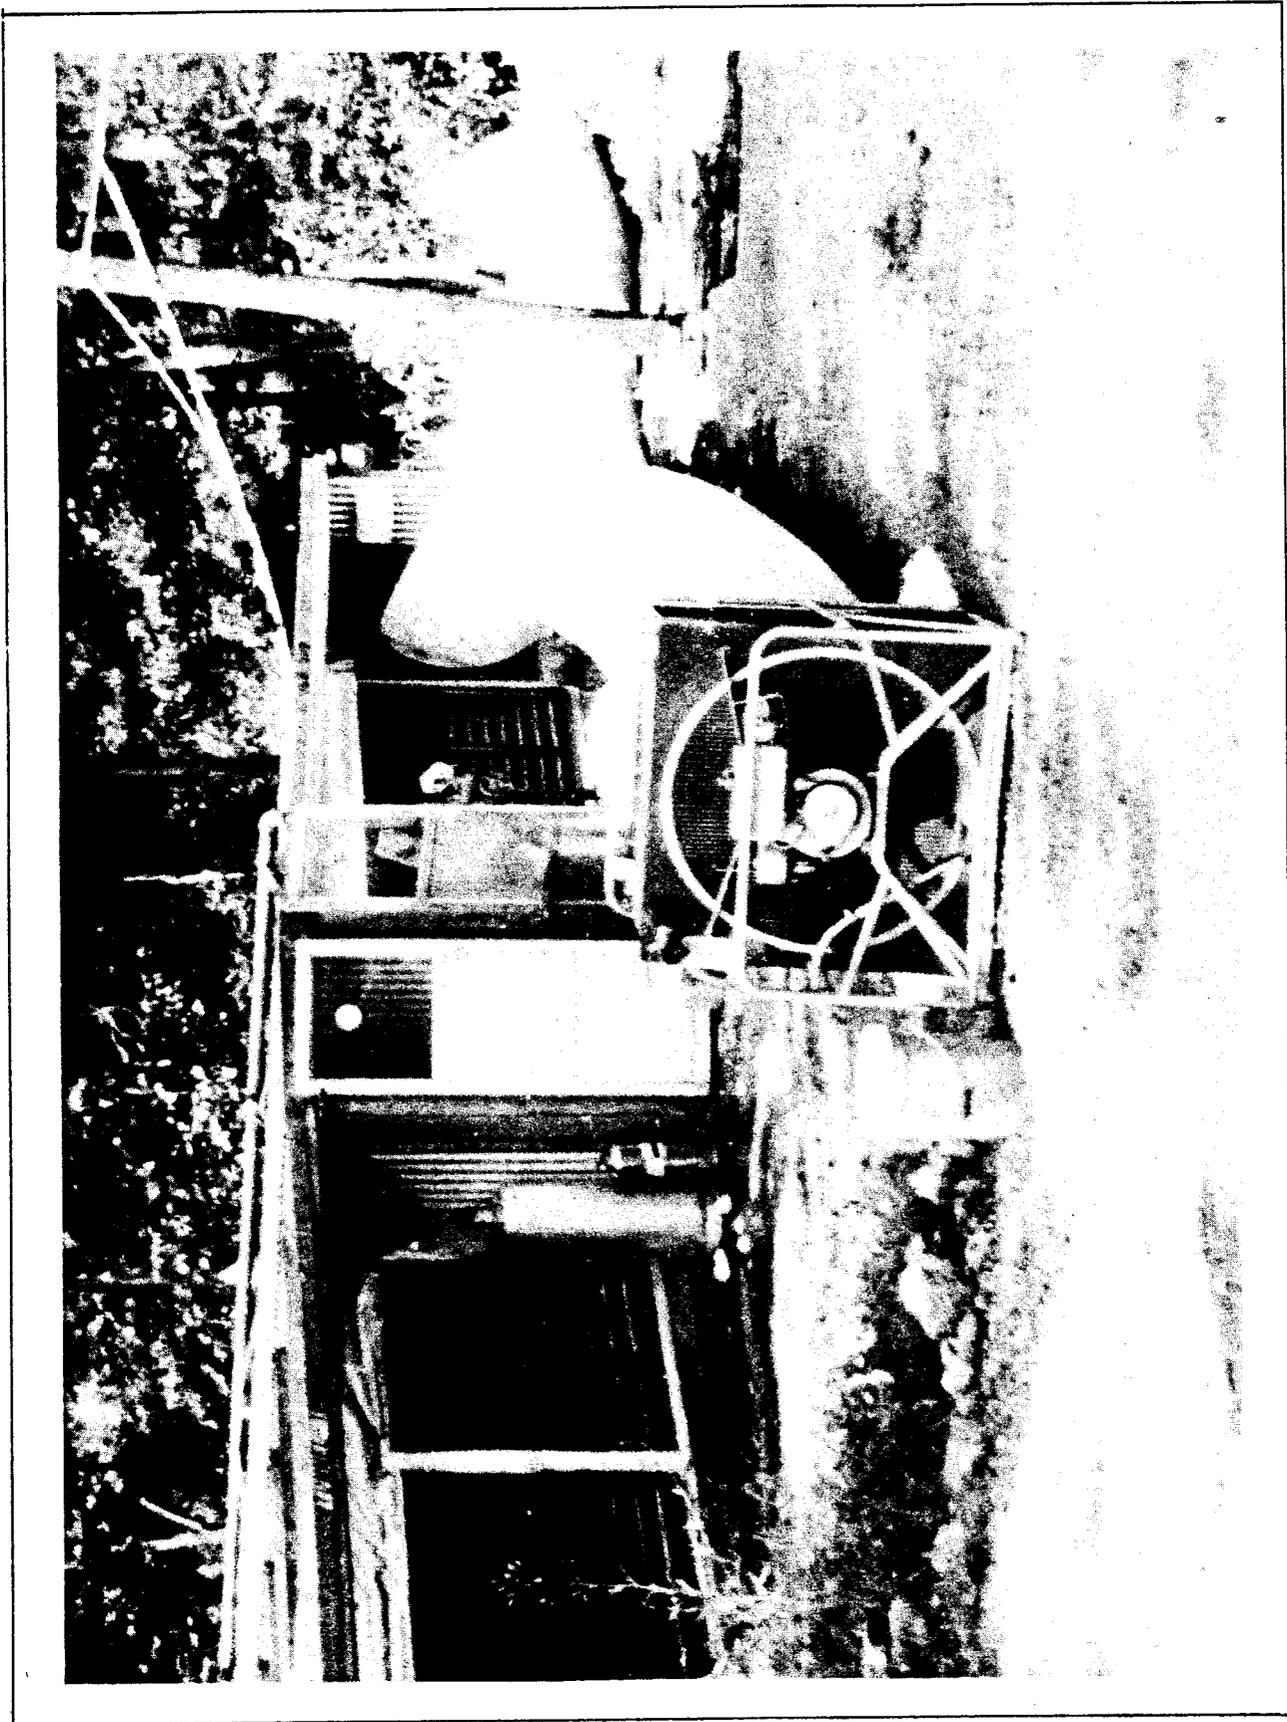
Figure 14  
High Expansion Foam Generator and Discharge Chute

The foam generator used was a Kidde Hi-Ex 5000 cfm portable unit which produced foam with an expansion ratio of approximately 1000 to 1 and a stability of not more than 25% drainage in 25 minutes. The only foam parameter varied was the generation rate which, at 5000 cfm, was capable of enveloping approximately 50 feet of test gallery in one minute. In order to hold the expansion ratio constant at 1000 to 1, the generator was operated at the 5000 cfm rated capacity with the excess foam being discharged outside the test gallery by means of a specially fabricated discharge chute. (See Figures 14 and 15.) The chute had two discharge vents, one into the gallery and one overboard, both of which were fitted with zippers to control their openings and consequently the rate of foam being discharged into the gallery. Several tests were conducted without a belt fire to establish the zipper settings for various foam discharge rates.

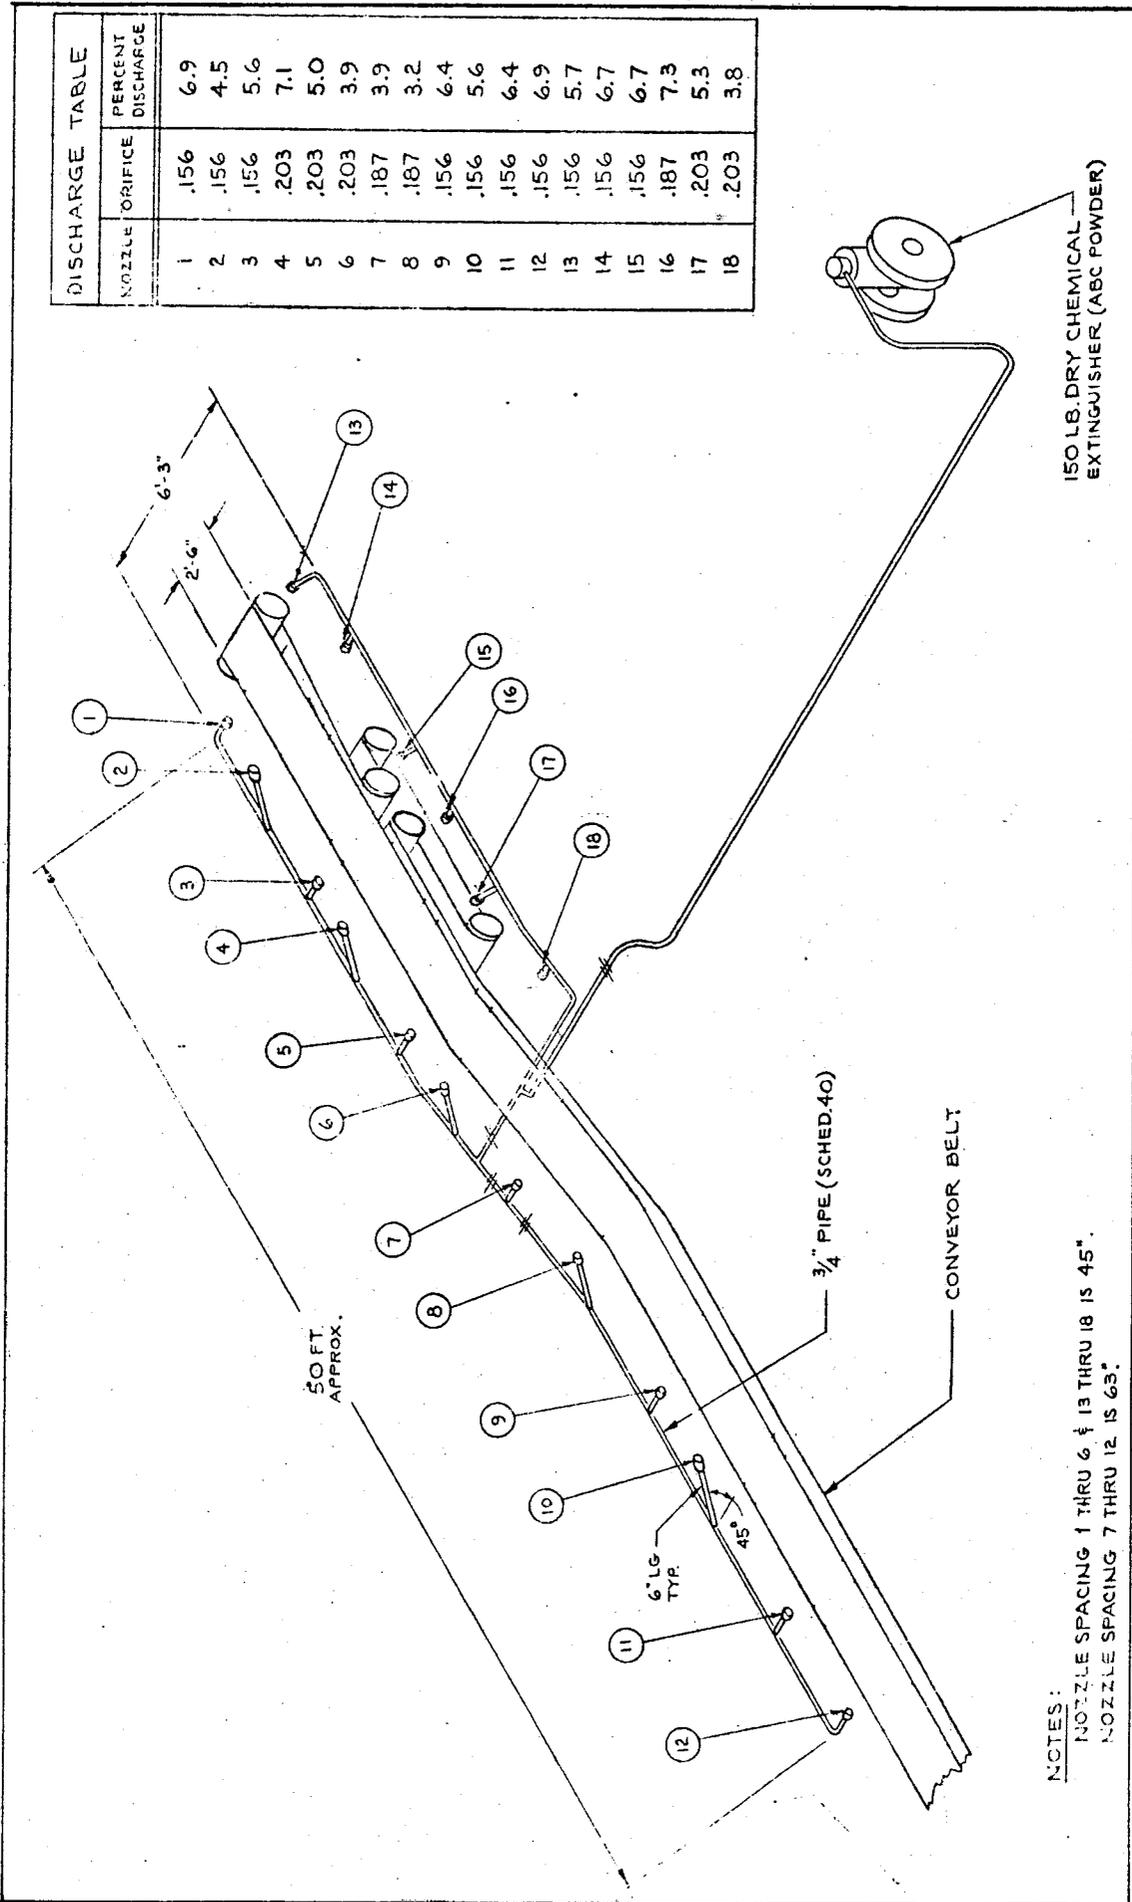
Figure 17 - Powder System Diagram, Coal Conveyor Dry Chemical Fire Protection System

The results of the eleven tests with the ABC multi-purpose powder are listed in Table B-III (Appendix B). The powder system tested was a Kidde system, and provided coverage for 50 feet, including 20.5 feet of the belt run. (See Figure 17.) The system consisted of three branches, one on either side of the take-up and drive mechanism up to the discharge pulley, and one along one side of the 20.5 feet of belt run adjacent to the take-up assembly. Distribution tests were conducted prior to the first fire test with powder to achieve a system design whereby approximately an equal proportion of powder was discharged from each of the three branches. The nozzles were arranged in an alternate pattern such that half were directed horizontally to discharge powder into the lower belt layer(s), and half were directed up at a 45° angle, to direct powder onto the top surface of the top belt. The powder reservoir was a 150 pound extinguisher unit pressurized to 350 psi. The powder used was ABC Multi-Purpose Dry Powder, manufactured by the Ansul Company.

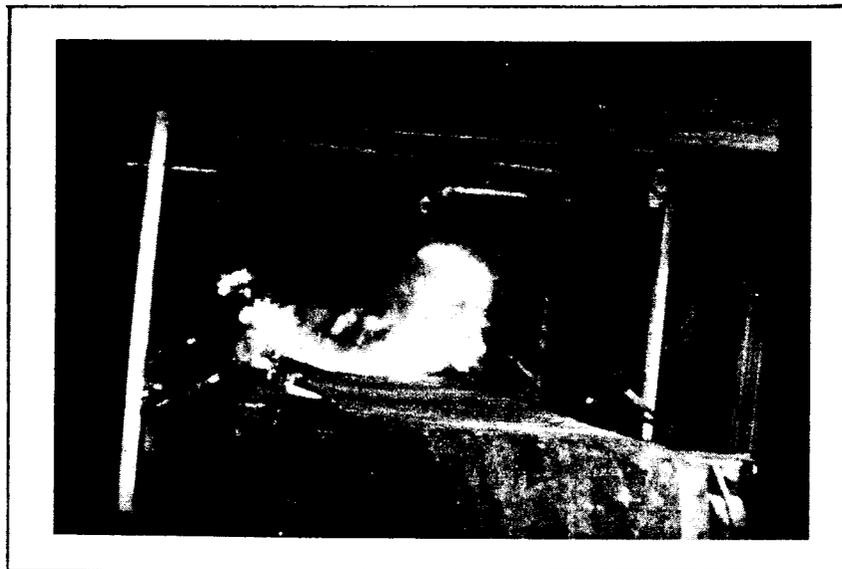
Figure 19  
Test Fire Prior to Actuation of Extinguishing System

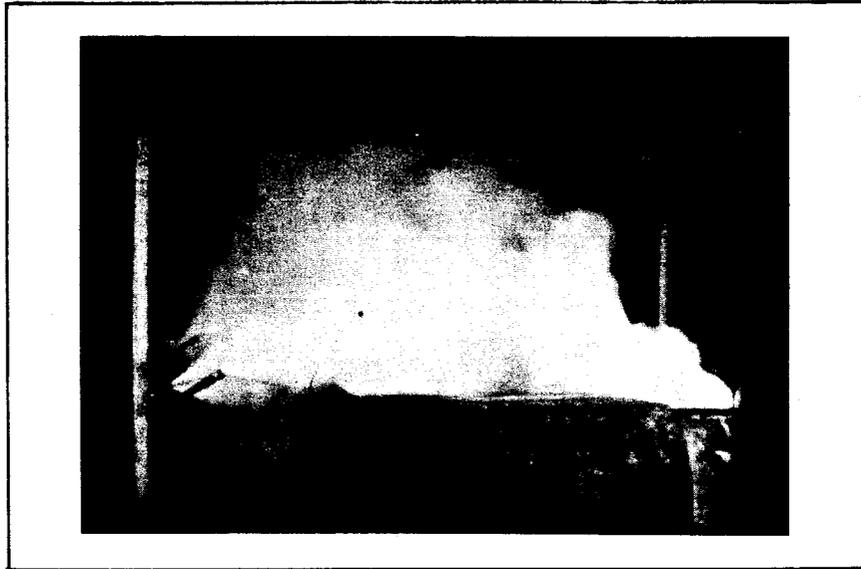
Figure 20  
Discharge of Powder

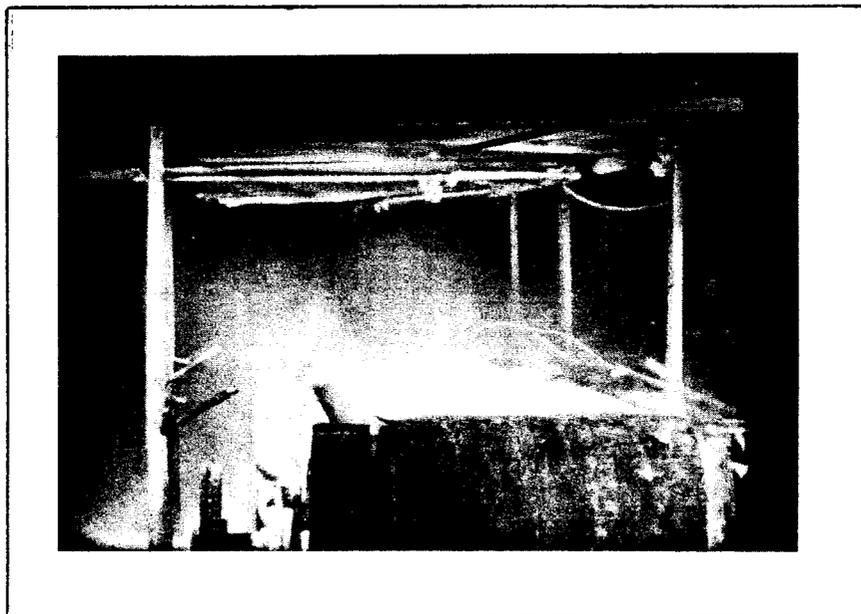
Figure 21  
View After Extinguishment

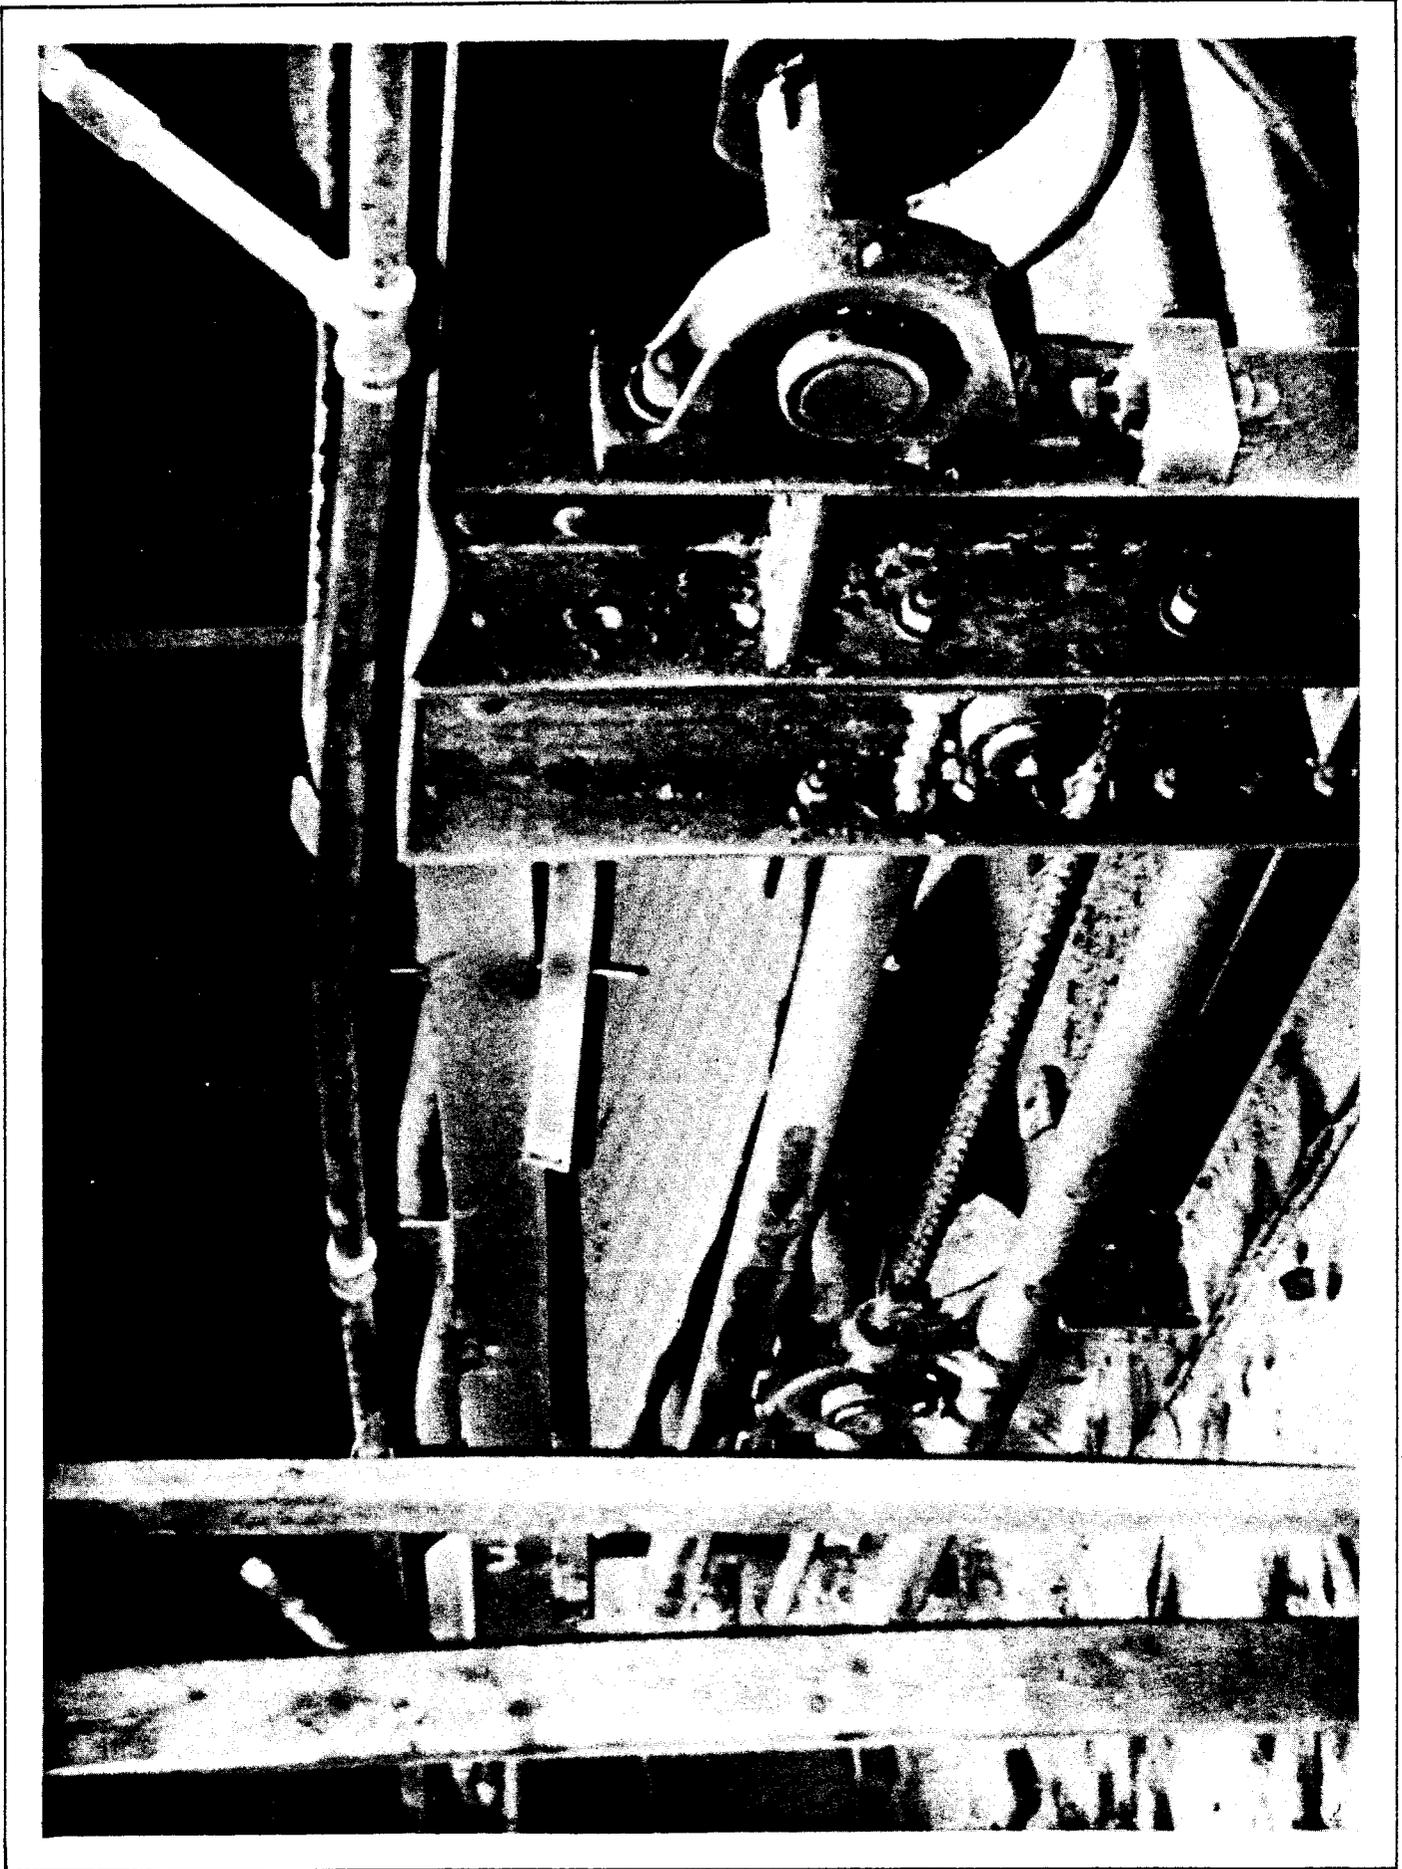
Figure 23  
View After Extinguishment Showing Penetration of Powder Into Takeup

The only extinguisher system parameter varied was the quantity of powder. Except for tests involving decking on the conveyor structure, all test fires were successfully extinguished with 75 pounds of powder, and some with 50 pounds. This included the standard test fire and tests with 350 fpm air flow and with the FR-2 belting. Figures 18 thru 21 are photos of test No. 114 conducted with 50 pounds of powder and with an air flow of 350 fpm. Figures 22 and 23 show powder penetration and distribution on other tests.

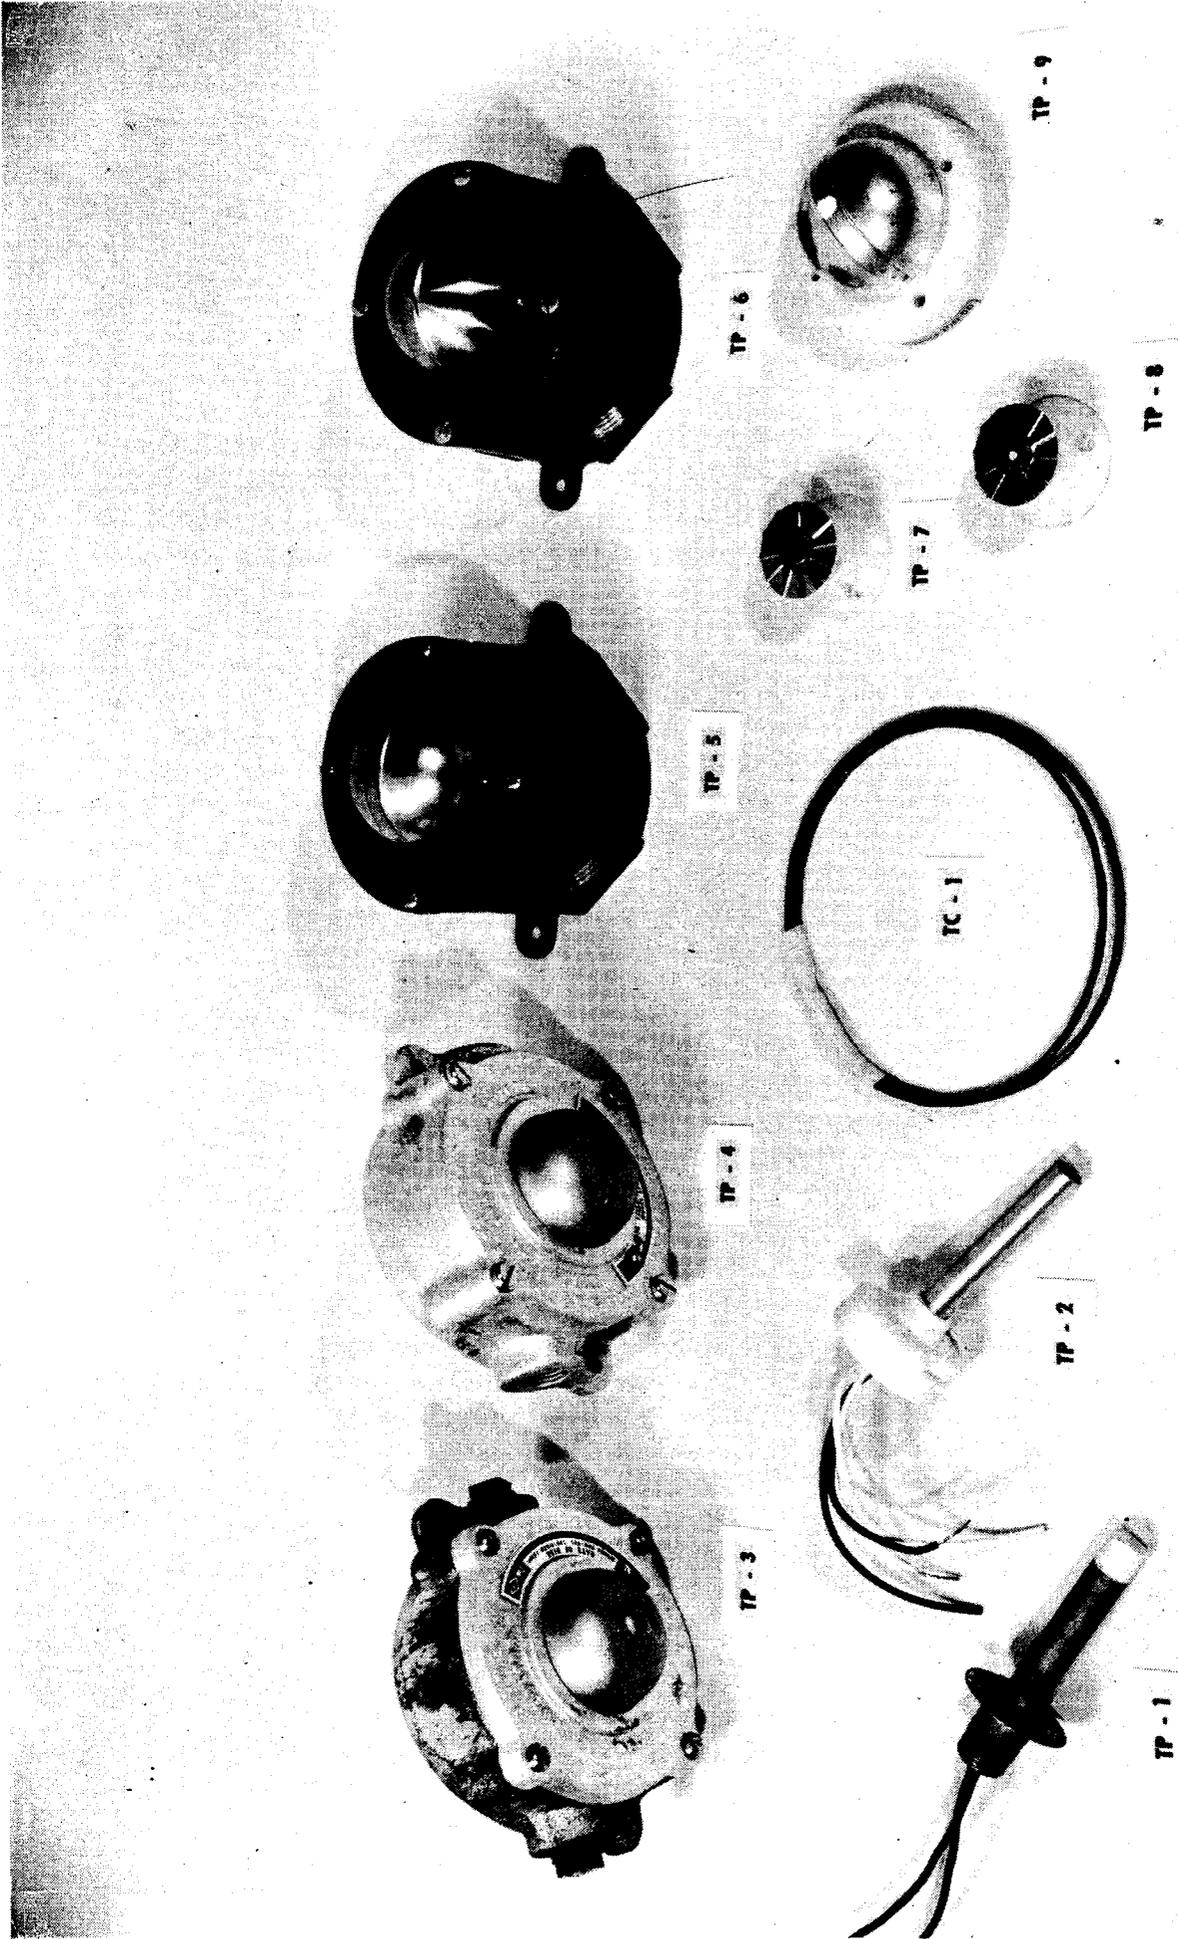
TP-1	140 <sup>o</sup> Rate Compensation (Fenwall Detect-A-Fire)
TP-2	135 <sup>o</sup> F Rate Compensation (Thermotech Model 302A-W)
TP-3	136 <sup>o</sup> F Combination Fixed Temperature/Rate of Rise, with explosion-proof base (Fire Devices Spot-Fire-Lowecator)
TP-4	136 <sup>o</sup> F Fixed Temperature, with explosion-proof base (Fire Devices Spot Fire Lowecator)
TP-5	135 <sup>o</sup> F Combination Fixed Temperature/Rate of Rise, with water-tight base (Kidde Fyrindex)
TP-6	135 <sup>o</sup> F Fixed Temperature, with water-tight base (Kidde Fyrindex)
TP-7	135 <sup>o</sup> F Fixed Temperature (Kidde Model S-2)

Figure 24  
Thermal Point Type Sensors

The thermal point type sensors tested included those listed as follows and shown in Figure 24.
