SUPPRESSION OF FIRES ON UNDERGROUND  
COAL MINE CONVEYOR BELTS

WALTER KIDDE & COMPANY, INC.  
BELLEVILLE, N.J.

USBM CONTRACT FINAL REPORT (Contract No. H0122086)

September 13, 1974

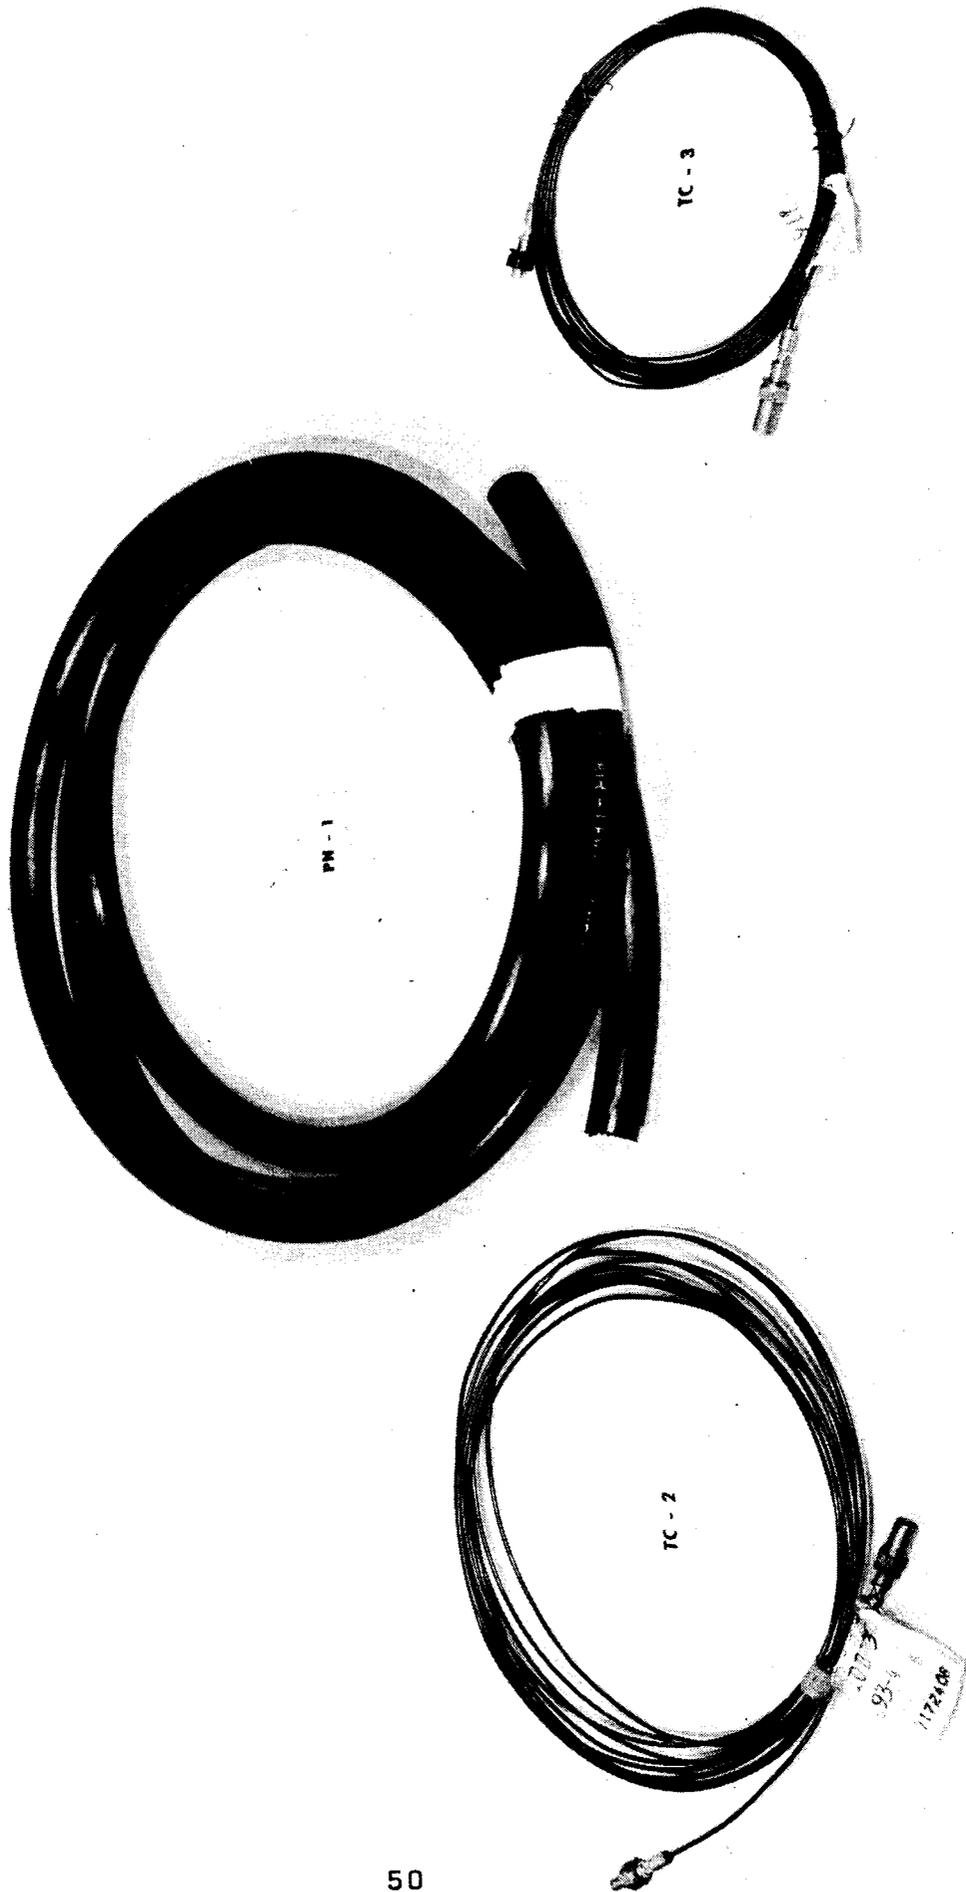
The averaging type thermistor core detector alarms when the average temperature over its 20 foot length reaches 140°F. If a shorter length were heated, the alarm temperature would be higher, such as 210°F if only 5 feet were heated. The detector element consists of two conductor wires embedded in a thermistor core which is contained in an Inconel sheath. The thermistor core decreases in resistance as its temperature increases, and causes the control panel to signal an alarm when the resistance drops to a predetermined level.

The discrete type continuous detector is similar in construction, except that the core is impregnated with a eutectic salt which becomes conductive at its 170°F eutectic temperature. Its alarm temperature remains the same regardless of the length of detector heated.

Figure 25  
Thermal Continuous Detector Elements

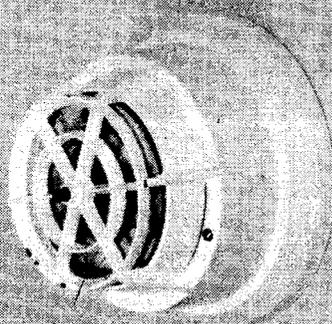
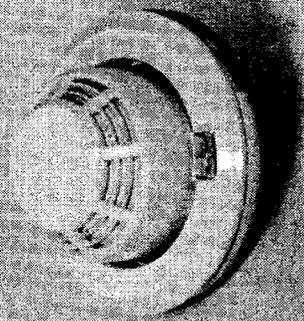
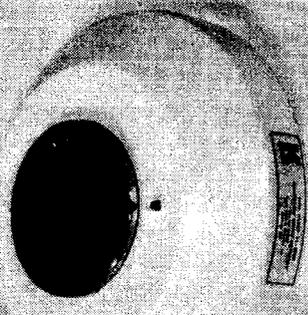
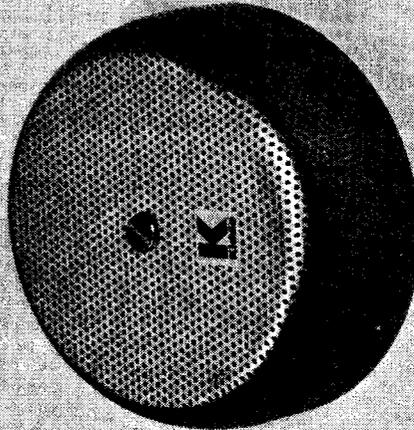
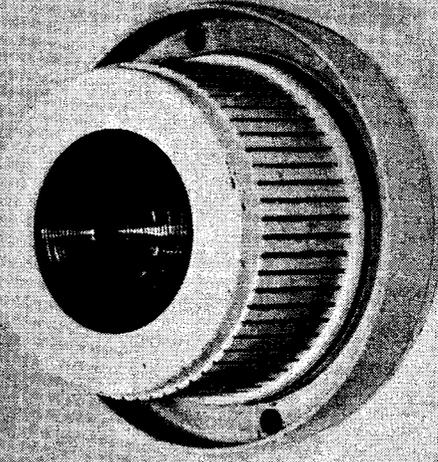
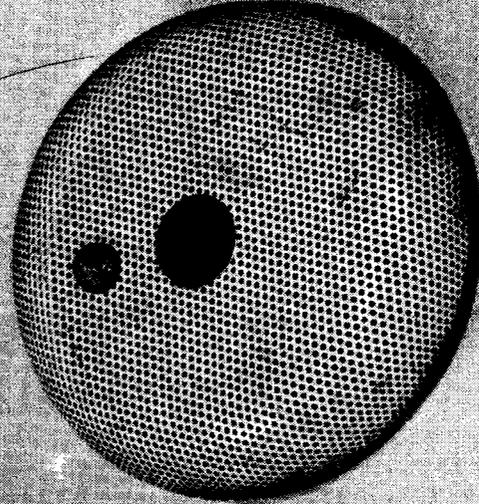
Figure 26  
Products of Combustion Detectors

Seven different products of combustion detection devices were included in the test program. Three were ionization types, three were photoelectric type, and one operated on a cloud density principle. The detectors tested are listed as follows and are shown in Figure 26:

SI-1	Combination ionization/moisture type (BRK Model SS69C)
SI-2	Ionization type (Pyrotronics Model DI-2)

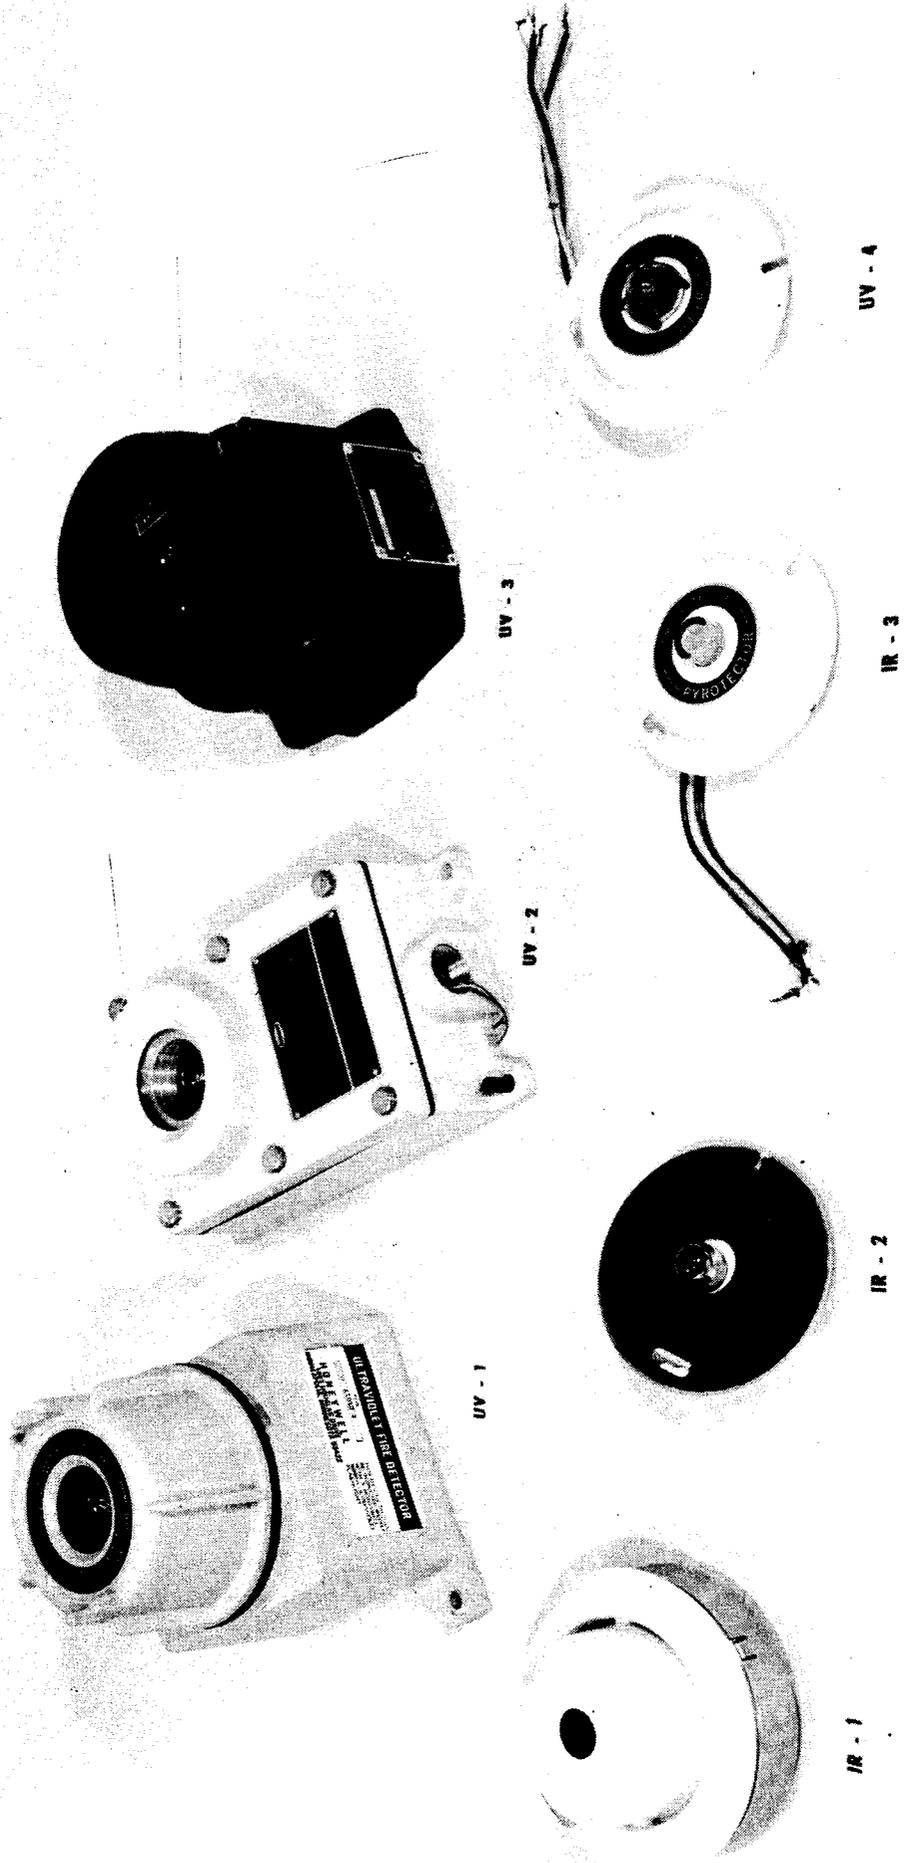
Figure 27  
Optical Detectors

As with smoke detectors, the sensitivity of optical detectors can usually be adjusted to the user's needs. This adjustment can even be made in the field on some devices. Higher sensitivity settings do, however, increase the probability of false actuations due to extraneous light sources such as welding operations, electric arcing, vehicle head lamps, cap lamps, and the like. Sensitivity of the above detectors to such extraneous light sources is discussed in the Environmental section of this report.

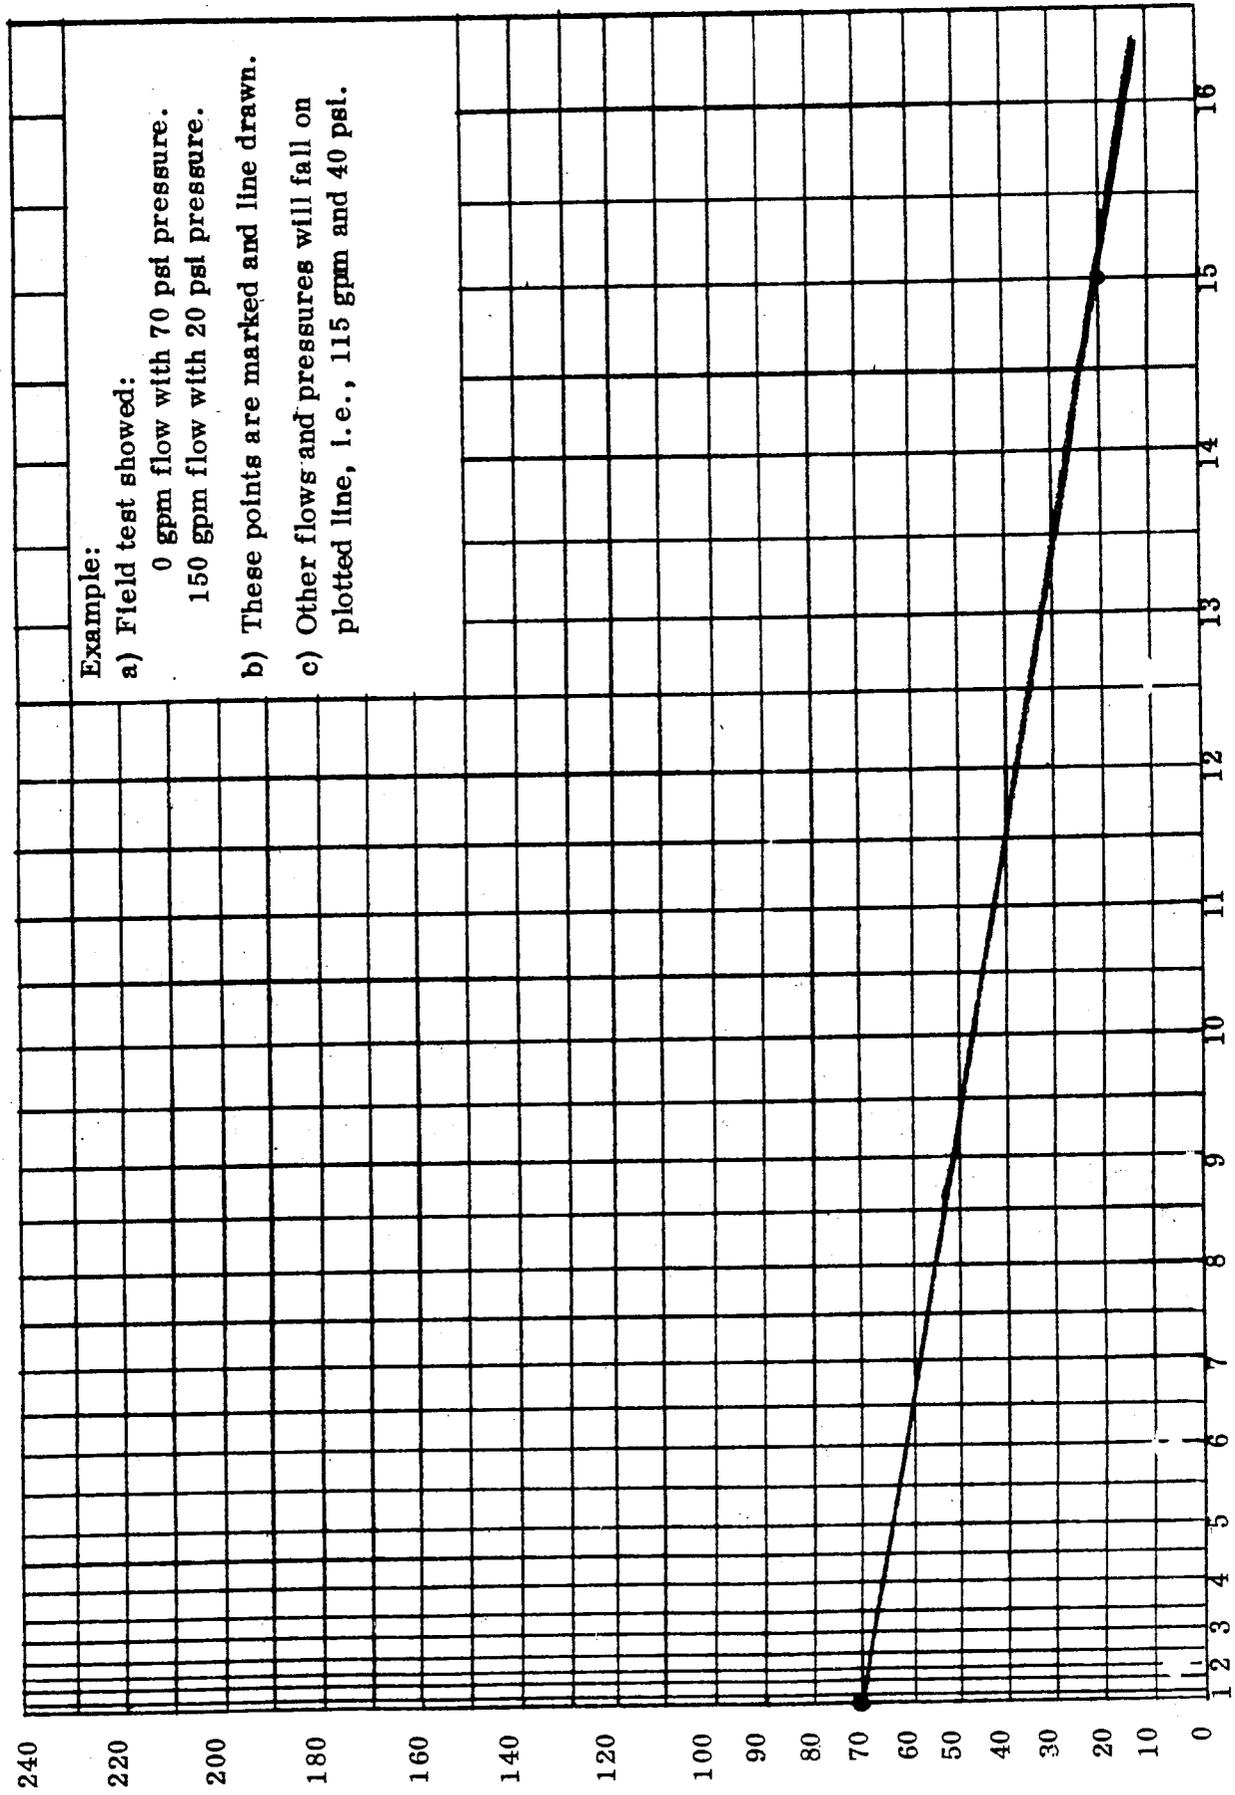
**Example:**

- a) Field test showed:  
 0 gpm flow with 70 psi pressure.  
 150 gpm flow with 20 psi pressure.
- b) These points are marked and line drawn.
- c) Other flows and pressures will fall on plotted line, i. e., 115 gpm and 40 psi.

For periodic checking of a sprinkler system, the system test pipe recommended in NFPA Standard No. 13 may be used. The test pipe should be at the end of the sprinkler system, so that the entire system, including the flow switch, is checked. The test pipe would include a valve, a pressure gage, and a known orifice, such as an opened sprinkler head. Or the system could be tested merely by replacing the last sprinkler with an open sprinkler. The pressure gauge is read with the water flowing through the open sprinkler, and the flow rate can then be determined from the known sprinkler flow characteristics. In the example shown in Figure C-1, the residual pressure with one open sprinkler would be approximately 65 psi (45 gpm flow rate).

The plotted point of pressure vs. flow rate should fall on the line plotted for the system. If it falls below the line, the system has been degraded, probably due either to a drop in static pressure, or to a restriction in the water lines. Any line restriction should, of course, be cleared. If the change is due to a drop in static pressure, a new line should be plotted to determine if the water supply is still adequate.
