PROGRAM INFORMATION BULLETIN NO. P05-21

SUBJECT: Non-Conforming Circuit Boards Used in GAI-Tronics GM1000A  
Ground Wire Monitors

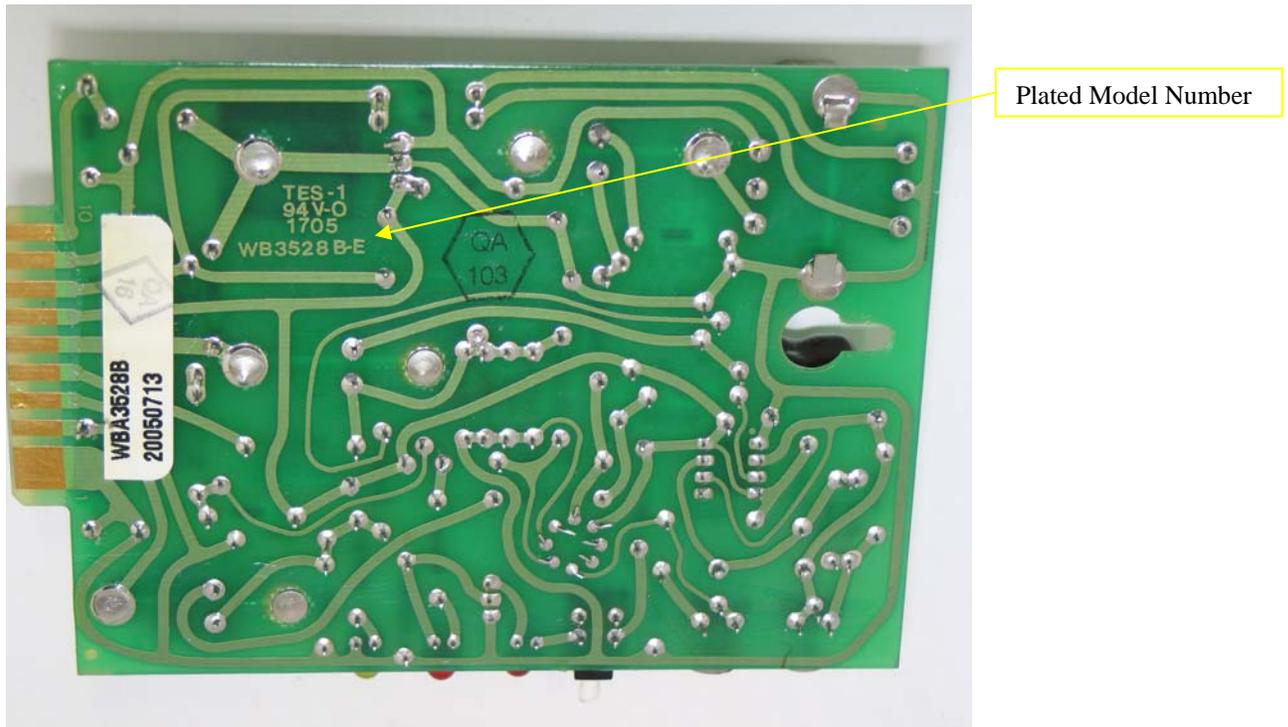
MSHA recommends that all non-conforming boards be removed from service and be replaced with circuit boards that meet the GM1000A Acceptance 030380FE criteria. Circuit boards that meet this acceptance criteria can be identified through the model number, WB3528B, plated on the bottom (trace side) of the circuit board (Fig.1) and WBA3528B screened on the top (component side) of the circuit board [Fig. 2(a)]. There may be an additional letter at the end

**Figure 1 - Accepted Circuit Board Trace Side (Bottom)**

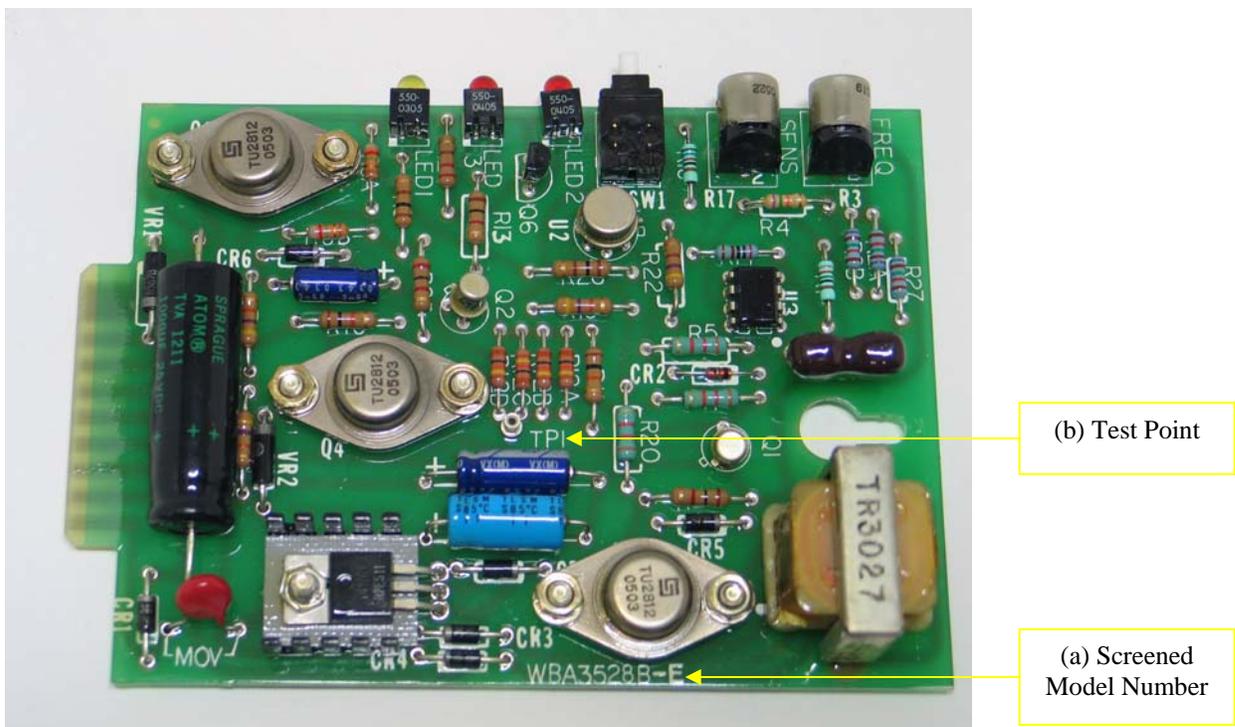
of the model number designating the circuit board revision. In addition there is a test point pin (TP1) [Fig. 2(b)] in the center of the circuit board.

**Figure 2 - Accepted Circuit Board Component Side (Top)**

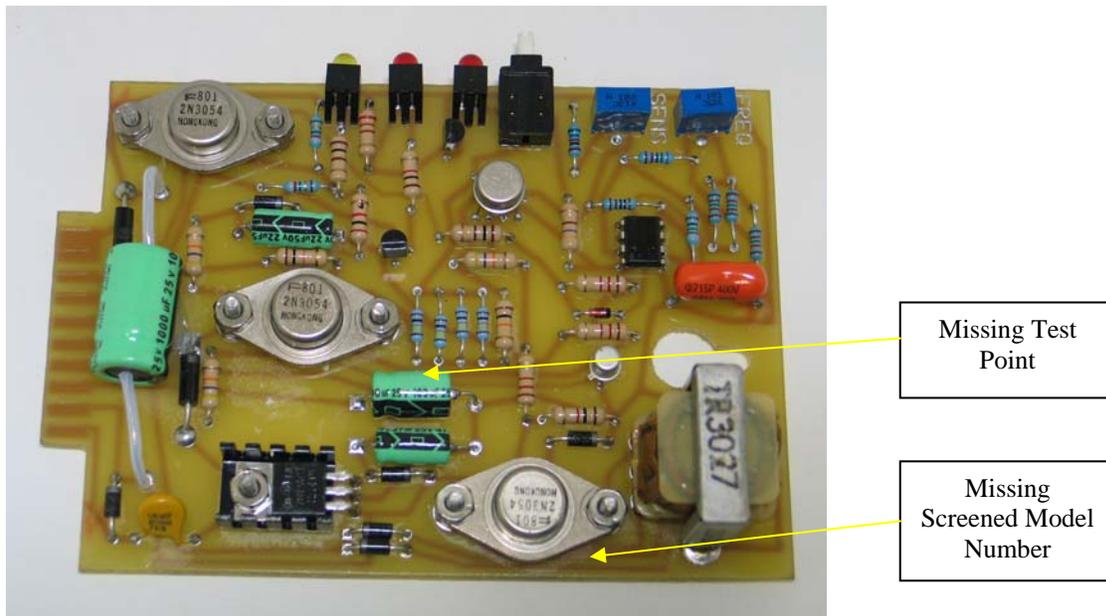
Non-conforming circuit boards will not have a model number identification on either side of the circuit board as shown in Figure 3 - Non-conforming Circuit

Board Component Side and Figure 4 - Non-conforming Circuit Board Trace Side. The non-conforming circuit boards as shown in Figure 3 will not have the identification screening shown in Figure 2 on the component side of the circuit board. The non-conforming circuit board will not have the test point pin shown in Figure 2 - Accepted Circuit Board and labeled in Figure 3 - Non-conforming Circuit Board. Another identifying characteristic of the non-conforming circuit board is the transposition of diode VR2 and resistor R15. Non-conforming circuit boards will have diode VR2 closer to the edge connector of the circuit board as shown in Figure 5a - Non-conforming Circuit Board instead as in Figure 5b - Accepted Circuit Board.

**Figure 3 - Non-conforming Circuit Board Component Side (Top)**

MSHA has discovered non-conforming circuit boards in GAI-Tronics GM1000A Ground Wire Monitors. The manufacturer of these non-conforming circuit boards is not known. After examination of the non-conforming circuit board, it has been determined that these circuit boards contain components that are not listed in the GM1000A Acceptance and therefore do not meet the acceptance criteria for the ground wire monitor. Because these circuit boards use non-conforming components and there appears to be no manufacturing controls with respect to the non-conforming boards, each circuit board may be built with different components giving each board a different operating characteristic. As a result, these circuit boards could pose an electrical danger which could cause serious or fatal injuries.

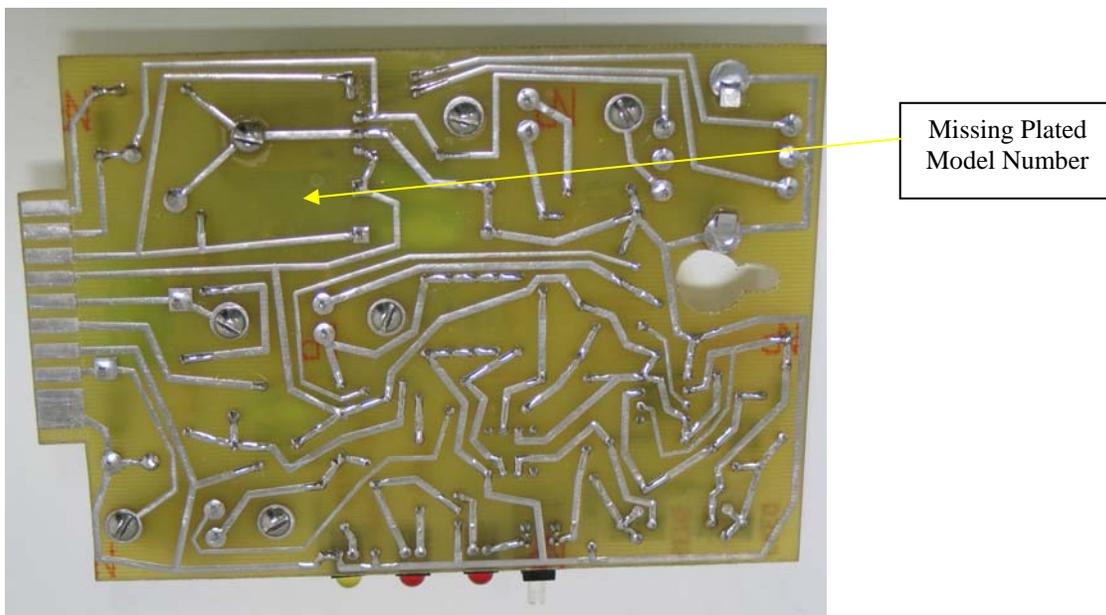
**Figure 4 - Non-conforming Circuit Board Trace Side (Bottom)**

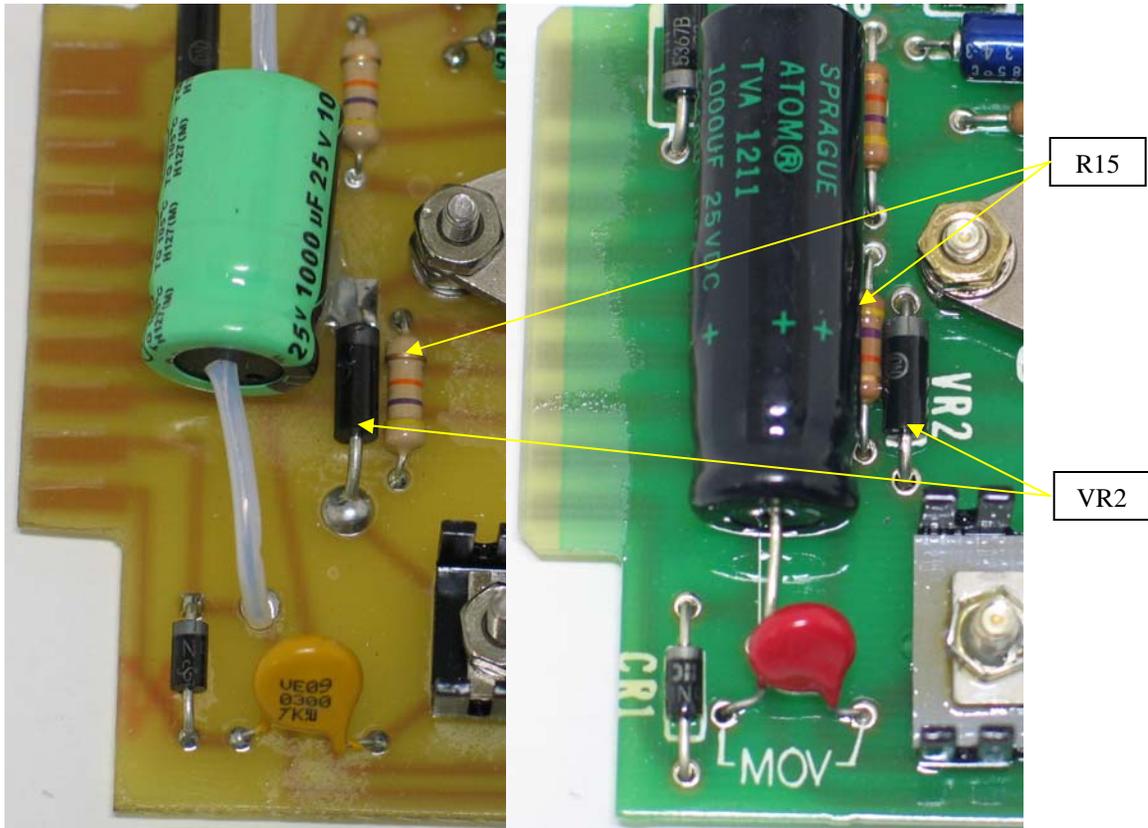
Figure 5a - Non-conforming Circuit Board

Figure 5b - Accepted Circuit Board
