## Polyurethane Foam Fire Hazard

On June 27, 2024, a fire occurred in an underground coal mine after a large quantity of polyurethane foam was injected into a roof cavity. This is the fourth uncontrolled heating event attributed to polyurethane foam application in 4 years. Polyurethane-based foam products produce heat from an exothermic chemical reaction. Injecting large quantities of polyurethane to fill voids can cause underground mine fires.

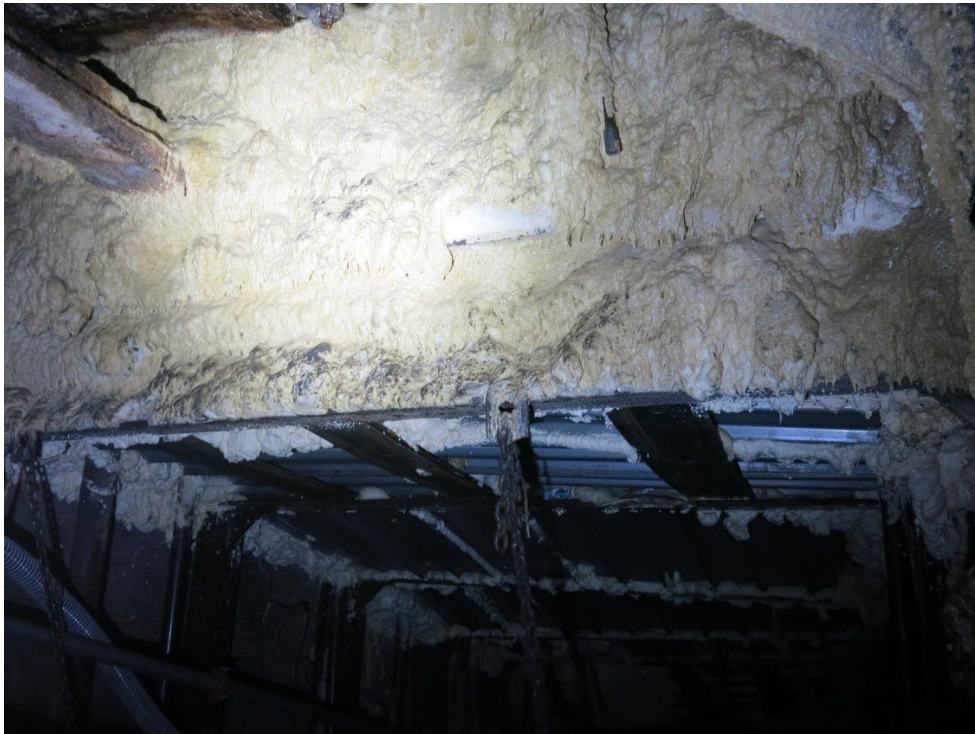
*Foam injected into a cavity above steel sets.*

- **Develop a Site-Specific Plan for Void Fills.** The plan should address appropriate formwork (placement of foam), injection volume and rates, personal protective equipment for chemical exposures, temperature monitoring, fire watch, and storage and handling.
- **Follow manufacturer's instructions.**
- **Use the Proper Product.** Do not fill large voids with polyurethane foam products that generate a hazardous amount of heat.
- **Train Miners.** Miners working in the application of polyurethane foam should be trained in the hazards, safety precautions, and manufacturer's Safety Data Sheets (SDS).
