Safety Alert

Electro-Hydraulic Lifts

Use qualified welders. Inspect welds and metal components. Train users.

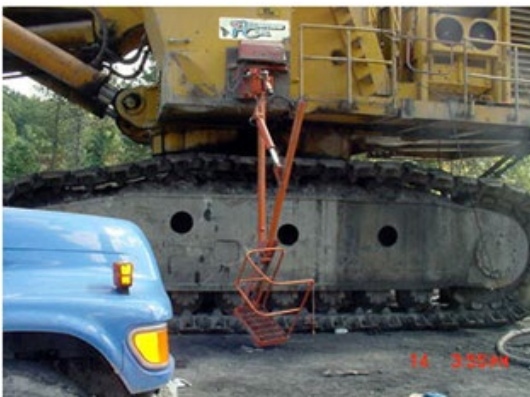
- A mechanic died while being lowered in an electro-hydraulic aerial lift. A weld splice fractured on a recently repaired arm of the lift, causing the arm to strike the victim in the head (Figure 1). The weld failed because of poor weld quality from an improper repair.
- A welder died while being lowered in an electro-hydraulic aerial lift when the lift arm catastrophically fractured at a critical weld connecting the arm support to its lift cylinder (Figure 2). Undetected cracks existed in the weld and the surrounding metal prior to failure.

Figure 1: Failure of lift from improper welding

- **Only qualified welders** should perform all welding.
- **Determine the service/fatigue life** of mechanical systems or parts by consulting with the manufacturer.
- **Inspect welds** following installation and repairs, and periodically during service life.
- **Train users in the proper operation of lifts** – including not exceeding their design capacity.
- **Routinely examine metal components** for signs of weakness, corrosion, fatigue cracks, bends, buckling, deflection, missing connectors, etc.
- **Use nondestructive test methods to detect cracks** that may be indistinguishable to the eye.
- **Take cracked mechanical components out of service immediately.** Small cracks can quickly grow and lead to catastrophic fracture.

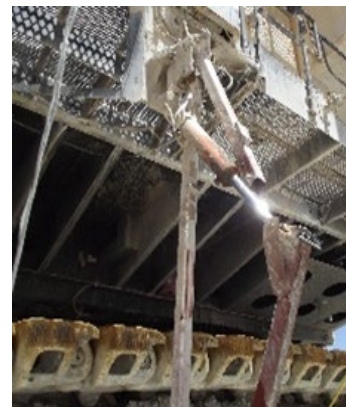
Figure 2: Failure of lift from undetected cracking
