**Fatality #21 - October 29, 2008**  
**Fall of Material - Utah - Copper Ore NEC**  
**Kennecott Utah Copper Corp - Copperton Concentrator**

**METAL/NONMETAL MINE FATALITY** - On October 29, 2008, an 81 year-old truck driver with 55 years of experience was fatally injured at a surface copper operation. The victim was unfastening a load of pipe when one 50-foot section rolled off the flatbed trailer and struck him.

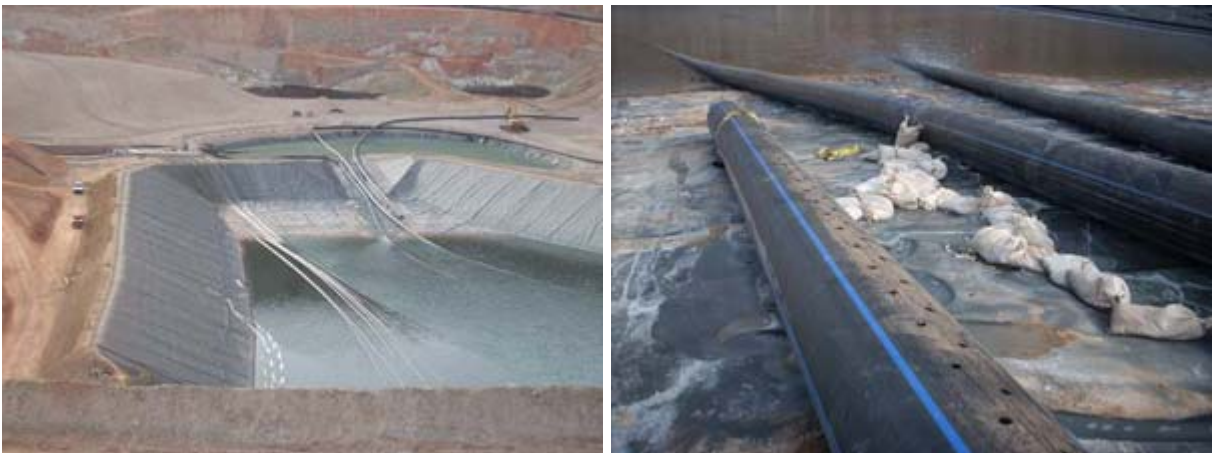
**METAL/NONMETAL MINE FATALITY** - On January 9, 2010, a 20 year-old contractor laborer with 21 weeks of experience was fatally injured at a copper operation. Two track excavators were being used to place a 400-foot long section of 24-inch diameter plastic pipe into a pond. To facilitate the installation process, the pipe was placed on top of an adjacent section of pipe that was previously placed on the plastic lining of the pond. During installation, the pipe being installed misaligned and the victim and two coworkers attempted to remove the end of this pipe from the top of the existing pipe. At that time, the end of the pipe shifted, hit a coworker, and then struck the victim. The victim fell to the ground and the pipe landed on him. The coworker was not injured.

- Task train all persons prior to performing any work.
- Always stay clear of suspended loads.
- Use taglines of sufficient length to adequately protect persons from potential hazards.

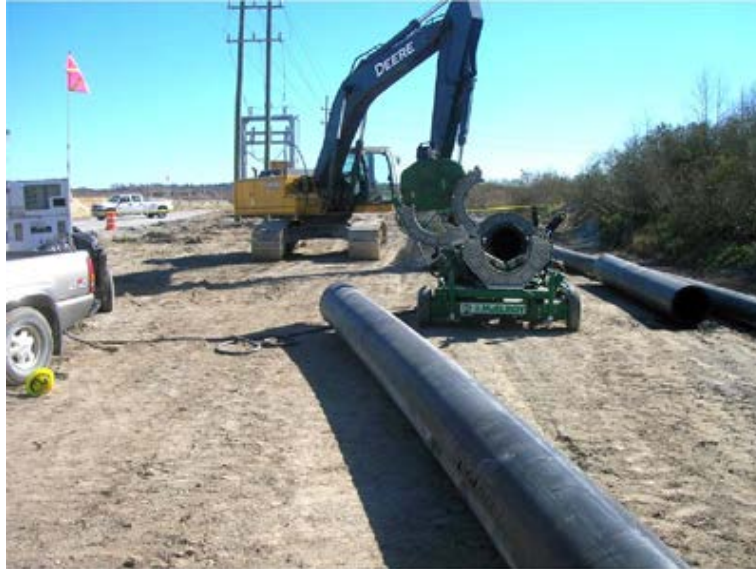
**METAL/NONMETAL MINE FATALITY** - On March 2, 2011, a 51 year- old contract superintendent with 24 years of experience was killed at a phosphate rock operation. The victim was attempting to join two ends of 24-inch diameter pipe. Two excavators were being used to position the pipe in the saddle of a pipe fuser when the pipe slipped out and struck him.

- Establish safe work procedures and identify and remove hazards before beginning a task. Follow the equipment manufacturer's procedures for the work being performed to ensure that all hazards have been addressed.
- Train persons to recognize the hazards associated with performing a task.
- Repair broken or damaged equipment immediately.
- Block material against motion to assure energy cannot be released while the task is performed.
- Do not place yourself in a position that will expose you to hazards while performing a task.
- Monitor personnel routinely to determine that safe work procedures are followed.

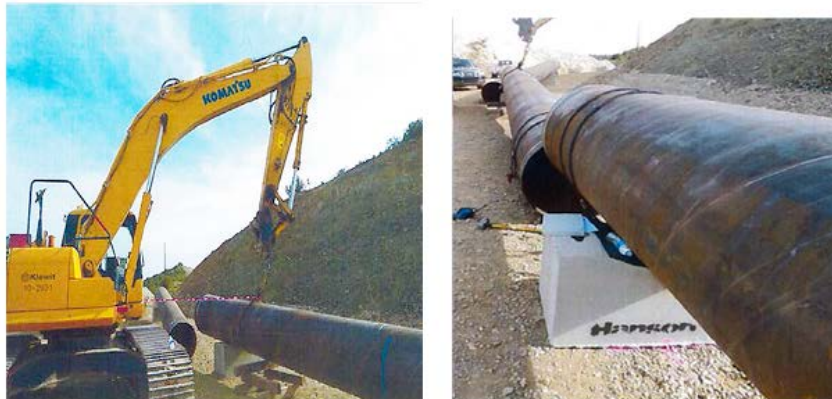
**METAL/NONMETAL MINE FATALITY** - On April 4, 2013, a 30-year old general foreman with 6 years of experience was killed at a copper ore operation. An excavator was being used to position a 36-inch diameter by 40-foot long section of pipe to connect it to another section of pipe. The pipe, attached to the excavator by a lifting strap, shifted and fell on the victim.

- Establish and discuss safe work procedures. Identify and control all hazards associated with the work to be performed along with the methods to properly protect persons.
- Task train all persons to recognize all potential hazardous conditions and to understand safe job procedures for elimination of the hazards before beginning work.
- Attach taglines to loads that may require steadying or guidance while suspended.
- Securely block equipment against hazardous motion to ensure energy cannot be released while performing work.
- Never work in the fall path of objects/materials of massive weights having the potential of becoming off-balanced while in a raised position.
- Implement measures to ensure persons are properly positioned and protected from hazards while performing a task.
- Monitor personnel routinely to determine that safe work procedures are followed.

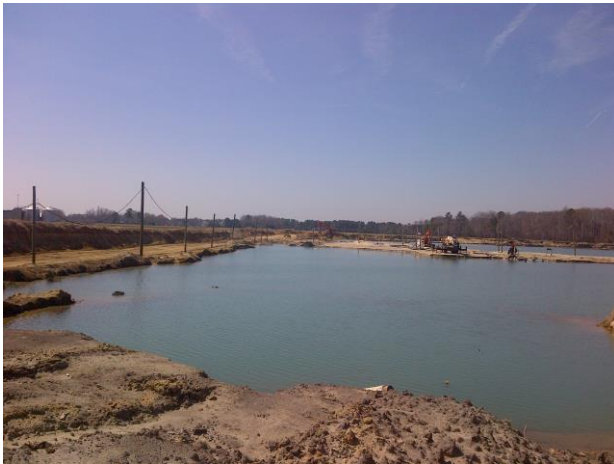
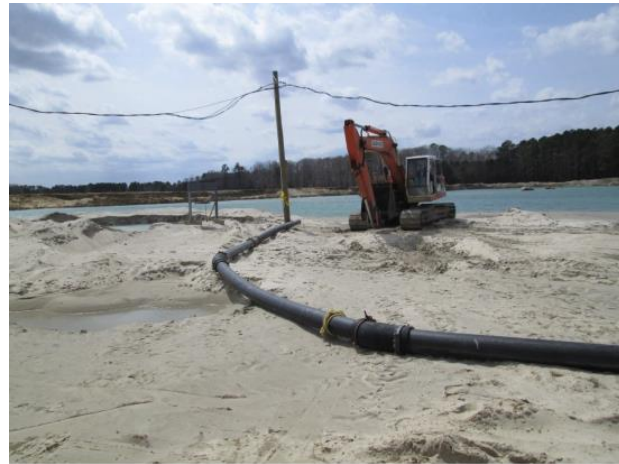
**METAL/NONMETAL MINE FATALITY** – On March 27, 2014, a 64-year-old foreman with 32 years of experience was seriously injured when he was struck by a section of plastic water pipe as it was being moved by an excavator. The victim was transported to a hospital where he died on March 30, 2014, as a result of his injuries.

- Establish and discuss safe work procedures before beginning work. Identify and control all hazards associated with the work to be performed and the methods to properly protect persons.
- Task train all persons to recognize all potential hazardous conditions and to understand safe job procedures for elimination of the hazards before beginning work.
- Wear suitable hard hats where falling objects may create a hazard.
- Stay clear of a suspended load.
- Attach taglines to loads that may require steadying or guidance while suspended.
- Implement measures to ensure persons are properly positioned and protected from hazards while performing a task.
- Monitor persons routinely to determine safe work procedures are followed.

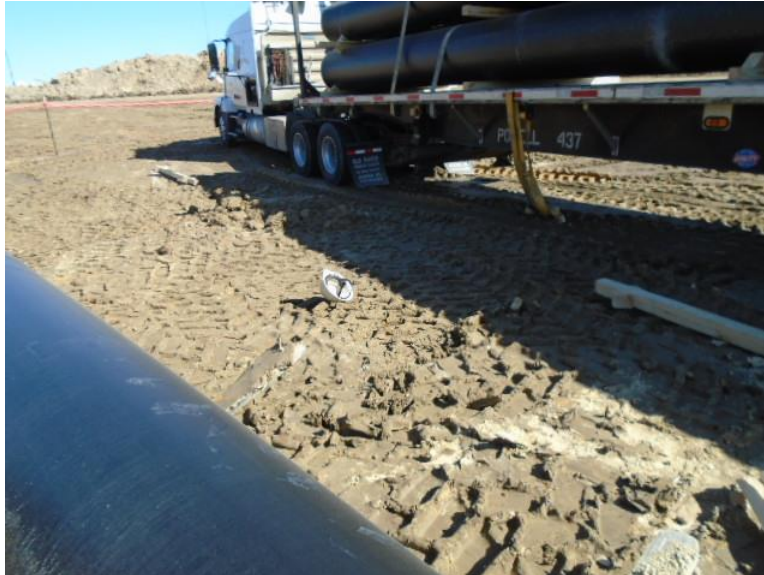
**METAL/NONMETAL MINE FATALITY** – On February 26, 2016, a truck driver delivering multiple sections of polyurethane pipe was struck by a section of pipe during the unloading process. A forklift removed two sections of pipe from the passenger side of the truck, and then left the area with the two sections. While the forklift was away, a single, unsecured section of pipe rolled off on the driver's side of the truck and struck the victim. Each section of pipe was approximately 50' long and weighed approximately 1,750 pounds. Miners began first aid but the driver was unresponsive. He was transported to the local hospital and later died.

- Analyze all tasks, identify possible hazards prior and eliminate the risks prior to beginning work.
- Before beginning work, establish safe work procedures, train and discuss with all persons performing the task.

- Examine work areas during the shift for hazards that may be created as a result of the work being performed.
- Evaluate the stability of the material before unfastening a load. Pay particular attention to loads that may have shifted or become unstable during transport.

- Install secondary supports (side stakes) of adequate height and strength to prevent material from falling when the load is unfastened; or prior to unfastening the material, secure the item being unloaded to the machine used in the unloading process.

- Stand clear of items of massive weights having the potential of becoming off-balanced while being loaded or unloaded.
- Implement measures to ensure persons are properly positioned and protected from hazards while performing a task. Ground personnel should be highly visible. Unauthorized persons should be kept clear of the area.
