METAL / NONMETAL

Near Miss Accident

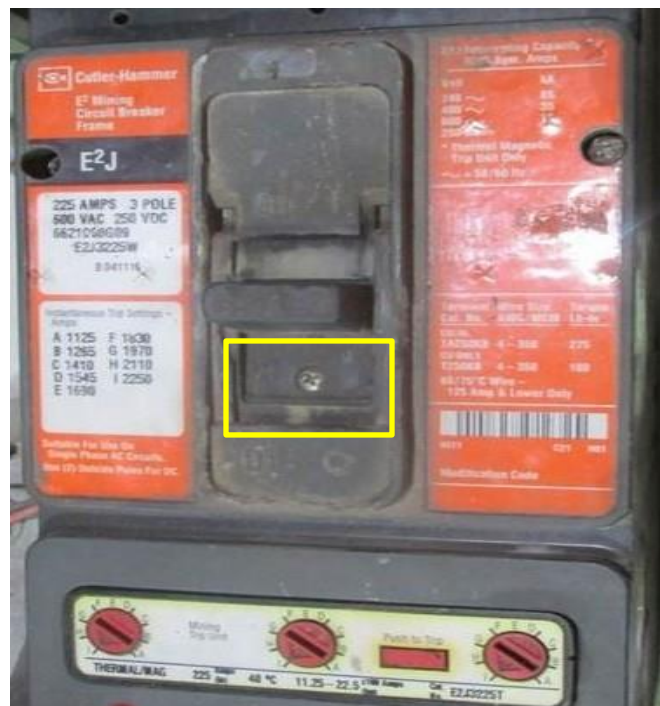
Underground Zinc Mine – A miner received an electrical shock when he contacted an exposed circuit breaker handle mounting screw (yellow box). When the miner operated the switch, his hand came into contact with the mounting screw, which was in direct contact with one phase of the 480 volt circuit. When the circuit breaker was disassembled, it was discovered that one of three cover shields had broken, leaving the handle mounting screw exposed.

- Before operating a circuit breaker, a visual inspection of the breaker and associated equipment must be done. If any part of this equipment looks out of place, stop and contact a qualified electrician.

- Any exposed metal should be considered energized unless verified that it is not. Do not touch exposed metal on or around a molded case circuit breaker unless using proper PPE for the application.

- Ensure handle cover plates/slides are in place before electrical equipment is put into service. These plates should slide back and forth smoothly with the handle as it proceeds through the different handle positions (Off, Tripped, On).

- Conduct frequent inspections on heavy use electrical equipment to ensure that deficiencies are corrected before they cause an accident.
- Set up and follow a routine maintenance program to replace worn components.

- If a circuit breaker is determined to need service, it is highly recommended that it be sent back to the manufacturer in order to meet factory specifications.
