# METAL / NONMETAL

## Serious Accident

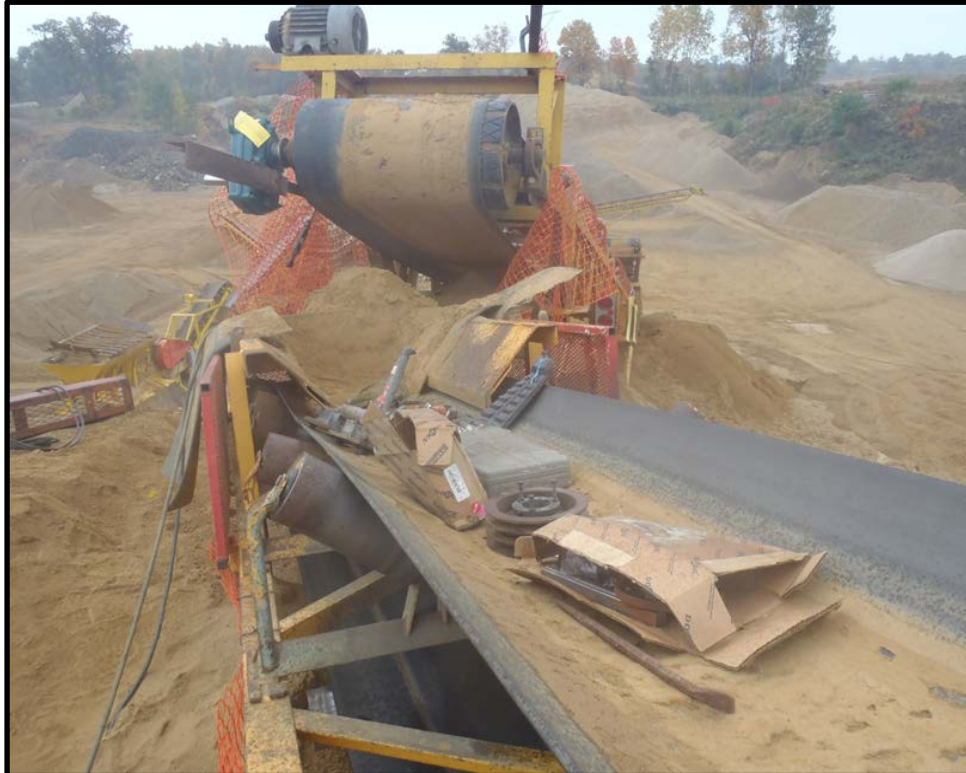
Sand & Gravel Mine – A miner fell from a conveyor and received serious injuries. The miner was working atop the tail pulley section of an inclined conveyor while changing a speed reducer; he fell approximately 42 inches to the ground. There were no handrails and the two miners were not using fall protection equipment.

- Establish safe work procedures, which include incorporating the manufacturer's recommendations, to assure that workers are not exposed to hazards when performing maintenance, repairs, or demolition activity.
- Prior to beginning work, ensure that all workers are trained in safe work procedures.
- Examine work areas during the shift for hazards that may be created as a result of the work being performed.
- Before starting any work, clear the area of tripping and stumbling hazards.
- Provide and maintain safe access to all work areas.
- Secure structures against unexpected movement when performing demolition work.
- Stay focused on your work for your own safety and the safety of your fellow workers.
