J. H. FLETCHER & CO. Box 2187 – Huntington, WV 25722-2187 – 304/525-7811 – FAX 304/525-4025

INFORMATION BULLETIN NO. 114

SUBJECT: DAMAGE TO TWO-LEG HINGED CANOPY

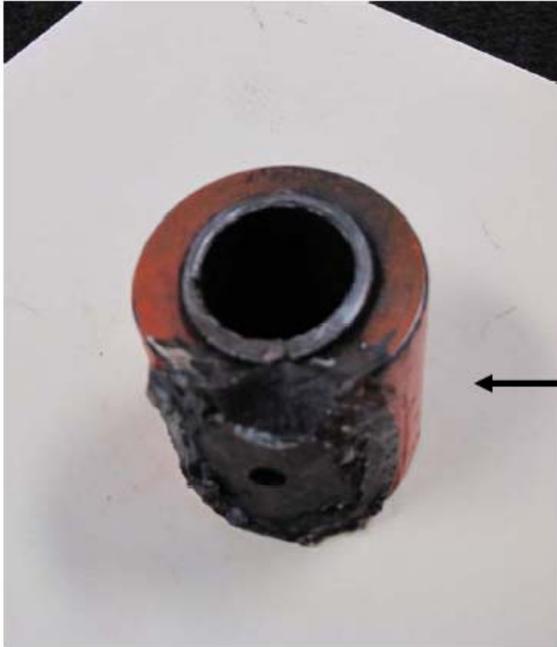
ATTACHMENT 1

In November 2009 an accident occurred at a West Virginia mine. The information obtained by J.H. Fletcher & Co. ("Fletcher") indicates that the roof bolter operator ribbed the tram canopy while tramming the roof bolter. The operator steered the machine into the rib. The damage to the tram canopy cylinder was so severe that the cylinder eye separated from the cylinder rod (Attachment 1). When this event took place the cylinder was no longer connected to the tram canopy and the canopy fell on the operator's head. The bolter had tram canopy extensions installed.

CYLINDER EYE

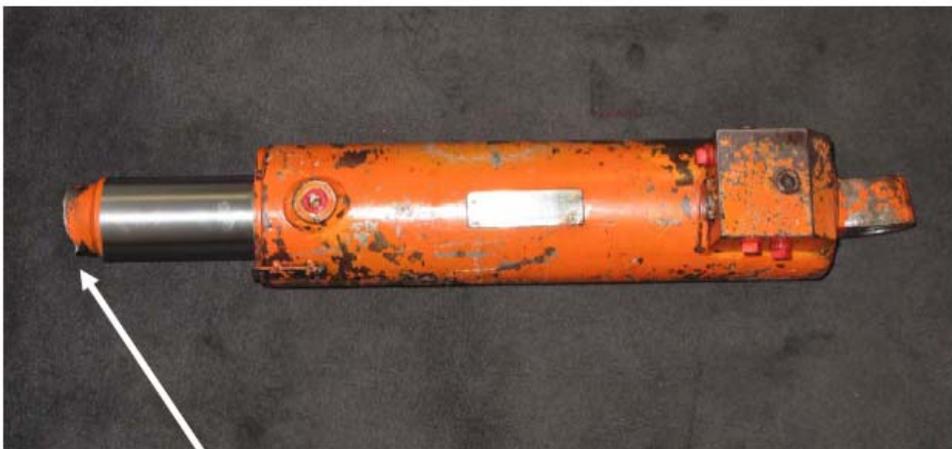
CYLINDER SEPARATED FROM EYE

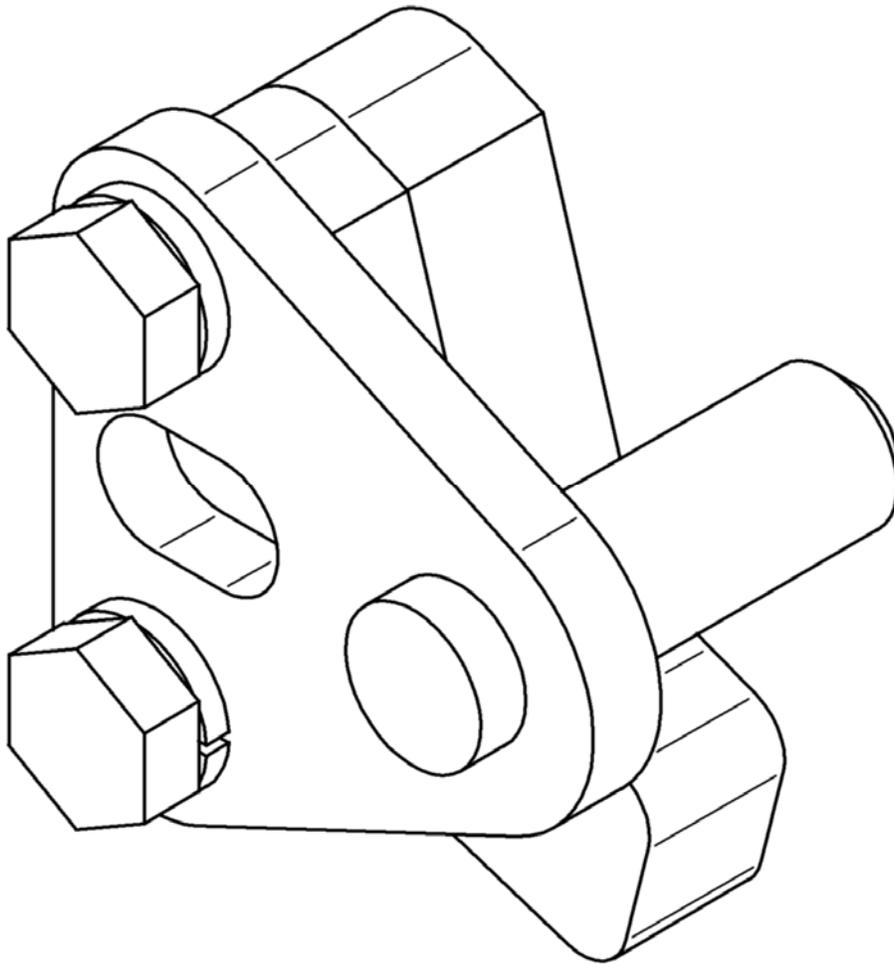
ATTACHMENT 2

“tram canopy stops” (Attachment 2). The available canopy stops are designed for a two-leg hinged type of canopy arrangement only. When placed on the canopy leg supports, the canopy stops prevent the canopy from falling all the way to the frame if the canopy support cylinder or its attachment to the canopy is broken (Attachment 3).

CANOPY STOP

2. Contact Fletcher’s Service Department or your local Fletcher authorized distributor to order the stop (part no. 422007). Provide the serial number of the machine(s) for which you are ordering the stops and you will be given a quote for the stop(s) for your specific machine(s).

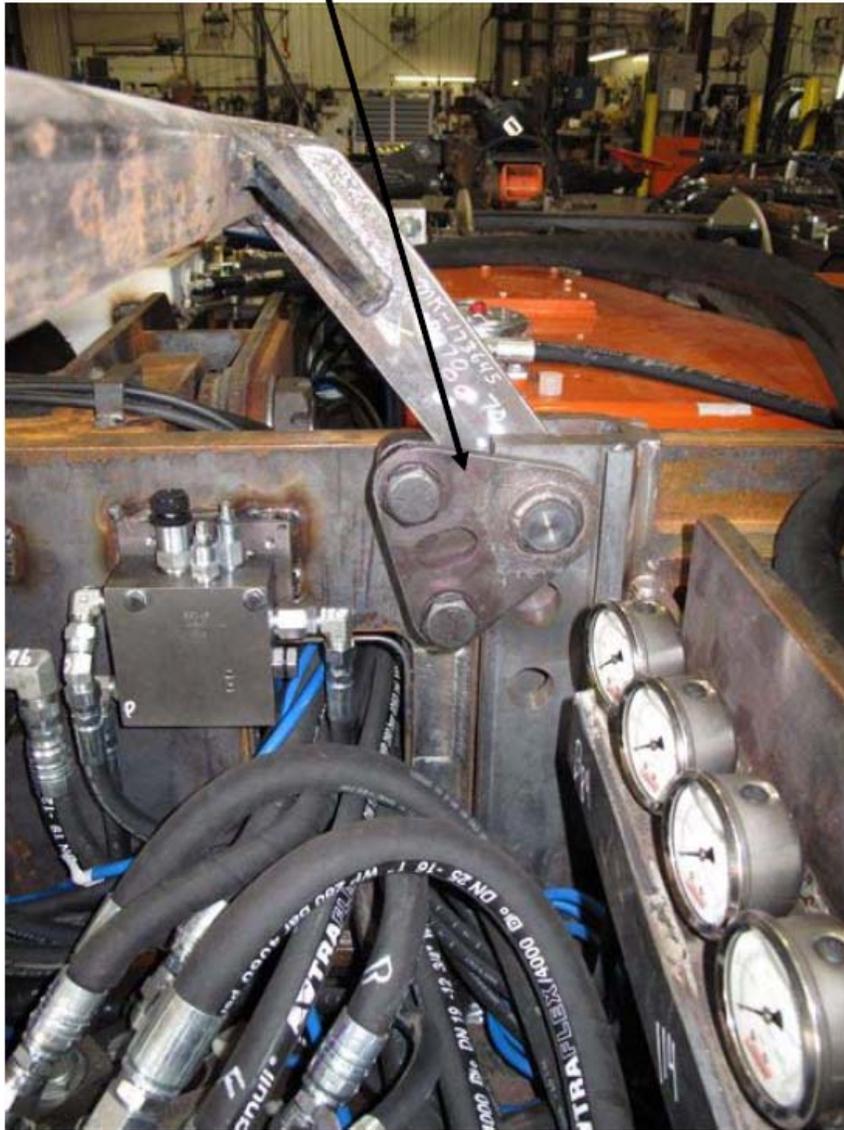
ATTACHMENT 3

**STOP AS SHOWN ON
SUPPORT POST**

3. Your machine will be equipped with either a hydraulic cylinder or a manual adjust post. If your machine is equipped with a hydraulic cylinder, when you receive the stops it will be necessary to change the hydraulic circuit. Fletcher requires that you change the tram canopy cylinder hydraulics so that when it is activated it is gravity feed down only. Pressure down of the tram canopy cylinder could cause damage to the canopy, hydraulic cylinder, or tram canopy stop.
