# Safety Hazard Alert

## High Voltage Meters

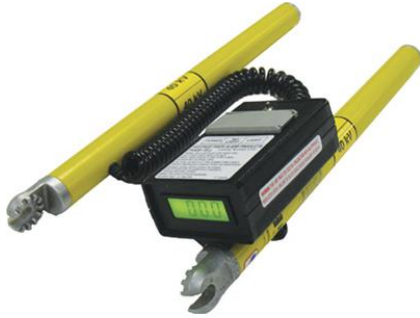
In a recent accident, a miner was using a high voltage meter, similar to the one above. During the accident, the coiled cord vaporized and the arc flash knocked the miner to the ground.

- Thoroughly evaluate the situation and ensure that you are using testing equipment that is properly rated for the voltage being tested.
- Be sure to completely understand the manufacturer's instructions and testing procedures for the equipment you are using. If you have any concerns, contact the manufacturer.
- Always use proper PPE when conducting any electrical testing on energized equipment.

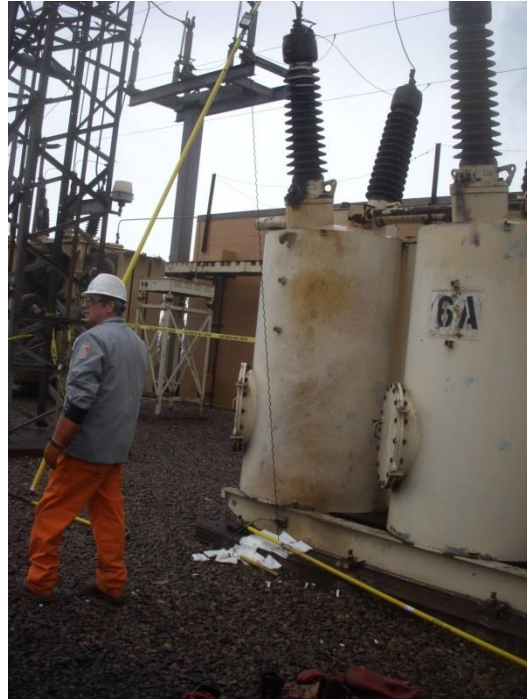
Several factors contributed to the accident: (1) the meter was not properly configured for the voltage being measured; (2) the manufacturer's instructions for the meter did not explicitly state the proper technique for taking voltage measurements (phase-to-phase or phase-to-ground); and (3) the manufacturer's instructions did not provide sufficient warning to keep the meter body, the coiled cord, and the fiberglass housings away from both energized and grounded parts. Sufficient clearances must be maintained for these components to ensure that a phase-to-phase or phase-to-ground fault does not occur.
