Fatality #23 - October 16, 2008
Machinery - Underground - Illinois
White County Coal, LLC - Pattiki

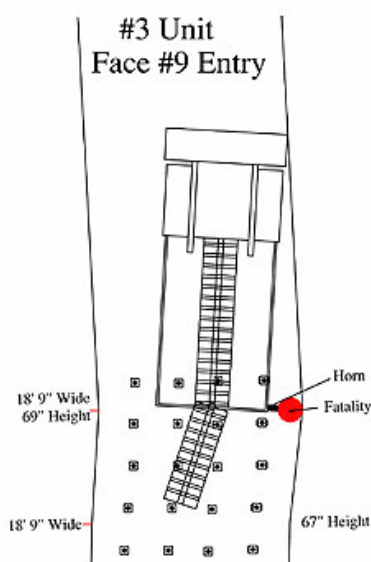
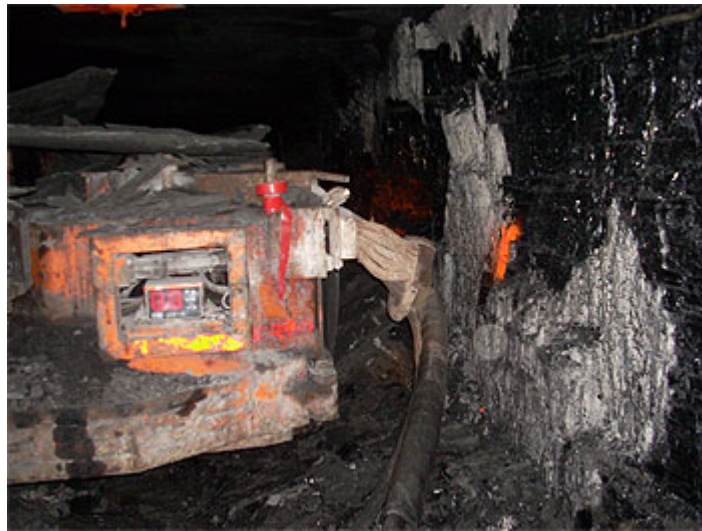
COAL MINE FATALITY - On Thursday, October 16, 2008, a 45-year old continuous mining machine operator was fatally injured in a crushing type accident. The operator was crushed between the cable horn on the radio-controlled continuous mining machine and the coal rib. The victim was apparently positioning the machine while standing adjacent to the cable horn. The coal seam height in this area was measured at 5 ½ feet. There were no witnesses to the accident.

- Install and maintain electronic proximity detection devices. [See the proximity detection single source page on the MSHA website.](#)
- Develop proactive programs, policies, and procedures for starting and tramming remote-controlled continuous mining machines.
- Train all production crews and management in the programs, policies, and procedures and ensure that they are followed.
- Ensure that mining machine operators are in a safe location while tramming the continuous mining machine from place to place or in the entry during cutting and loading.
- Ensure everyone is outside the machine turning radius before starting or moving the equipment.
