**Fatality #14 - October 27, 2009**  
**Hoisting - Underground - West Virginia**  
**Newtown Energy Inc - Eagle Mine**

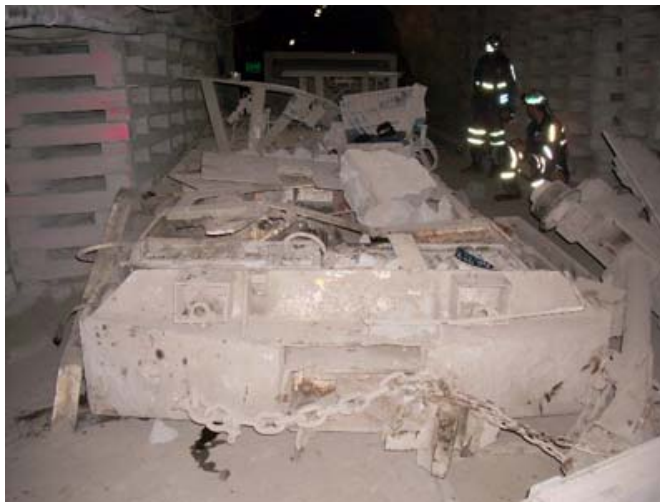
**COAL MINE FATALITY** - On Tuesday, October 27, 2009, a 56 year old trackman with 25 years of mining experience was fatally injured. While the hoist was traveling up the slope, the hoist rope broke. This allowed the brake/mantrip car, mine locomotive and loaded rail car to run away down a 16 degree, 1,750 foot slope. The victim was at the bottom of the slope. Two miners were in the brake/mantrip car when the rope broke. They jumped out of the car and received non-life threatening injuries.

- Ensure persons working or traveling in the slope are positioned in safe locations while the hoist is being operated.
- Install audible and visual alarms to notify persons working on the slope bottom that the hoist is in motion.
- Examine hoist ropes regularly for broken wires, wear, corrosion, and proper lubrication. Remove ropes from service when any rope retirement criterion is met.
- Ensure hoists (and ropes) have rated capacities consistent with the loads handled. Ensure brakes on the brakeman car can stop the hoist when hoisting passengers.
- Ensure persons conducting daily inspections of hoisting equipment and brake cars have proper training.
- Install derail devices to prevent run away trips from traveling into the mine.
- Properly maintain and operate rollers and guide blocks.
