Fatality #33 - April 22, 2010
Machinery - Underground - West Virginia
ICG Beckley LLC - Beckley Pocahontas Mine

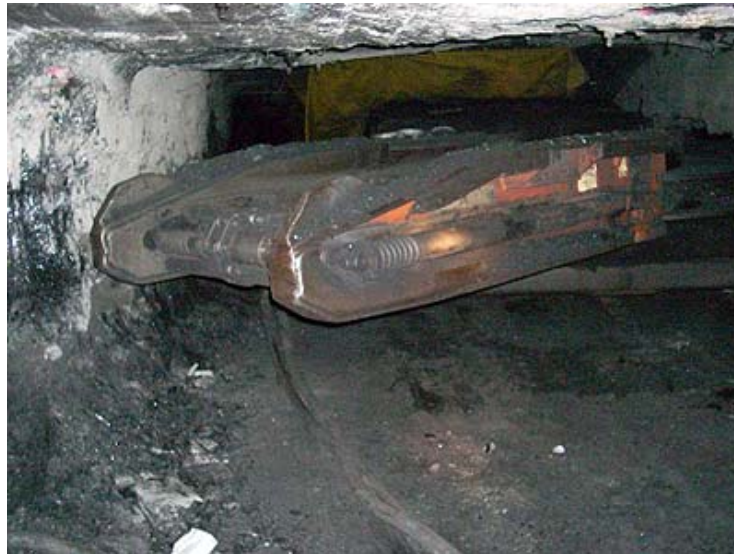
COAL MINE FATALITY - On Thursday, April 22, 2010, a 28-year old continuous mining machine operator with 5 years of experience was fatally injured when he was crushed between the conveyor boom of the continuous mining machine and the coal rib. The victim was located near the continuous mining machine while positioning it. The mining height in this area was approximately five feet.

- Ensure the continuous mining machine operator is positioned beyond the turning radius, and away from the conveyor boom turning radius before starting or moving the equipment.
- Frequently review, retrain, and discuss avoiding the "RED ZONE" areas when operating or working near a remote controlled continuous mining machine.
- Pursue new technology, such as proximity detection, to protect personnel from accidents of this type. See the [proximity detection single source page](#) on the MSHA web site.
- Minimize the number of miners working or traveling near continuous mining machines and maintain effective communications between miners and equipment operators.
- Train all productions crews and management in programs, policies, and procedures for operating remote controlled continuous mining machines.
