Fatality #12 - July 27, 2011

Electrical - Facility - West Virginia

Superior Processing, Inc. - Superior Cleaning Plant

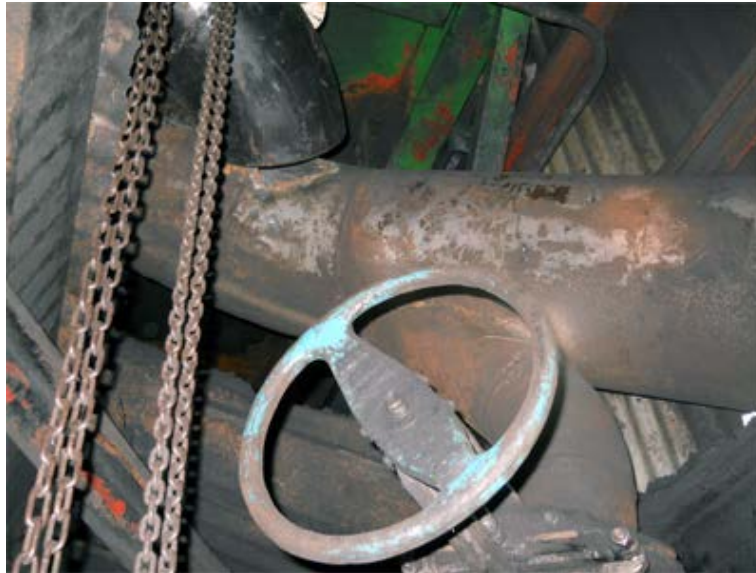
COAL MINE FATALITY - On Wednesday, July 27, 2011, a 39-year-old miner with 22 years of mining experience was electrocuted while welding to connect two pipes together. He was working in the ceiling of the filter room of a preparation plant. This area, where the welding was being conducted, was wet and the illumination was limited. The victim contacted an energized welding electrode.

- Do not touch an energized electrode with bare skin.
- Avoid wet working conditions. A person's perspiration can lower the body's resistance to electrical shock. Do not drape electrode wires or leads over your body.

- Work in a confined space only if it is well ventilated and illuminated.
- Do not use the plant structure as the work (return) conductor. Connect the work cable (return) as close to the welding area as practical to prevent welding current from traveling unknown paths and causing possible shock, spark, and fire hazards.

- Insulate yourself from work and ground by using and/or wearing dry insulating mats, covers, clothes, footwear, and gloves. Inspect welding gloves for damage prior to welding and ensure the gloves are dry.

- Use only well maintained equipment. Frequently inspect welding wires or leads for damaged or exposed conductors. Replace or repair wires or leads immediately if damaged.

- Use voltage reduction safety devices (if available) for arc welders.
