Fatality #18 & #19 - October 28, 2011
Fall of Face/Rib/Highwall - Surface - Kentucky
Armstrong Coal Company Inc – Equality

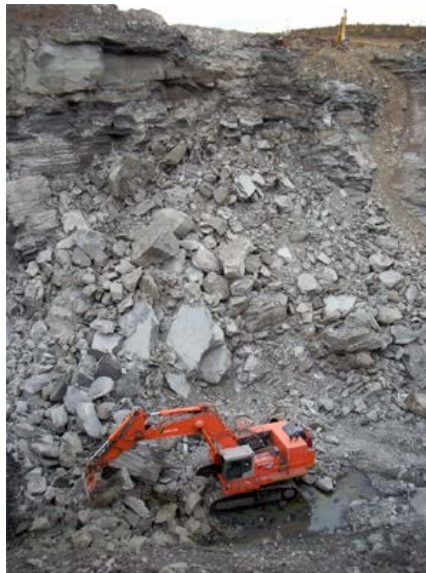
COAL MINE FATALITY - On Friday, October 28, 2011, a 47-year old lead blaster and 23-year old blaster helper were killed when the 1-ton truck they were riding was struck and completely covered by fallen rock from a failed highwall. The victims were driving in the pit, past a trackhoe loading coal as they approached their work area. The rock reached approximately 80' across the 100' wide pit and struck the trackhoe and a haulage vehicle being loaded at the time of the accident.

- Train all miners to recognize hazardous highwall conditions.
- Look, Listen and Evaluate your highwall and pit conditions daily, especially after each rain, freeze, or thaw.
- Be your own examiner and find hazards before they find you.
- Maintain adequate lighting to aid in examinations of highwalls and pit during no light or low light situations.
- Observe and communicate highwall hazards immediately.
- Insure appropriate action is taken to remove the hazards associated with any anomaly that may appear in the highwall or pit.
- Ensure that personnel's work or travel areas and mining systems or equipment are operating are a safe distance from the toe of the highwall.
- Follow safe job procedures.
