Fatality #4 - March 10, 2012
Fall of Face/Rib/Highwall - Underground - West Virginia
Kingston Mining, Inc. - Kingston NO. 2 Mine

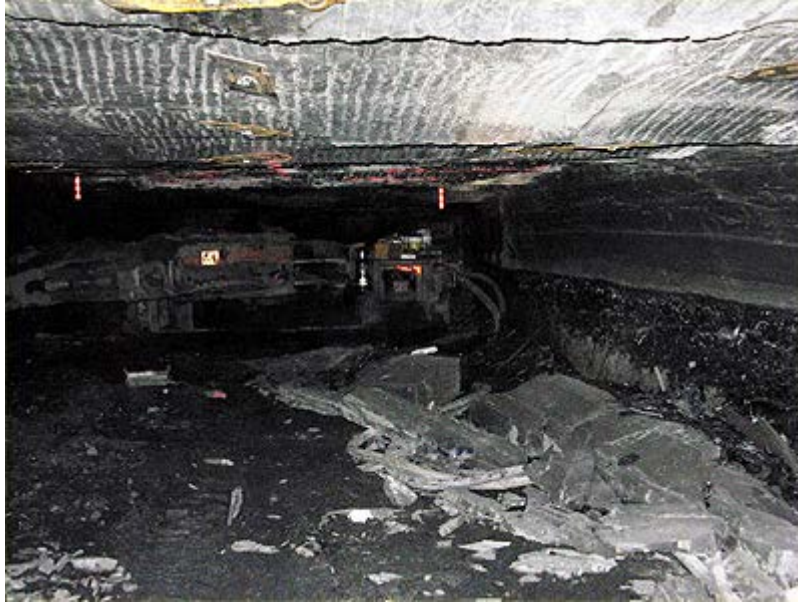
COAL MINE FATALITY - On Saturday, March 10, 2012, at approximately 6:15 p.m., a 34-year-old section foreman with 11 years of experience was killed while operating a continuous mining machine in the No. 2 entry. He was struck by a section of rock that fell from the right-hand rib. The rock was approximately 10 feet and 6 inches long, 3 feet and 4 inches high, and 10 inches thick.

- Conduct thorough pre-shift and on-shift examinations of the roof, face, and ribs. A thorough exam must be conducted before any work or travel is started in an area and thereafter as conditions warrant.
- Support any loose roof or rib material adequately or scale loose material before working or traveling in an area.
- When hazardous roof or rib conditions are detected, areas should be dangered-off until they are made safe.
- Rib bolts, installed on cycle and in a consistent pattern, provide the best protection from rib falls.
- Assure that the Approved Roof Control Plan is followed and is suitable for the geologic conditions encountered. If adverse conditions are encountered, the plan must be revised to provide adequate support for the control of the roof, face, and ribs.
