**Fatality #6 - March 23, 2012**  
**Electrical - Underground - Alabama**  
**Drummond Mining Company - Shoal Creek Mine**

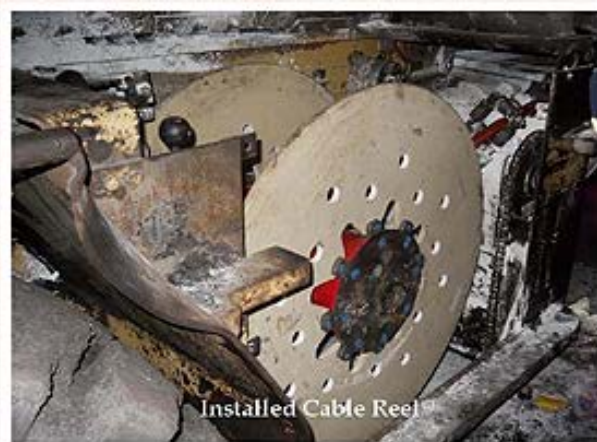
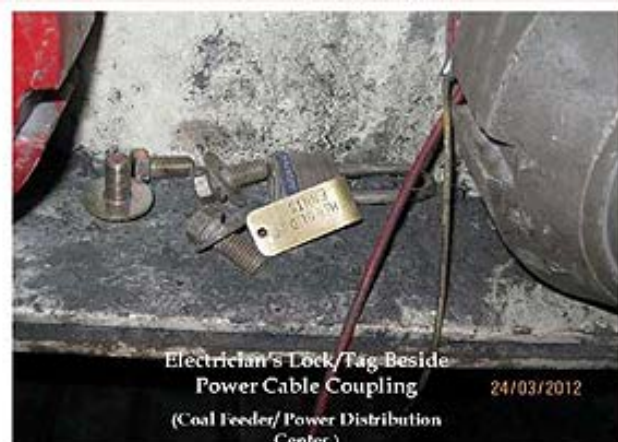
**COAL MINE FATALITY** - On Friday, March 23, 2012, a 37-year old electrician, with approximately 3½ years experience (approximately 1½ years as an electrician), was killed when he contacted the energized conductors of a shuttle car trailing cable. He was making the final electrical connections for a replacement cable reel when he was electrocuted.

- Develop a hazard analysis work plan before conducting repairs.
- Always lock and tag-out electrical equipment prior to electrical work.
- Perform your own lock and tag-out procedure. Never rely on others to de-energize or disconnect a circuit for you.
- Use proper Personal Protective Equipment (PPE) for all electrical work.
- Ensure that all electrical circuits and circuit breakers are identified properly before troubleshooting or performing electrical work.
- Use properly rated non-contact voltage testers to ensure that circuits are de-energized.
- Eliminate personal distractions when working on equipment.
