**Fatality #8 - March 22, 2013**  
**Fall of Roof/Rib - Underground - Utah**  
**Castle Valley Mining, LLC - Castle Valley Mine #4**

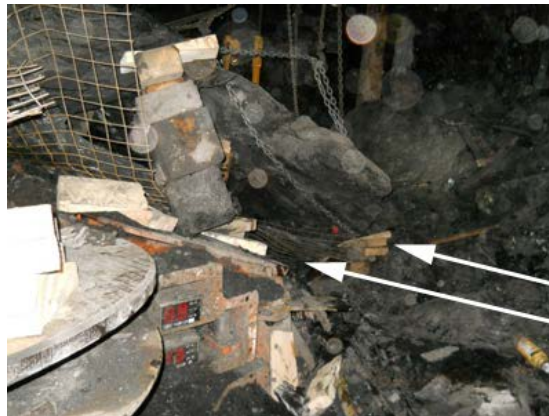
**COAL MINE FATALITY** - On Friday, March 22, 2013, a 29-year old continuous mining machine operator, with 9 years of mining experience, was killed while operating a remote-controlled continuous mining machine during retreat mining. While mining a left hand lift, the victim and his helper were positioned near the right rear corner of the continuous mining machine and the right rib. A section of roof, approximately 8 feet long by 7 feet wide and 16 inches thick, fell and broke several roof bolts. The fallen rock struck the victim and knocked down the victim's helper, injuring him. The slab of rock that fell was a portion of a larger fall, approximately 20 feet wide by 25 feet long, that included the bolted roof between the rear of the continuous mining machine and the mobile roof support units located inby.

Victim (Operator)  
Survivor (Helper)

- Ensure that the approved Roof Control Plan support provisions are suitable for the geological conditions at the mine and that the plan is followed.
- Develop a map of geologic features, so additional support can focus on those areas.
- Conduct frequent and adequate examinations of roof, face, and ribs. Be alert for changing conditions. When hazardous conditions are detected, danger off access to the area until it is made safe for work and travel.
- Maintain proper entry widths and pillar dimensions.
- Develop a safe procedure to align Mobile Roof Supports with the lift being mined.
- Install and examine test holes regularly for changes in roof strata.
- Take additional measures when hazards associated with draw rock are encountered, such as mining shorter cuts and decreasing roof bolt spacing.
- When joints are encountered, install adequate supplemental support.
