# MNMM Fatal 2007-01

- 'Other' Accident
- January 2, 2007 (Texas)
- Alumina Operation
- Instrument Technician
- 37 years old
- 2½ years experience

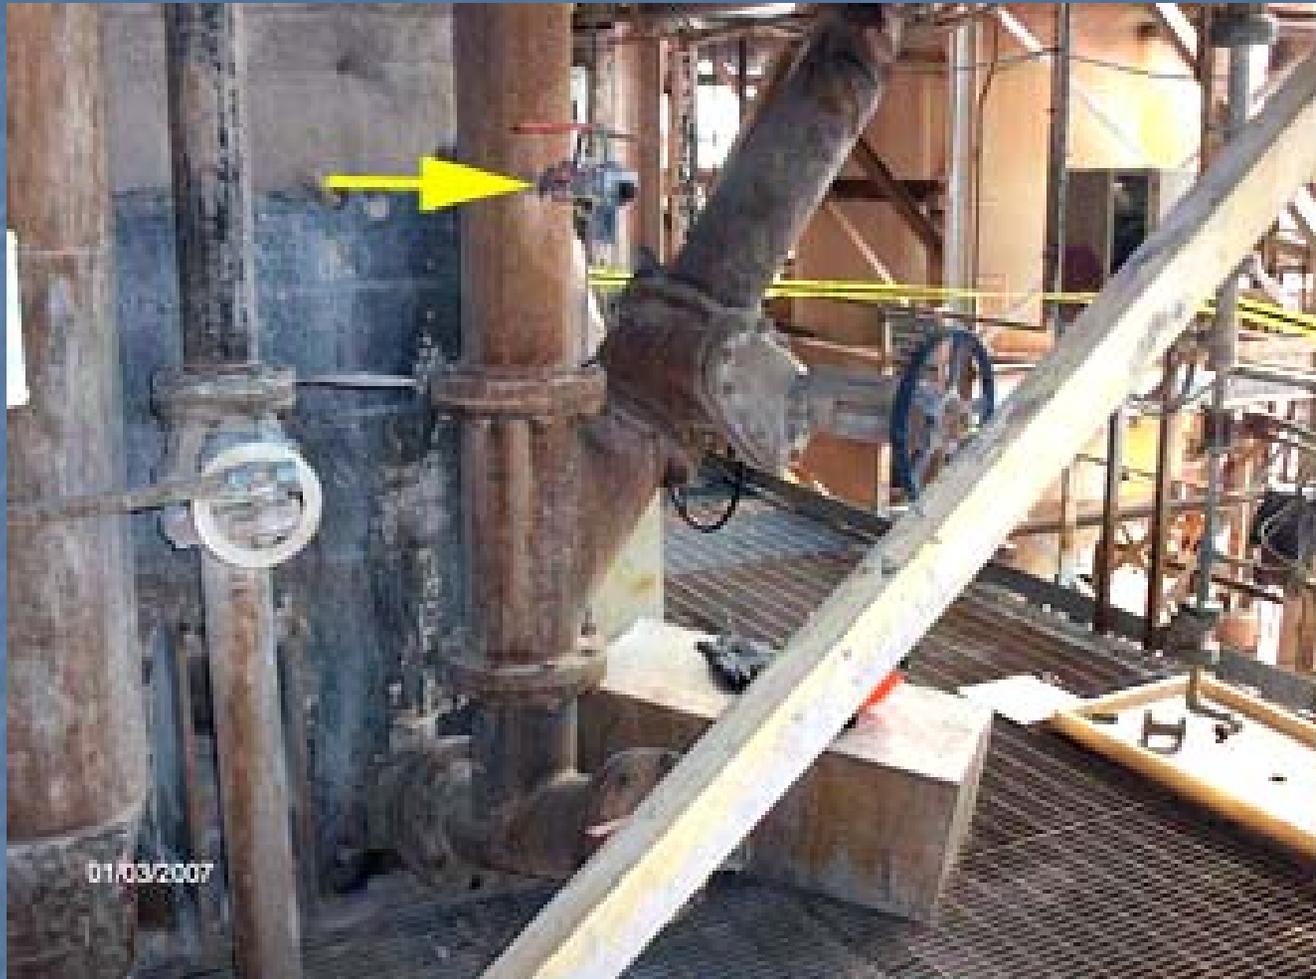
01/03/2007

The victim was fatally injured when he opened a valve in the piping system of a vacuum monitoring line and hydrogen fluoride discharged onto his face. He was not wearing a respirator or face shield when he opened the valve in preparation for unplugging the stem.

- Review maintenance and inspection practices to ensure all possible hazards have been identified and appropriate controls are in place to protect miners.
- Train miners in safe work procedures and hazard recognition, specifically when performing maintenance on pipelines.
- Require appropriate respiratory protection, special protective clothing, and face shields where hazards from gases, fumes, chemicals, or mechanical irritants may exist.
- Stop, Look, Analyze, and Manage, SLAM each task to identify all potential hazards Ensure that all hazards are eliminated so the task can be safely performed.
