MNMF Fatal 2008-07

- Powered Haulage Accident
- April 24, 2008 (Iowa)
- Industrial Sand Operation
- Laborer
- 48 years old
- 32 weeks experience

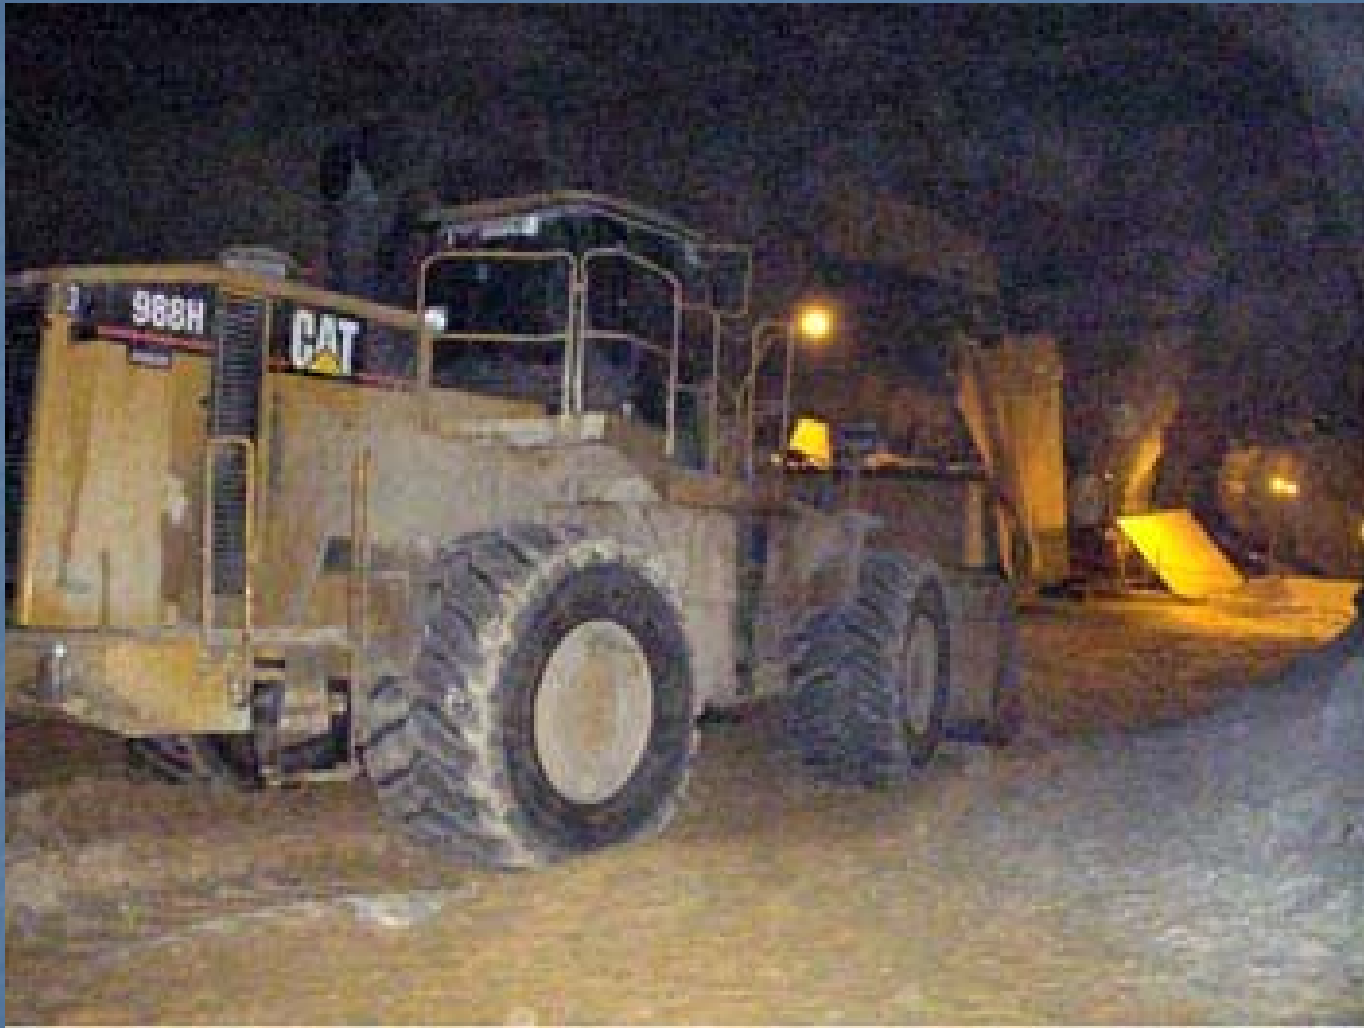
The victim was fatally injured when she was struck by a front-end loader that backed up. The accident occurred because management policies and procedures failed to ensure that persons could safely work in areas where mobile equipment operated and failed to ensure that safety defects were corrected in a timely manner. The right rear-view mirror on the front-end loader was broken along the top portion and the mounting bracket was bent. The victim's cap lamp was not positioned on her hard hat and no reflective material was on the hard hat. Reflective material on the victim's equipment belt was obscured by the cap lamp battery, self-rescuer, and possibly by the black coat she was wearing.

- Management policies and procedures failed to ensure that safety defects that were reported were corrected in a timely manner.
- Management policies and procedures failed to ensure that persons could safely work in areas where equipment operated.

- Before moving mobile equipment, look in the direction of travel, be certain no one is in the intended path, sound the horn to warn possible unseen persons, and wait to give them time to get to a safe location.
- Ensure all miners are trained to recognize work place hazards, specifically the limited visibility and blind areas inherent to operation of large equipment and the hazard of mobile equipment traveling near them.
- Supervisors should regularly monitor work practices, especially those of new miners, and reinforce the importance of safe work practices and take immediate action to correct unsafe conditions or work practices.
- Wear reflective clothing to ensure high visibility when necessary to walk or work in the area of moving equipment.
- Correct any defects that may affect the safe operation of self-propelled mobile equipment.
