MNMM Fatal 2008-22

- Powered Haulage Accident
- November 17, 2008 (Iowa)
- Crushed Stone Operation
- Mechanic
- 67 years old
- 36 years of experience

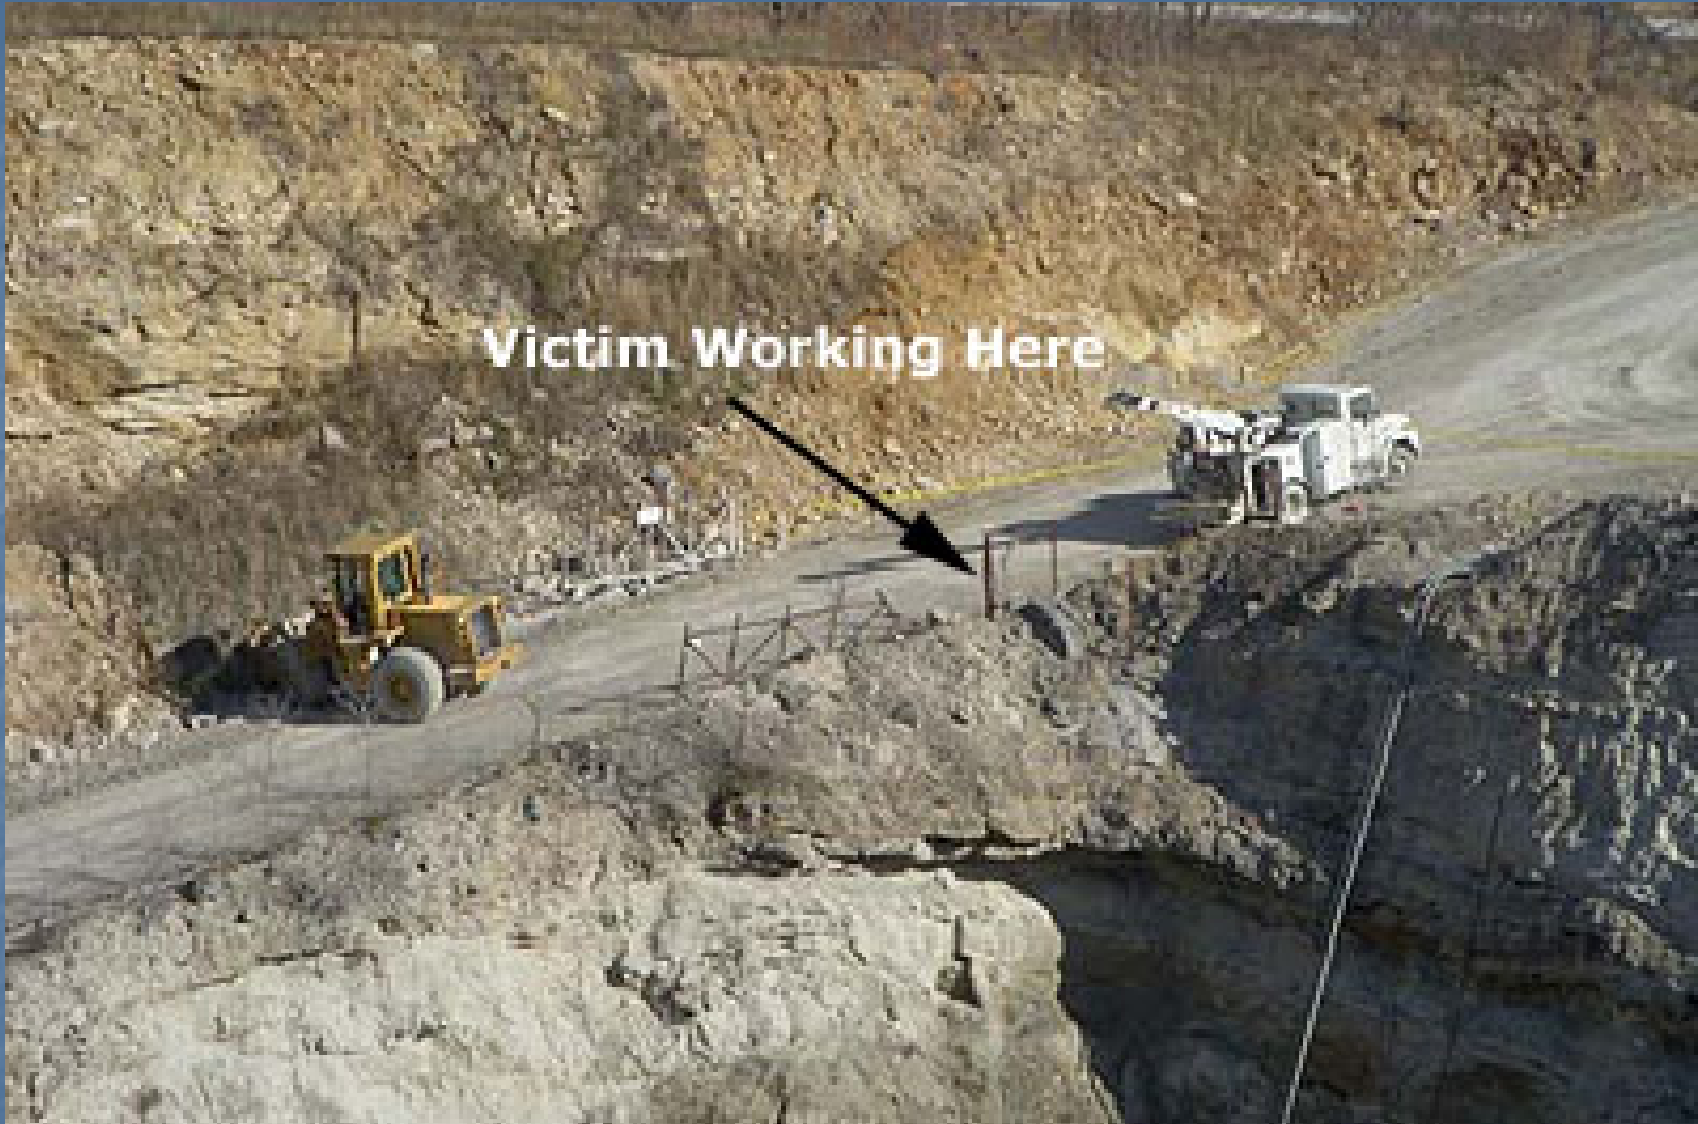
Victim Working Here

The victim was fatally injured when he was struck by a front-end loader. He was repairing a bent gate post along a haul road leading to the underground mine portal. The front-end loader approached to assist in the repair work and went out of control, striking him.
