Fatality #1 - January 21, 2008
Slip/Fall of Person - California - Cement
Riverside Cement Co. - ORO Grande Quarry

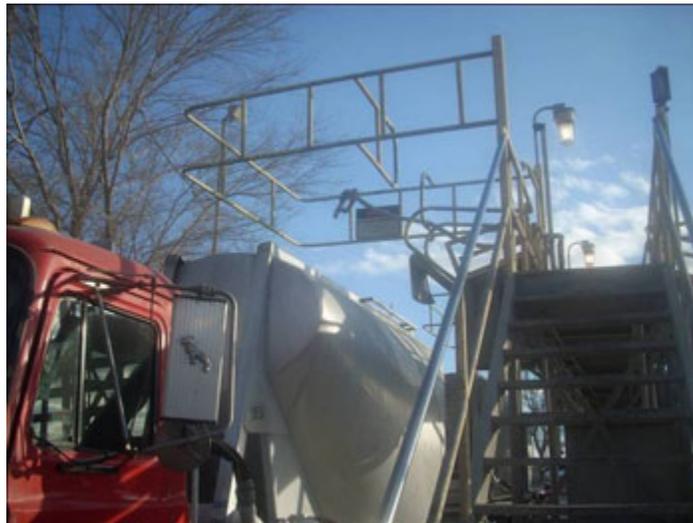
METAL/NONMETAL MINE FATALITY - On January 21, a 58 year-old contractor truck driver with 3½ years experience was fatally injured at a cement operation. He was found on the ground behind the rear tires of a bulk cement truck that was located at a truck access rack. Truck drivers used this facility to access the hatches on the top of the trucks. Although there were no eyewitnesses, the victim's injuries were consistent with a fall from an elevated location.

- Discuss work procedures; identify all potential hazards; and ensure the job is done safely. (SLAM) Stop, Look, Analyze, and Manage.
- Train all miners to recognize hazards from falling and ensure that safe work procedures are discussed and established.
- Ensure that persons wear fall protection where there is a danger of falling.
- Establish traffic patterns that ensure safe alignment of vehicles with access equipment.
