UNITED STATES  
DEPARTMENT OF LABOR  
MINE SAFETY AND HEALTH ADMINISTRATION

REPORT OF INVESTIGATION

Surface Nonmetal Mine  
(Sand and Gravel)

Fatal Other (Drowning) Accident  
January 23, 2008

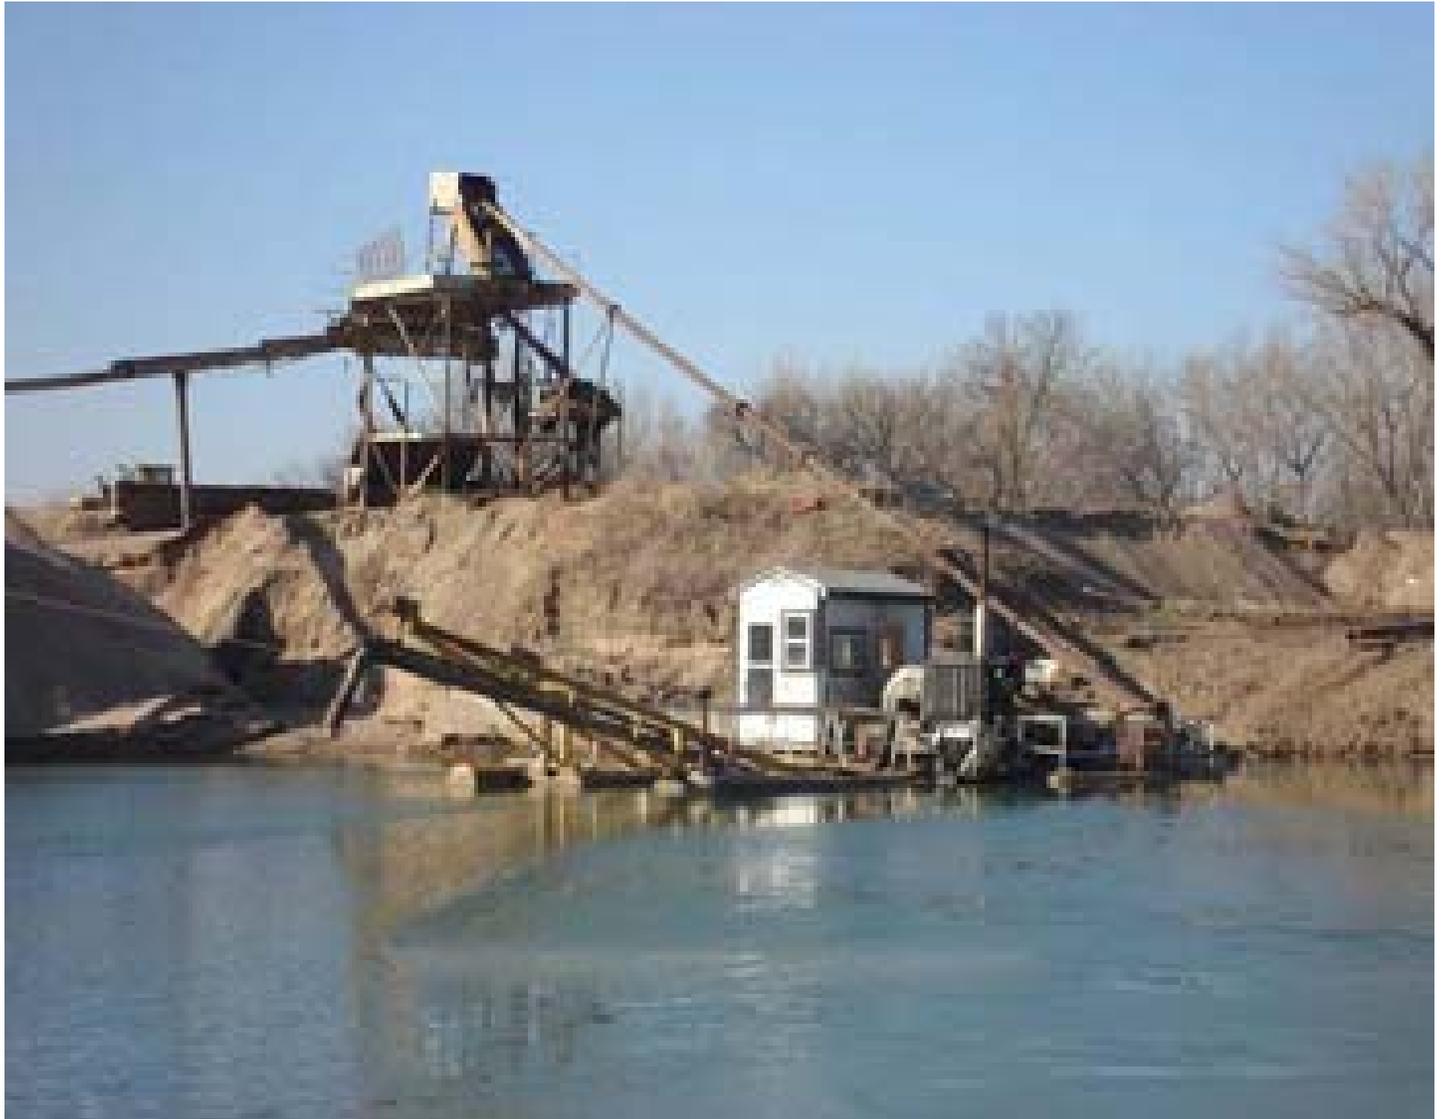
The investigators were unable to safely access the dredge so the investigation was conducted from the shore. The boat used to access the dredge was not at the mine site. Apparently the victim accessed the dredge by stepping from the shore onto the discharge pipe float.

The dredge was fabricated locally. The dredge deck was approximately 30 feet long and 25 feet wide. It was powered by a mounted diesel engine and generator located in the middle of the dredge deck. Sand and gravel was dislodged from the underwater bank by a water jet suction head powered by a water pump mounted on the dredge deck. The 9-inch suction pipe extended approximately 15 feet from the edge of the dredge deck.

The dredge discharge pipe was mounted on two floats constructed of pieces of wood nailed together and plastic barrels. The float nearest the dredge was approximately 11.3 feet by 11.6 feet with a plywood deck under a 9-inch discharge pipe. The float nearest the shore was approximately 7.3 feet long and 5.3 feet wide and was not covered.

The dredge was facing towards the south. A 9-inch discharge pipe carried the materials from the dredge to the screen plant where the processed sand fell below the screening plant. The reject fines were returned to the pond.
