MNMM Fatal 2009-08

- Machinery Accident
- May 1, 2009 (Texas)
- Dredging Operation (Sand & Gravel)
- Dredge Operator
- 59 years old
- 3 years of experience

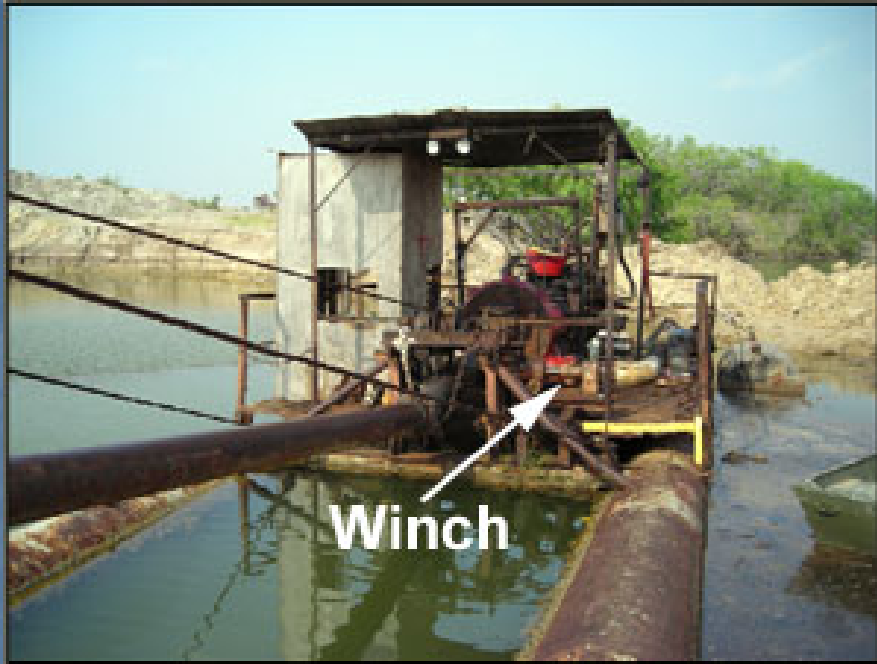
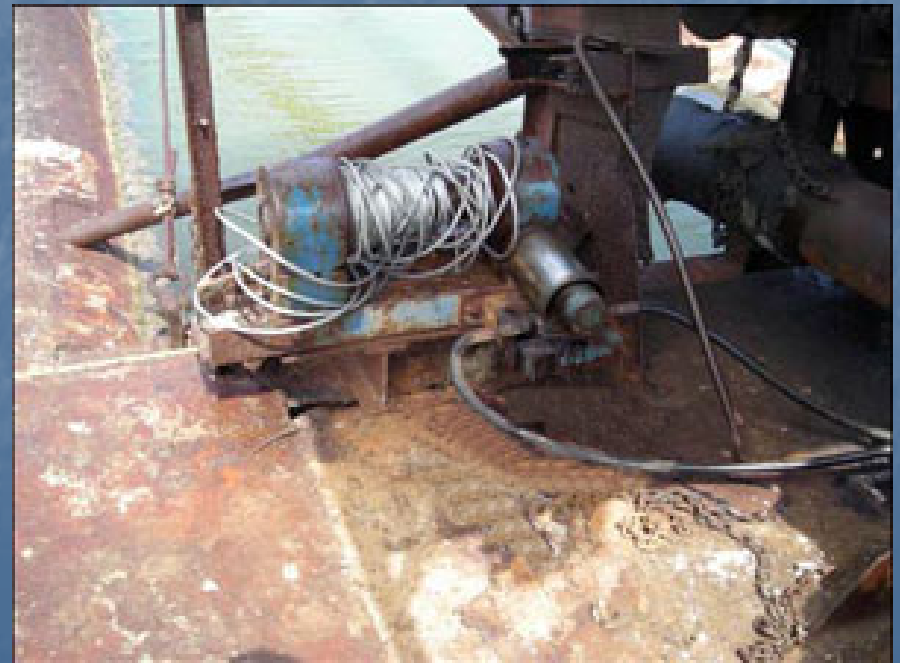
The victim was fatally injured when he became entangled in one of two positioning winches on a dredge. He was attempting to hand guide the cable onto the winch while it was rewinding.

The accident occurred because management had not established adequate policies and safe work procedures for performing maintenance on the dredge. The winch was not taken out of service when the winch control lever functions reversed following the installation of a new winch cable. The winch was not shut off before maintenance was performed.

Root Cause: Management had not established clear policies and procedures for winch maintenance.

Corrective Action: The mine was permanently abandoned before management could implement corrective action.
