MNMM Fatal 2010-07

- Machinery Accident
- May 24, 2010 (Oklahoma)
- Crushed Stone Operation
- Maintenance Foreman
- 61 years old
- 37 years of experience

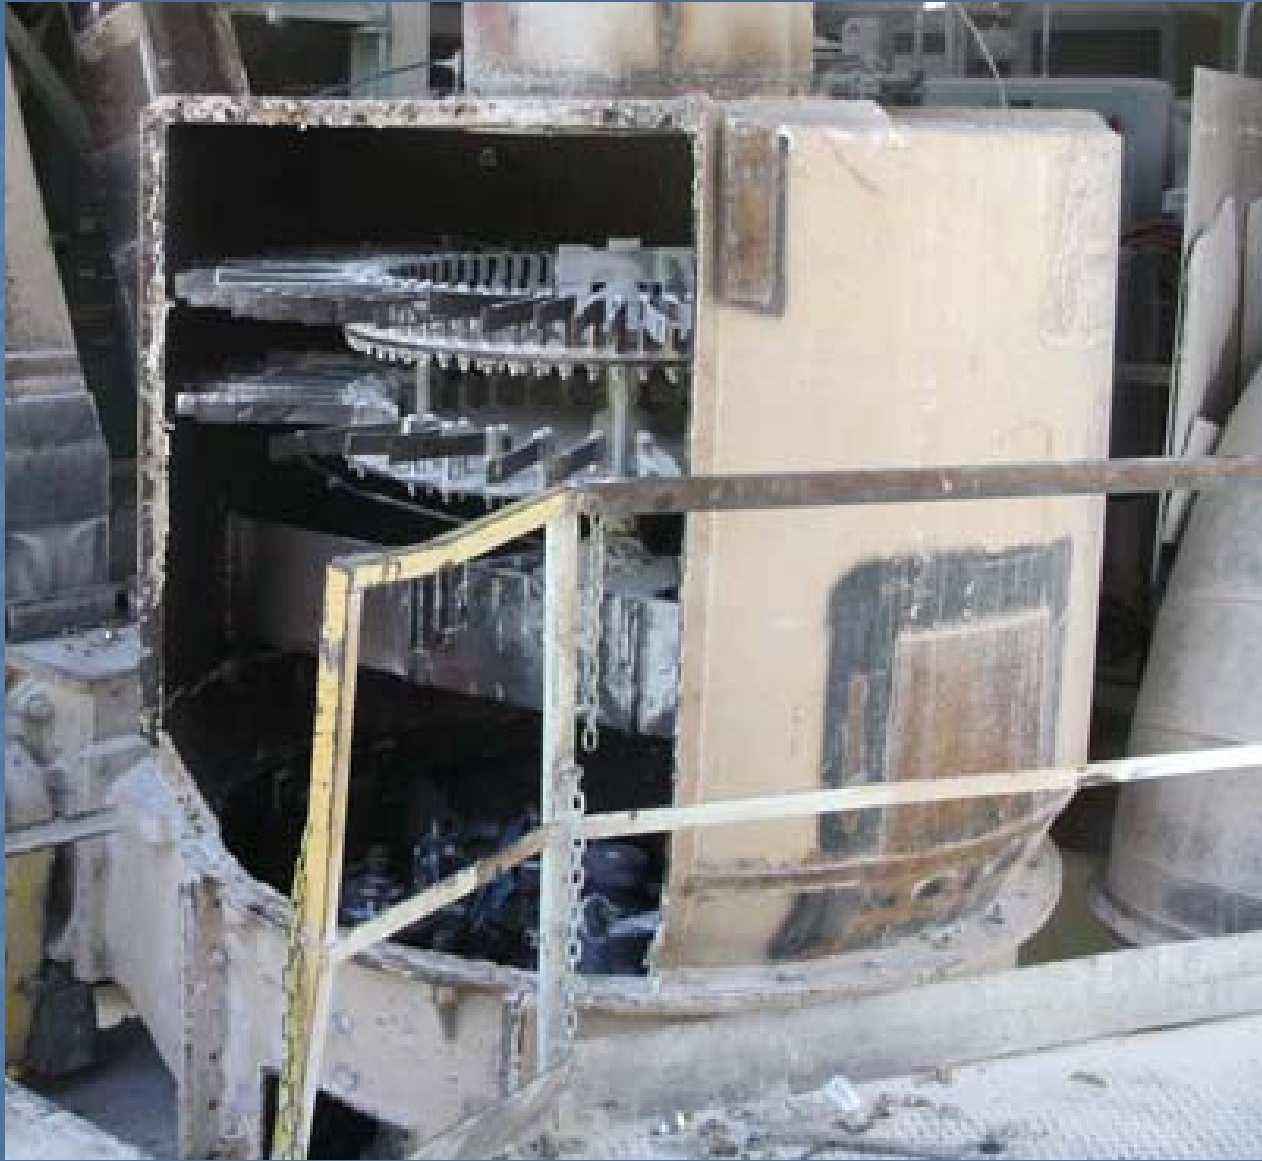
The victim died while in a roller mill when it started. Electrical power to the roller mill had not been locked out.

The accident occurred because management failed to ensure that safe work procedures were followed while performing maintenance and mechanical work in the roller mill. The victim asked another person to lock out the roller mill for him then entered it without ensuring that the electrical circuits had been de-energized and locked out. The roller mill started while the victim was inside it.

Root Cause: Safe operating procedures were not followed during maintenance and mechanical work on the roller mill. Farris entered the roller mill without locking out the two electrical circuits that powered the moving parts inside it.

Corrective Action: Automatic startup alarms were installed on the roller mill. All persons working in the plant were retrained regarding lock-out procedures.

Root Cause: The defective breaker box was not removed from service before it became a hazard to persons. The breaker box handle was moved to the "OFF" position but did not disconnect the power to the mill rollers.

Corrective Action: The defective breaker box was repaired. All electrical boxes at the plant were examined to ensure they were in functional condition.
