MNMM Fatal 2010-13/14

- Fall of Material Accident
- August 12, 2010 (Nevada)
- Underground Gold Mine
- Maintenance Technician
 - 38 years old
 - 3 years of experience
- Leadman
 - 47 years old
 - 21 years of experience

Overview

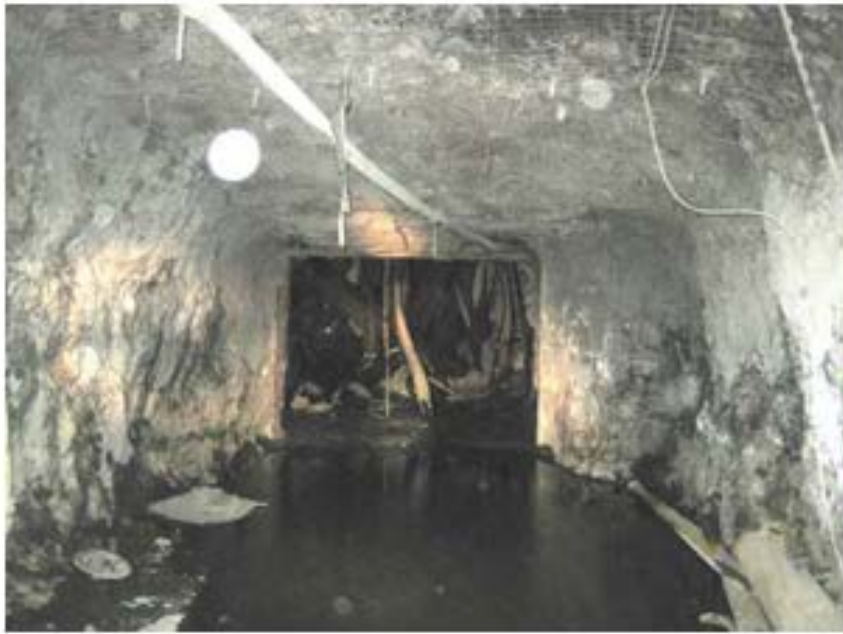
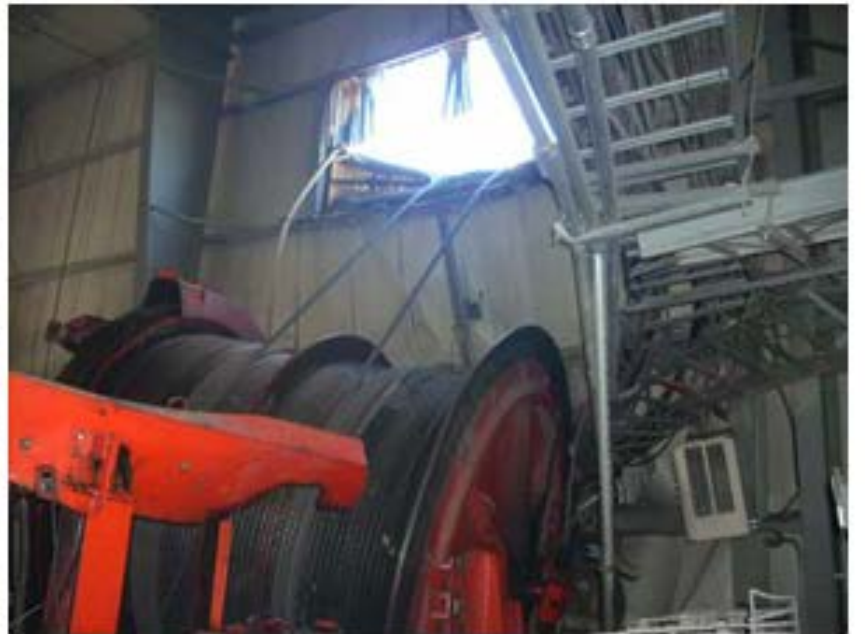
Two miners were killed while attempting to locate and free an obstruction in a 24-inch diameter aggregate delivery pipe in a ventilation shaft. The pipe conveyed crushed aggregate material from the surface of the mine to an underground batch plant. The batch plant produced a cement rock fill ("CRF") that is used as backfill in the mine. This pipe traveled down one side of the 16-foot diameter shaft to a drop rock box silo at the 860 level. The miners were above the 820 foot level when the obstructed pipe failed catastrophically.

The accident occurred because management did not have adequate policies and procedures that provided for the safe operation, inspection, maintenance, and training regarding the aggregate pipe delivery system. Management failed to ensure that the pipe, its support system, and electrical system were maintained in a safe condition to protect all persons who could be exposed to a hazard from any failure of the system. Management failed to ensure that the 24-inch pipe, brackets, bolted connections, and bearing plates were maintained in a safe condition. Additionally, management failed to maintain the electrical sensors and alarm systems and ensure that these systems could not be by-passed. A broom handle was used to wedge the electrical control panel reset button so the aggregate delivery system would continue to operate and not trip out.

Corrective Action: Management removed all systems from the shaft and built a new aggregate delivery system through a borehole eliminating the hazard. Policies and procedures have been established for the safe operation of the system and all persons have been trained regarding these policies and procedures.
