MNMM Fatal 2010-18

- Powered Haulage Accident
- October 16, 2010 (Kansas)
- Crushed Stone Operation
- Haul Truck Driver
- 52 years old
- 5 years of experience

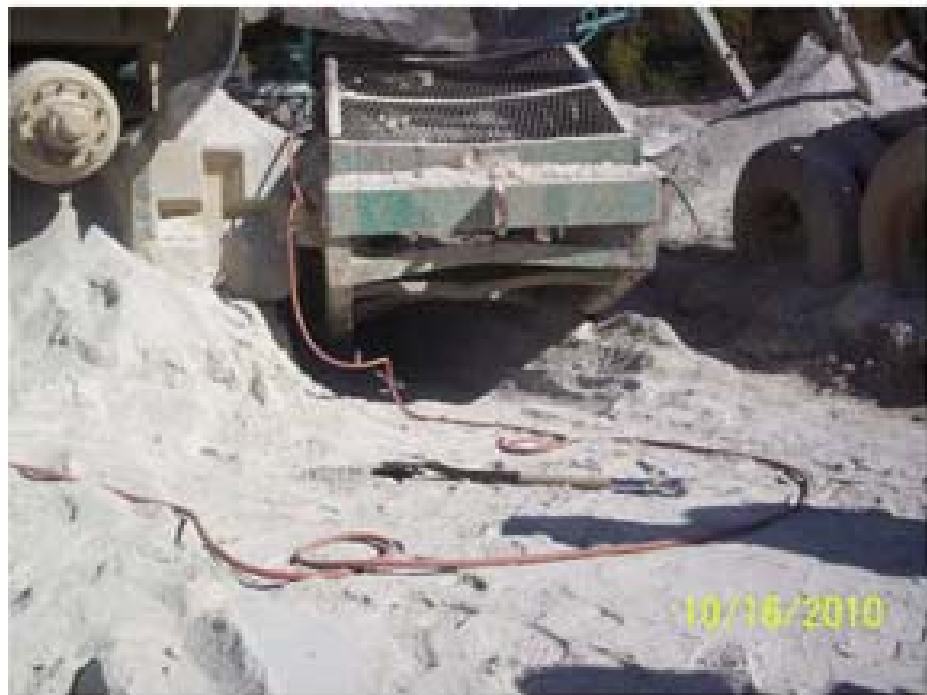
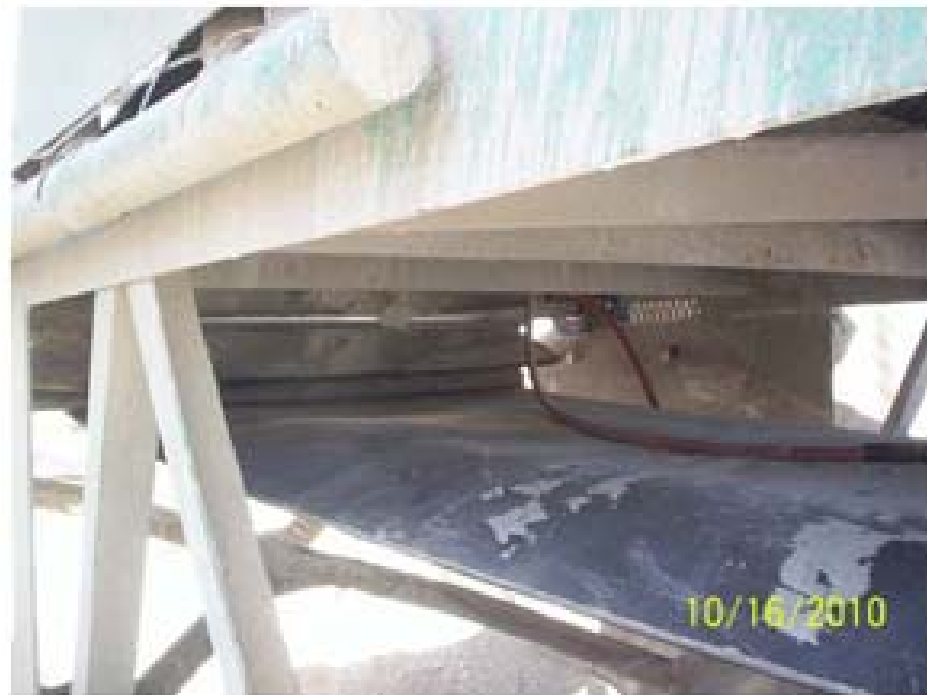
The victim died when he died while he was cleaning out hardened material on a belt conveyor tail pulley. He was positioned on top of the return side of the belt conveyor when the belt conveyor was energized, entangling him in the tail pulley.

The accident occurred because management failed to ensure that safe work procedures were followed while persons performed work on the belt conveyor tail pulley. The belt conveyor was not deenergized and blocked against motion before persons removed spillage. Additionally, the procedures for starting the belt conveyor did not ensure that persons were protected.

Corrective Action: The procedures to deenergize and block equipment from hazardous motion have been revised. All miners have been trained regarding the new procedures.

Corrective Action: Safe operating procedures for starting belt conveyors have been established and all miners have been trained regarding the new procedures.
