MNM Fatal 2011-15

- Powered Haulage Accident
- December 8, 2011 (Minnesota)
- Crushed Stone Operation
- Crusher Operator
- 41 years old
- 9 years of experience

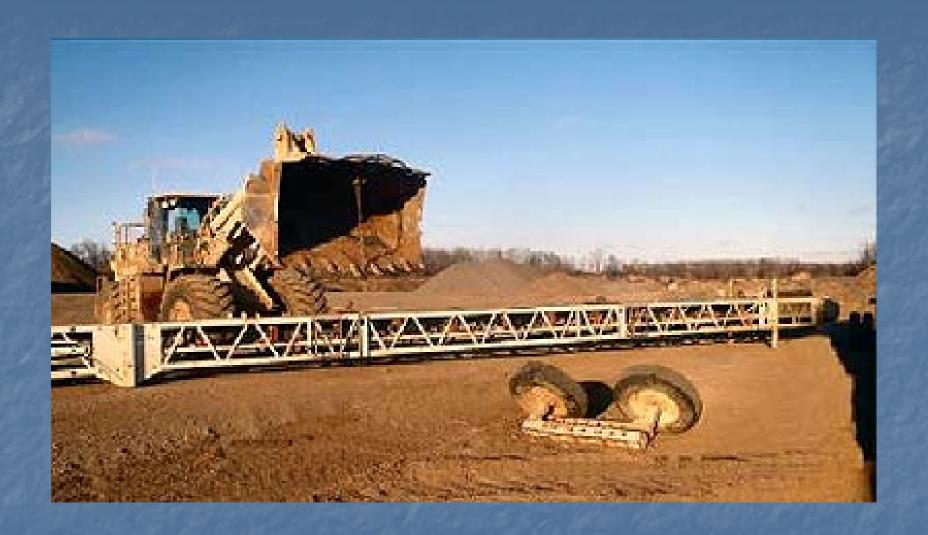
The victim was killed when a wheel strut axle assembly struck him. The wheel assembly was to be installed on a conveyor to transport it from the mine site. A front-end loader was used to lift the conveyor. The loader bucket suddenly dropped, allowing the frame of the conveyor to strike the wheel assembly. The wheel assembly shifted, striking the victim.

The accident occurred due to management's failure to have procedures in place to ensure equipment is taken out of service or properly repaired when defects affecting safety are found. Investigators determined the cold temperatures at the time of the accident affected the performance of the main control valve of the front-end loader's hydraulic system. Other factors contributing to the accident include the victim's position near a suspended load, no blocking in place to prevent the fall of the conveyor, and the victim not task trained regarding the installation of the wheel strut axle assembly.

- <u>Corrective Action:</u> Management established policies, procedures, and controls to ensure persons are not exposed to suspended loads when lifting conveyor components. Management trained all persons to identify hazards and eliminate them before beginning to lift conveyors.

- **Root Cause:** Management failed to ensure any defects on equipment affecting safety be corrected in a timely manner.
- <u>Corrective Action:</u> Management established and implemented policies, procedures, and controls requiring any defects affecting safety be corrected or the equipment removed from service.
