**Fatality #15 - December 8, 2011**  
**Powered Haulage - Minnesota - Crushed, Broken Stone NEC**  
**Knife River North Central – 43491**

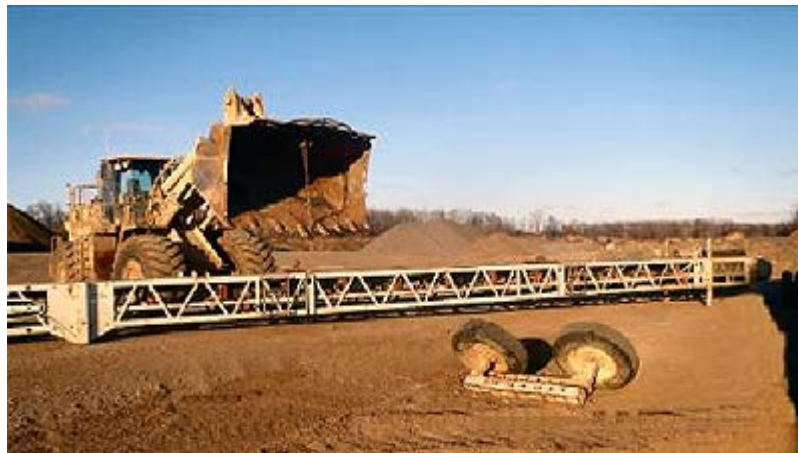
**METAL/NONMETAL MINE FATALITY** - On December 8, 2011, a 41 year-old crusher operator with 8 years of experience was killed at a surface stone operation. A set of wheels was to be placed on a conveyor to transport it from the mine. A front-end loader was being used to lift the conveyor when the loader bucket suddenly dropped, allowing the frame of the conveyor to strike one of the tire assemblies. The tire assembly then shifted, striking the victim.

- Inspect mobile equipment before placing it in operation for the shift.
- Correct safety defects on equipment in a timely manner to prevent the creation of a hazard to persons.
- Establish safe work procedures and identify and remove hazards before beginning a task.
- Ensure that persons are task-trained and understand the hazards associated with the work being performed.
- Do not place yourself in a position that will expose you to hazards while performing a task.
- Monitor personnel routinely to determine that safe work procedures are followed.
