# MNM Fatal 2012-02

- Fall of Highwall Accident
- February 14, 2012 (Alabama)
- Shale Operation
- Mine Owner
- 40 years old
- 8 years of experience

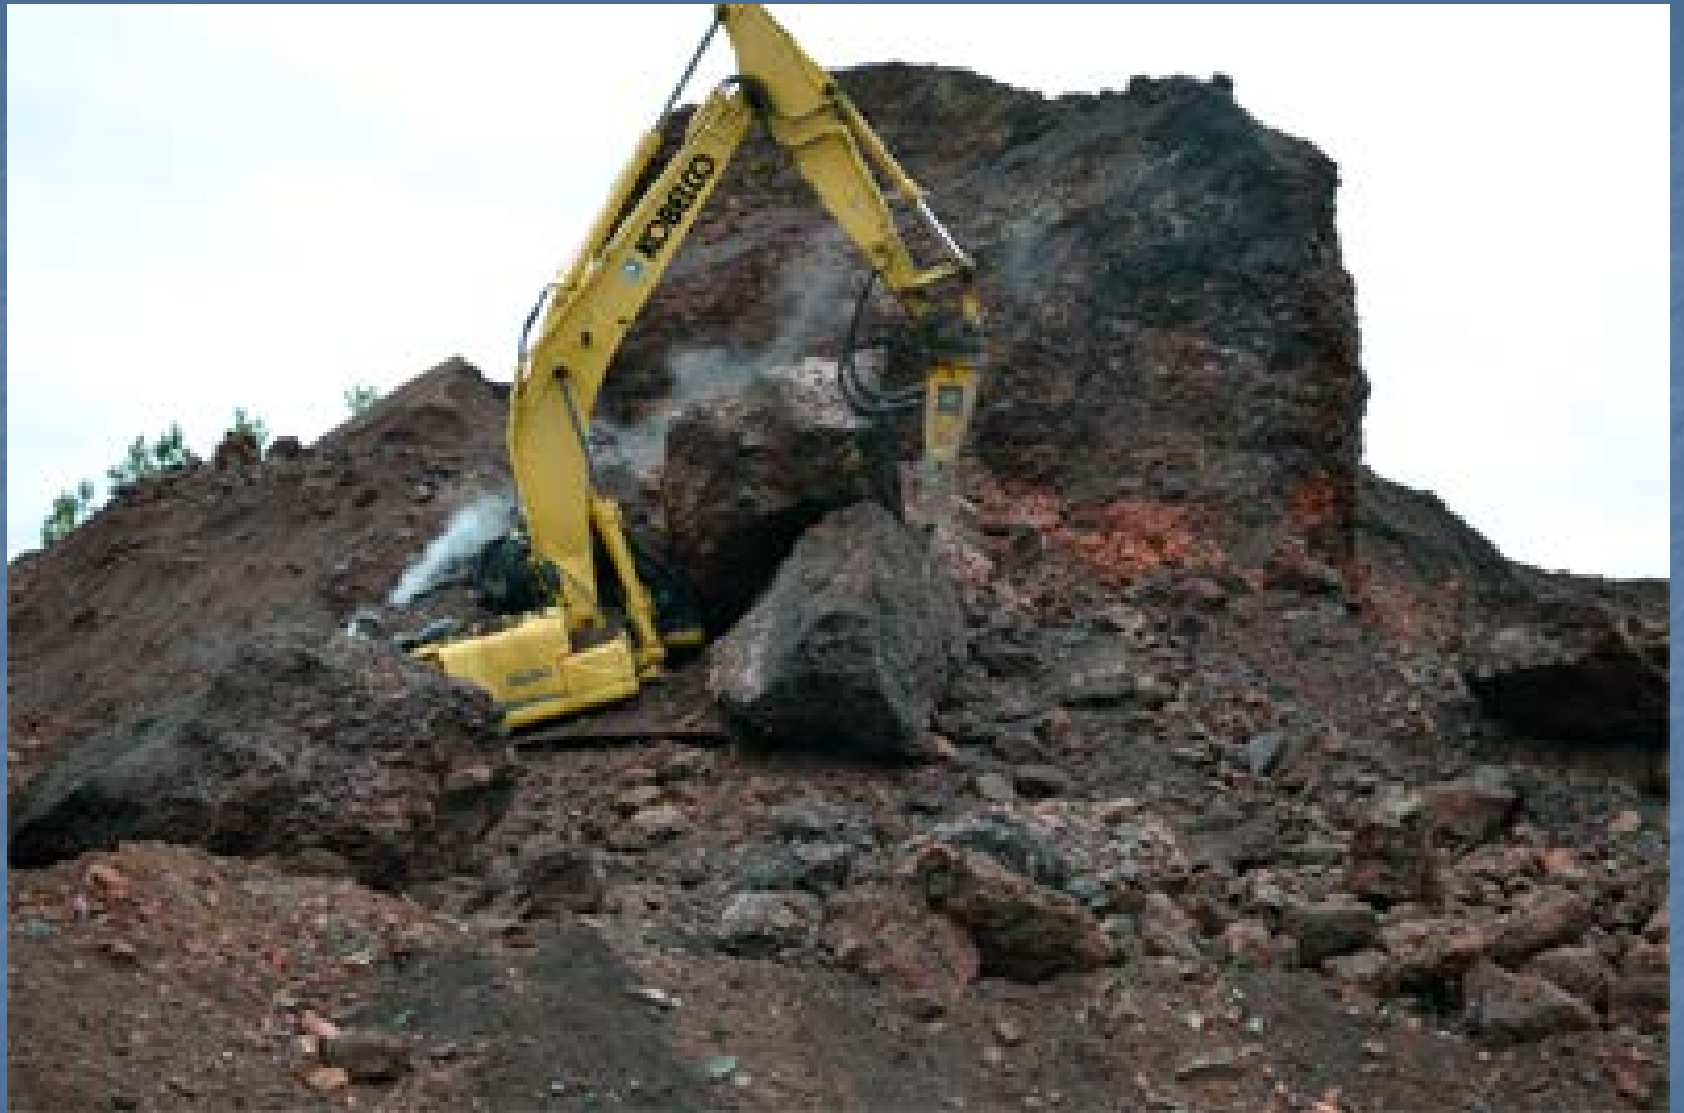
The victim was killed when the excavator he was operating was covered by falling material from a highwall. He was using a rock breaker, attached to the excavator, to break and mine material from a near vertical wall when the face fell onto the cab of the excavator, crushing him.

- **Root Cause**: Management failed to provide adequate procedures that included safe mining methods, required examinations, and training to protect persons working near the vertical walls of unstable material.
- **Corrective Action**: Management established Standard Operating Procedures (SOP) for mining loose unconsolidated material at a safe slope angle. Before mining resumed, a blasting contractor was employed to drill and shoot the mounds of harder material to reduce the near vertical walls to a slope angle that was safe to mine. Safe mining methods were established for future mining. These methods include having a person conduct required examinations, and conducting required training for all persons working near the highwalls.
