MNM Fatal 2012-05

- Falling Material Accident
- April 11, 2012 (North Carolina)
- Sand & Gravel Operation
- Equipment Operator
- 48 years old
- 8 years of experience

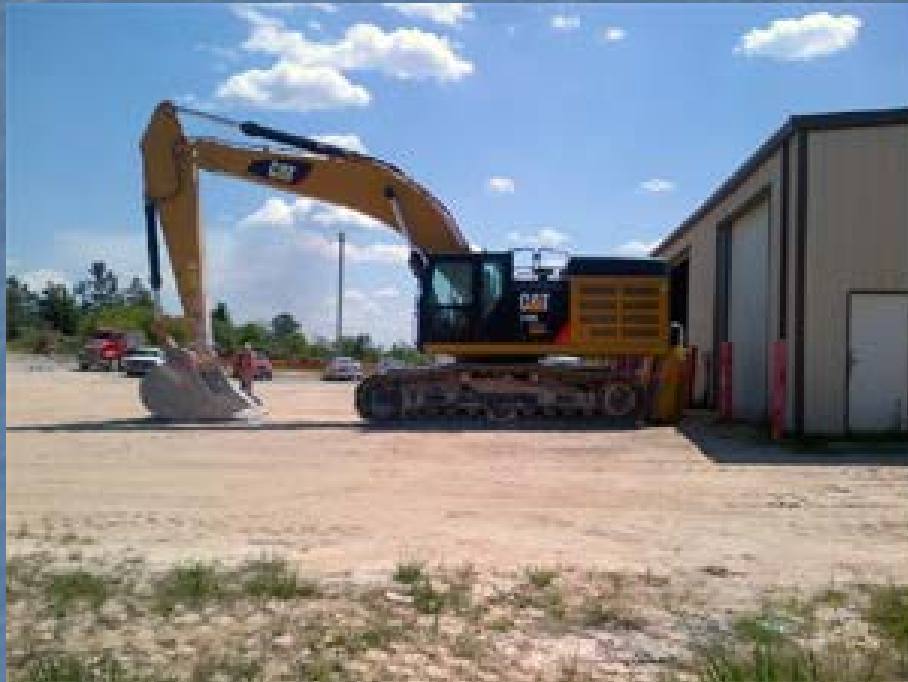
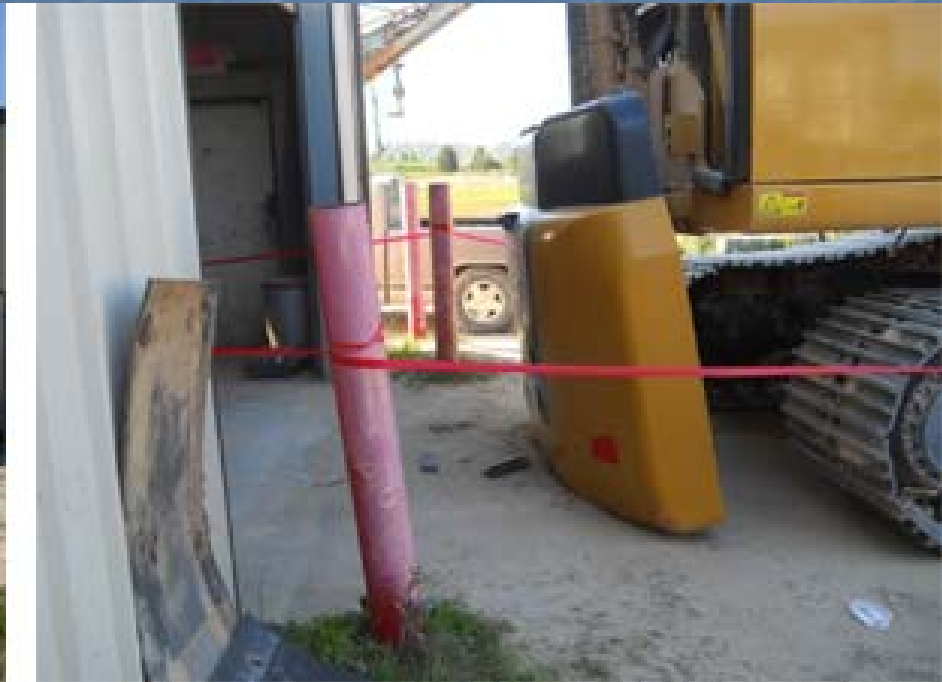
The victim was injured when the counterweight from an excavator fell and struck him. He and the Plant Manager were removing bolts from the counterweight in preparation to move the excavator to another mine site. Following the removal of the last of six bolts, the counterweight dropped to the ground. The victim was hospitalized and died on April 12, 2012, as a result of his injuries.

The accident occurred due to management's failure to follow the manufacturer's procedures for removing the counterweight from the excavator. The excavator was equipped with a hydraulic system that secures and lowers the heavy counterweight to the ground safely; however, this system was not used on the day of the accident. Raised components were not secured to prevent accidental lowering when persons were working on or around mobile equipment and exposed to the hazards of accidental lowering of the component. The victim did not receive task training regarding the procedures to be followed in the health and safety aspects of the task before performing the new task.

Corrective Action: Management established procedures and controls to ensure persons can remove a counterweight from an excavator safely. The procedures include following the manufacturer's procedures when removing a counterweight. The mine operator will provide adequate task training in the health and safety aspects of the task to all miners before performing any new task.
