Fatality #6 - May 15, 2012
Powered Haulage - Kentucky - Crushed, Broken Limestone NEC
Sterling Materials - Sterling Materials

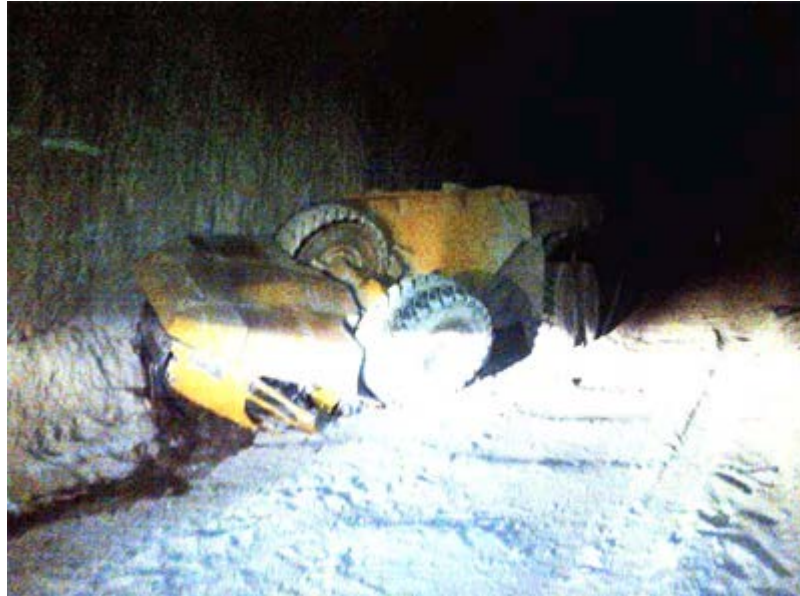
METAL/NONMETAL MINE FATALITY - On May 15, 2012, a 37 year-old haul truck driver with approximately 2½ years of experience was killed at an underground crushed stone operation. The victim was operating a loaded articulated haul truck down a slope when the truck went out of control and struck a rib. The tractor of the truck (cab) overturned. The victim was found outside of the cab and had been run over by the truck.

- Ensure that mobile equipment operators are task trained adequately and demonstrate proficiency in all phases of mobile equipment operation before performing work.
- Conduct adequate pre-operational checks and ensure the service brakes are properly maintained and will stop and hold the mobile equipment prior to operating.
- Operators of self-propelled mobile equipment shall maintain control of the equipment while it is in motion.
- Operating speeds shall be consistent with conditions of roadways, tracks, grades, clearance, visibility, curves, and traffic.
- Ensure that equipment manufacturer's load limits are not exceeded.
- Slow down or drop to a lower gear when necessary. Post areas where lower speeds are warranted.
- Always wear a seat belt when operating self-propelled mobile equipment.
- Ensure that equipment operators maintain adequate communications.
