MNM Fatal 2013-07

- Powered Haulage Accident
- May 17, 2013 (New Mexico)
- Underground Molybdenum Mine
- Mucker
- 22 years old
- 31 weeks of experience

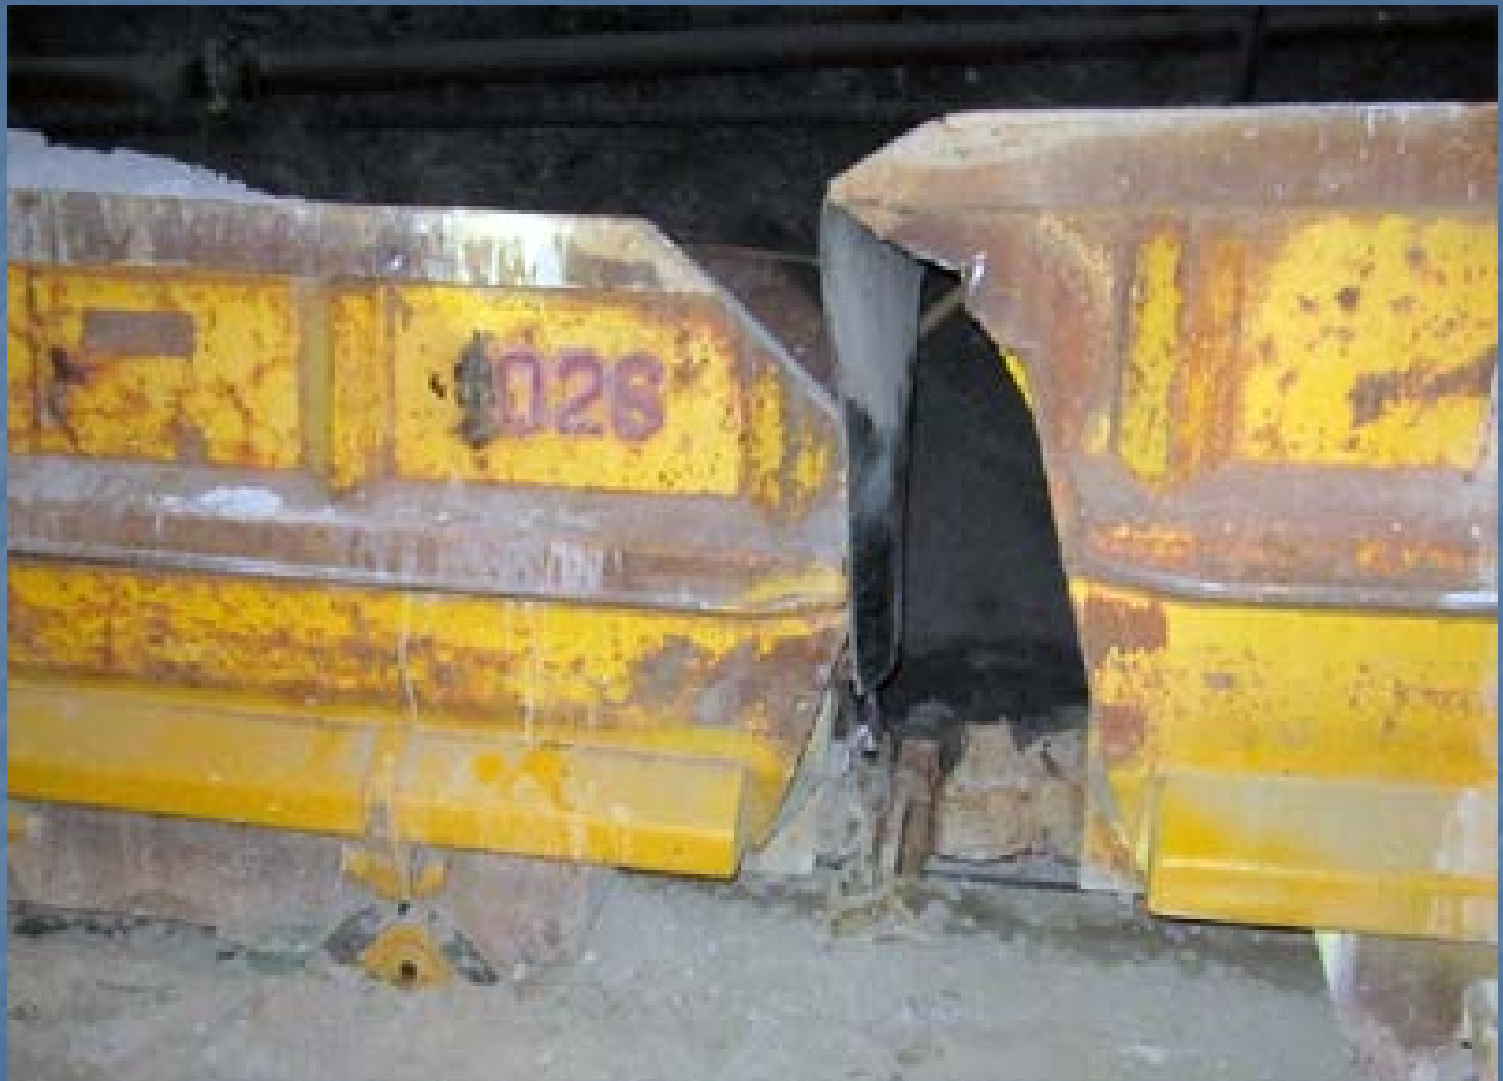
The victim was killed when he was pinned between two loaded ore cars. An electric locomotive was pulling a train of 13 cars loaded with ore up a grade when the eleventh car derailed and uncoupled from the tenth car. He was attempting to unhook the safety chain between the two ore cars.

The accident occurred due to management's failure to ensure that established safe procedures were followed while the victim worked between ore cars. He did not notify the locomotive operator that he would be positioned between the two ore cars and he did not block the ore cars against hazardous motion. Additionally, the braking systems on the locomotive were not maintained in functional condition.

Corrective Action: Although they had been trained, management retrained all miners regarding established procedures to be followed when rail cars derail on the track. Miners will not be positioned between rail cars until they notify the locomotive operator of their intentions and he acknowledges their presence.

Corrective Action: Although they had been trained, management retrained all miners regarding established procedures to be followed when rail cars derail on the track. Management instructed miners to block rail haulage equipment against hazardous motion before working on derailed ore cars.

Corrective Action: The locomotive was removed from service.
