MNM Fatal 2013-15

- Powered Haulage
- November 7, 2013 (Georgia)
- Granite Mine
- Equipment Operator
- 46 years old
- 27 years of experience

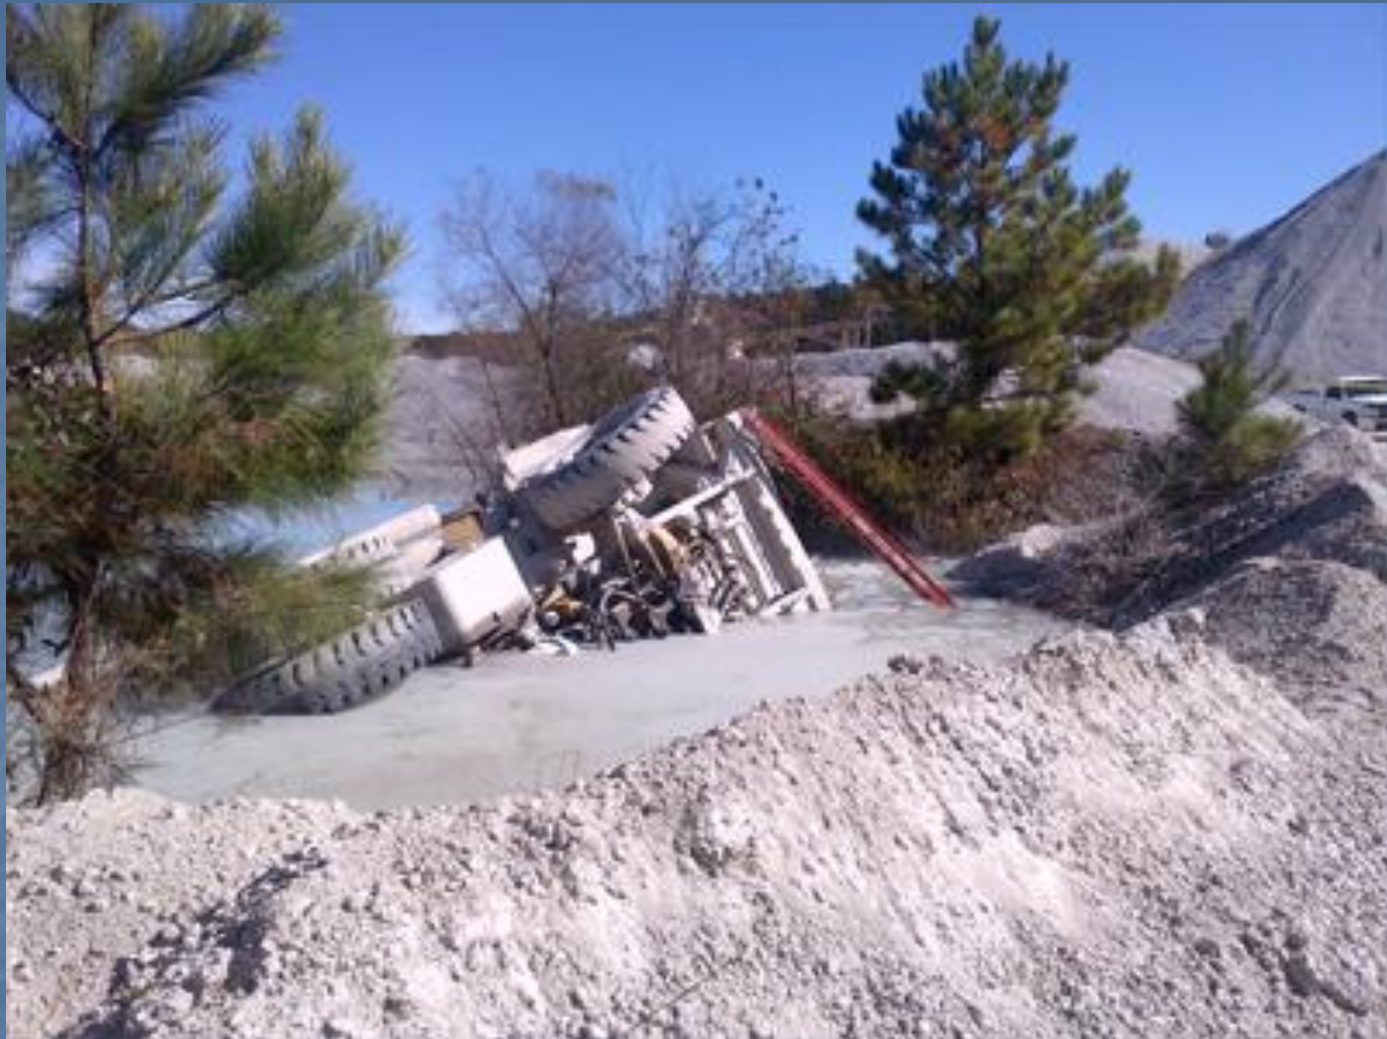
The victim was killed while operating a haul truck that veered off the left side of a haul road and traveled through a berm. The haul truck went over an embankment and rolled on its side into a water filled settling pond.

The accident occurred due to management's failure to ensure that persons could safely operate mobile equipment. Investigators learned through interviews that the victim was drowsy and was found sleeping during his shift; however, he continued to operate mobile equipment. The combination of alcohol and drugs found in the toxicology screening could account for the observed drowsiness displayed by the victim. The victim was not wearing a seat belt.

Corrective Action: Management established rules and responsibilities regarding any employee suspected of being impaired while on the job. The rules were explained to all of the employees at the mine.
