Fatality #5 - April 16, 2013
Falling/Sliding Material – Louisiana – Salt
North American Salt Company - Cote Blanche Mine

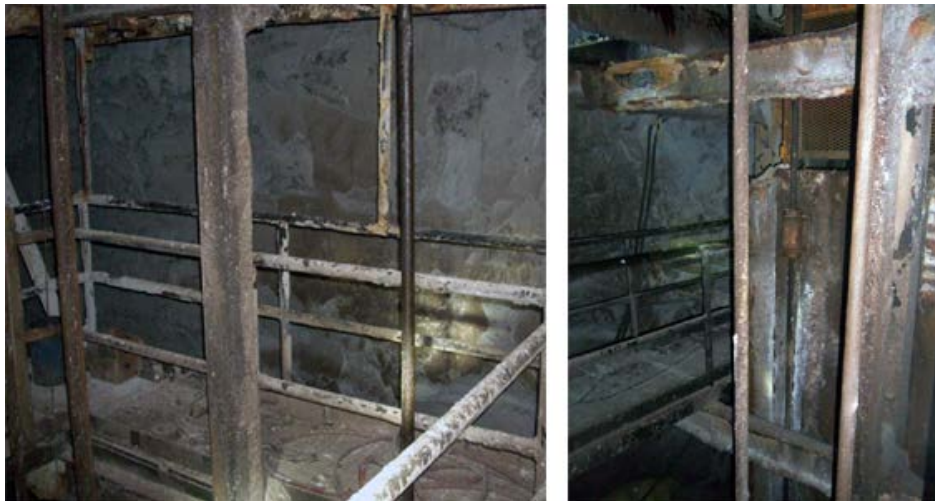
METAL/NONMETAL MINE FATALITY - On April 16, 2013, a 58-year old shaftman with 32 years of experience was seriously injured at an underground salt mine. The victim and two coworkers were replacing a bushing on the side of a skip hoist in the production shaft. The victim was standing on a steel beam outside the handrails of a covered work platform where the coworkers were standing, when a piece of salt fell and struck him. He was transported to a hospital where he died on April 17, 2013.

- Establish and discuss safe work procedures. Identify and control all hazards associated with the work to be performed in a shaft with the methods to properly protect persons.
- Task train all persons to recognize all potential hazardous conditions and to understand safe job procedures for elimination of the hazards, such as falling material, before beginning work.
- Examine the shaft and remove loose material prior to commencing work.
- Implement measures to ensure persons are properly positioned and protected from falling material while performing shaft maintenance work.
- Perform shaft maintenance work from a substantial platform with adequate overhead protection.
- Perform maintenance work for skip hoists and other conveyances on the surface whenever possible.
- Monitor personnel routinely to determine that safe work procedures are followed.
