MNM Fatal 2013-05

- Falling Material Accident
- April 16, 2013 (Louisiana)
- Underground Salt Operation
- Shaftman
- 58 years old
- 32 years of experience

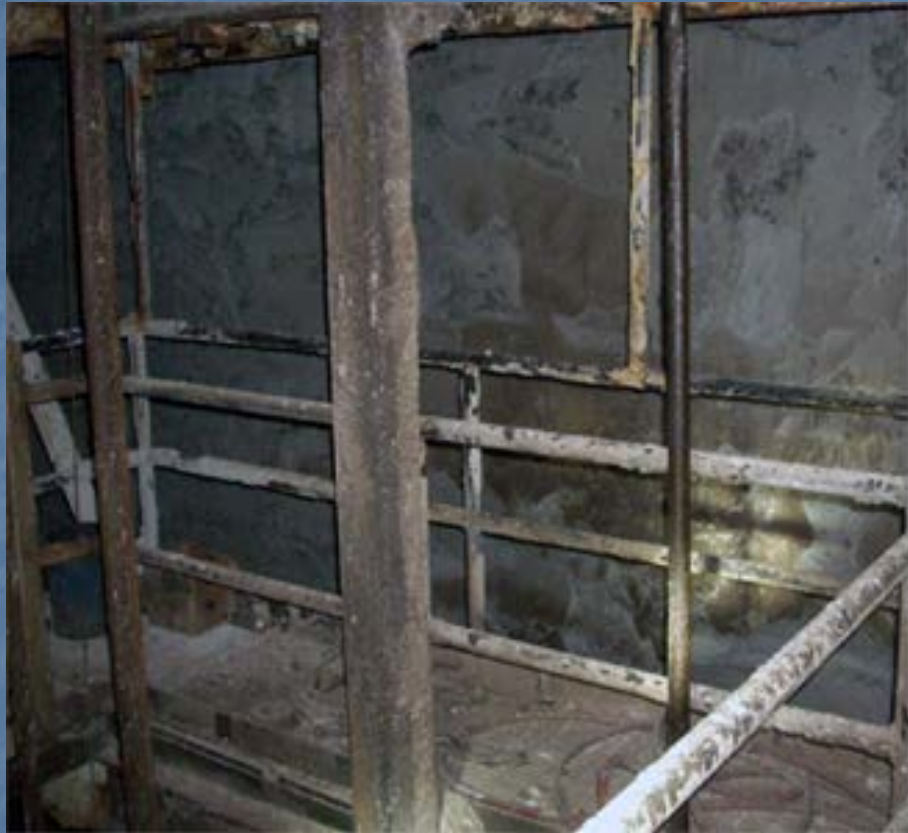
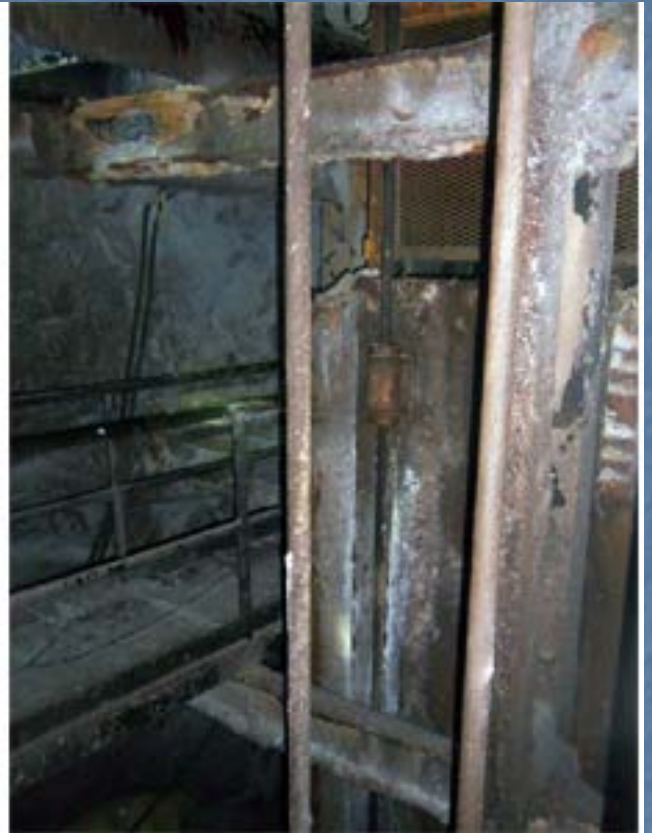
The victim was seriously injured when a piece of salt fell and struck him. He and two coworkers were replacing a bushing on the side of a skip hoist in the production shaft. The victim was working while standing on a steel beam, outside the handrails of a covered work platform where the coworkers were standing, when the material struck him. He was transported to a hospital where he died on April 17, 2013. The coworkers were also struck by the falling material and received minor injuries.

The accident occurred due to management's failure to ensure ground conditions that created a hazard to persons working in the shaft were taken down before work was permitted. Management also failed to ensure that persons performed the task of replacing the bushing from a substantial platform equipped with a bonnet or equivalent overhead protection.

Root Cause: Management did not ensure ground conditions that created a hazard to persons were taken down before work was permitted in the shaft.

Root Cause: The victim was not performing work from a substantial platform equipped with a bonnet or equivalent overhead protection.

Corrective Actions: The shaft was inspected and scaling was performed before work was resumed.

Corrective Actions: Management established a policy of changing guide ropes and bushings at the surface. This policy eliminates the need for persons to perform this work in the shaft. All shaftmen were trained in this policy. If any work is required in the shaft, the work will be performed from a substantial platform equipped with a bonnet or equivalent overhead protection.
