MNM Fatal 2014-10

- Machinery
- April 28, 2014 (Nevada)
- Underground Gold Mine
- Miner
- 53 years old
- 32 years of experience

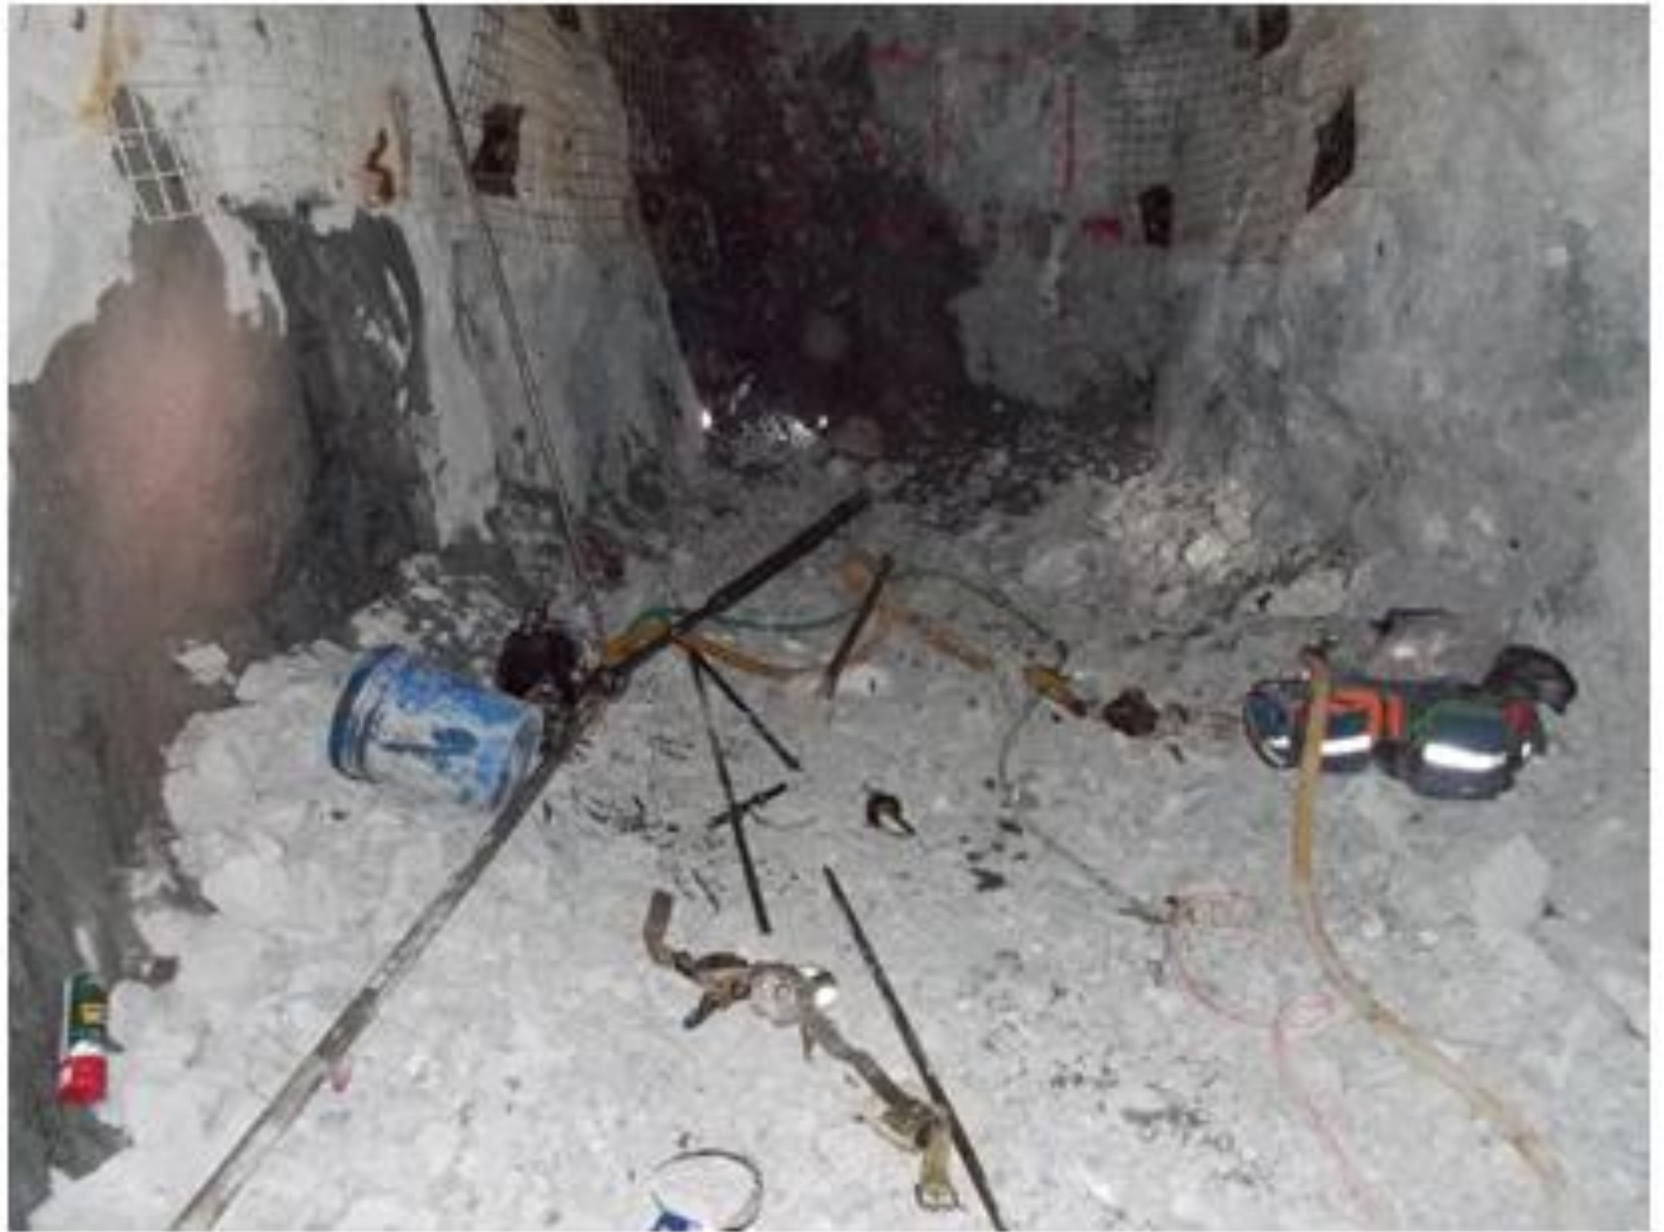
The victim was killed when he became entangled in a 6-foot drill steel of a jackleg drill. He had been drilling blast holes in the face of the stope, preparing for a production blast in the No. 8-4540 south stope. A coworker found the victim's coveralls entangled in the drill steel approximately 15 feet 6 inches away from the face. The jackleg drill was still operating when he was found.

The accident occurred due to management's failure to ensure procedures were established to provide that the victim's workplace was kept clean and orderly. The stope contained large rocks, air and water hoses, drill steels, and an oil container, exposing the victim to slip, trip, and fall hazards as he moved about while drilling.

Management also failed to ensure that procedures were established to provide secure footing in the workplace where the accident occurred. The floor of the stope was strewn with loose rock and other items which did not provide secure footing for the victim or the drill. Secure footing is needed to keep the leg of the drill from moving or sliding while in operation.

Management failed to ensure that procedures were established to provide that the victim's workplace was kept clean and orderly. The floor of the stope was strewn with large rocks, air and water hoses, drill steels, and an oil container, exposing the victim to slip, trip, and fall hazards as he moved about while drilling.

Management abandoned the No. 8-4540 south stope and bolted an eight foot high chain link metal fencing from rib to rib and posted the heading as "inactive, keep out". Additionally, management updated the jackleg drilling SOP and reviewed the SOP with the jackleg operators.
