# MNM Fatal 2014-13

- Hoisting
- June 2, 2014 (Idaho)
- Underground Silver Mine
- Shaft Repairman
- 36 years old
- 18 years of experience

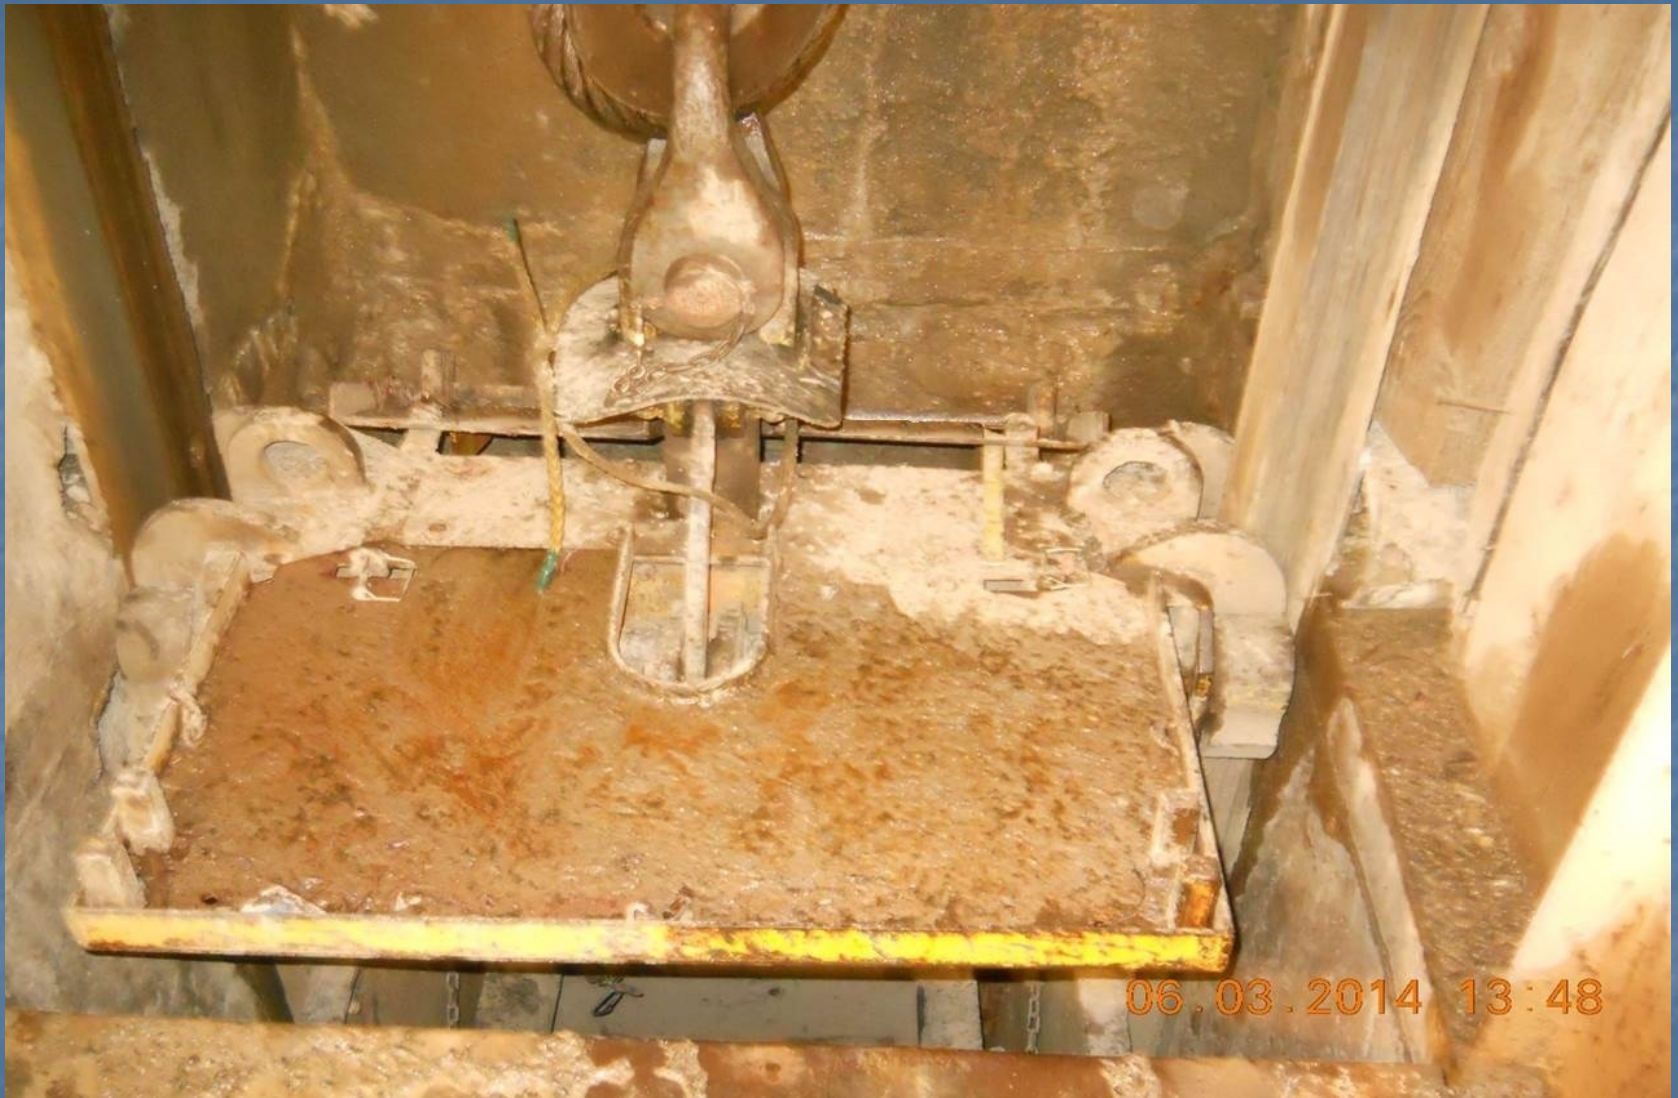
The victim was killed while working in the chippy (personnel) hoist compartment of the Jewell Shaft. The victim and another miner were working in the shaft performing rehabilitation work. Prior to the accident, the victim had tied off his fall protection lanyard to a stationary metal rod (hanging rod) located on the shaft wall behind him. After loading and securing wooden lacing onto the chippy work deck, the hoist operator was given the okay to move the hoist upwards to the surface. However, the victim had not disconnected his lanyard from the hanging rod and when the chippy conveyance moved, he was pulled into the space between the chippy work deck and the shaft wall.

The accident occurred due to management's failure to identify possible hazards and establish safe work procedures associated with performing shaft maintenance work, specifically where miners were to safely tie off their lanyards. A safe procedure for replacing or transporting wooden lacing during shaft maintenance had not been developed or implemented. Material on the chippy work deck affected where the miners could tie off their lanyards while performing shaft maintenance.

**Root Cause:** Management failed to ensure that a safe procedure for shaft maintenance work. Material on the deck affected where the miners could tie off while performing shaft maintenance. The victim had tied his lanyard off to a stationary metal hanging rod located on the wall of the shaft between the timber sets. When the conveyance was moved, the victim was pulled from the platform he was standing on.

**Corrective Action:** Management developed and implemented procedures for shaft maintenance work. The procedures also address the proper use of fall protection while working from conveyances. The miners involved in the rehabilitation of the shaft were all trained regarding the new procedures.
