MNM Fatal 2014-16

- Powered Haulage
- July 23, 2014 (Florida)
- Cement Operation
- Contract Truck Driver
- 51 years old
- 30 years of experience

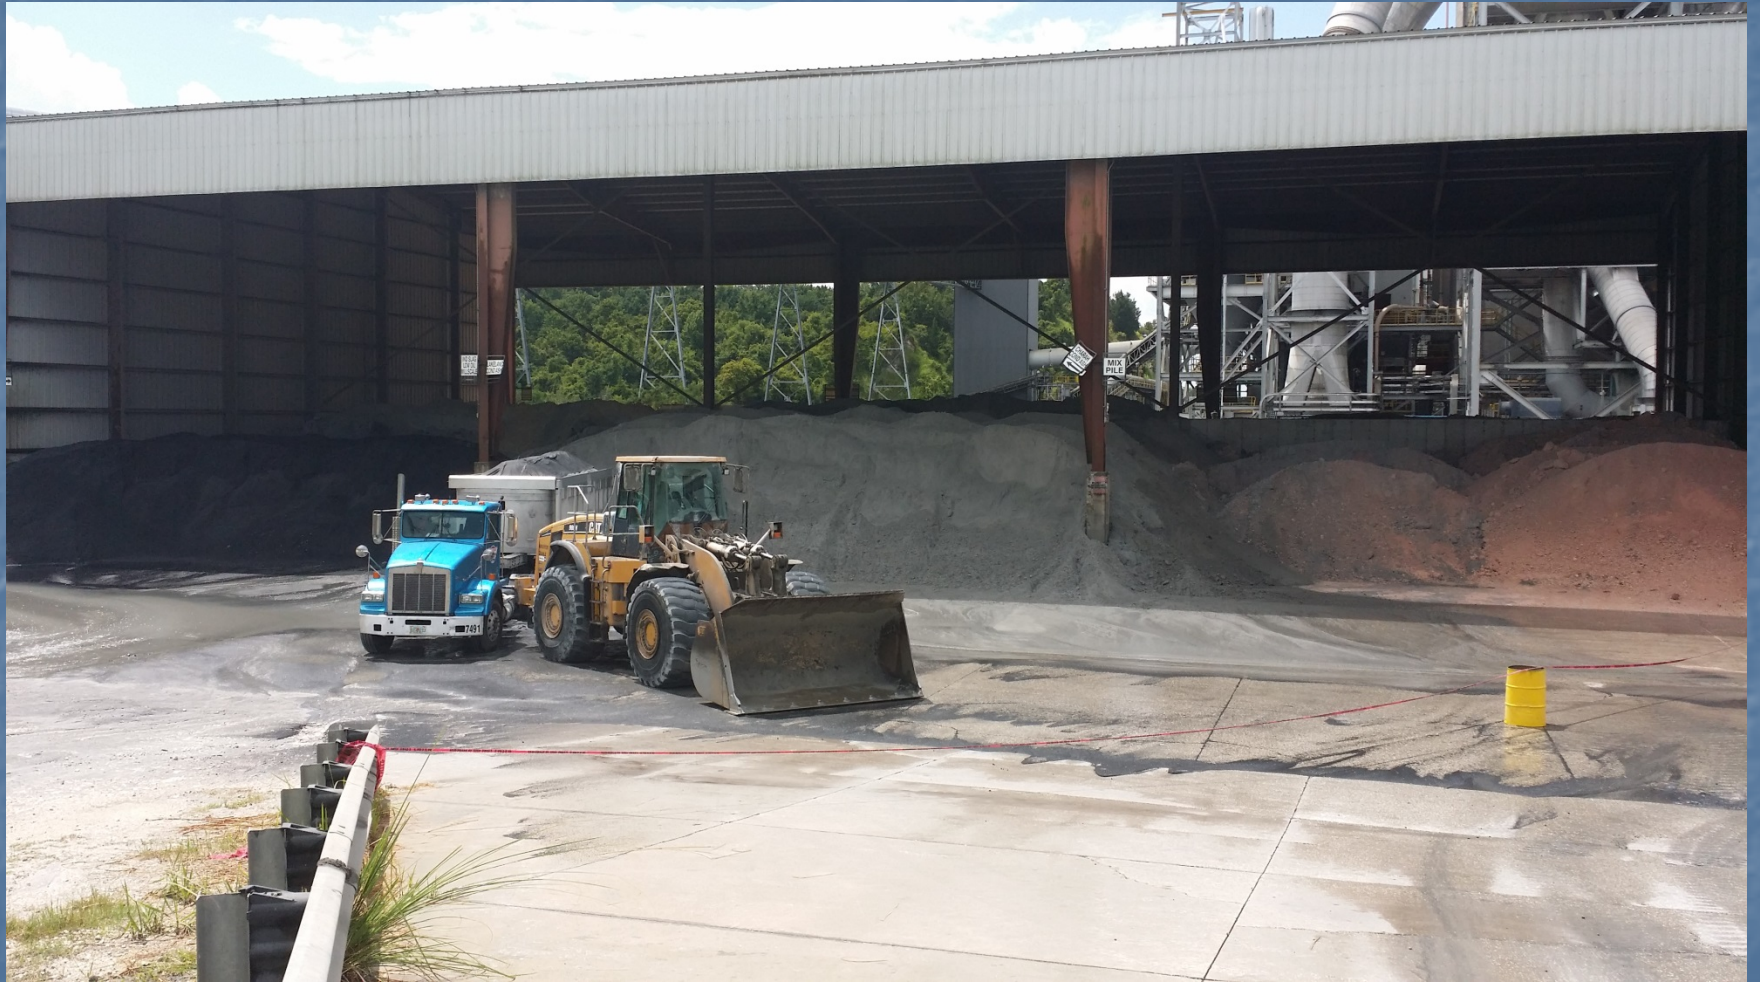
The victim was killed on July 23, 2014, when he was struck and pinned between his haul truck and a front-end loader. He drove the haul truck to the fly ash dumping point at the materials storage building. The victim exited the haul truck, preparing to untarp the truck's trailer, when the front-end loader backed down a ramp from a nearby hopper and struck and pinned him against the truck.

The accident occurred because management failed to ensure that the operator of the front-end loader maintained control of the loader at all times, specifically while other equipment traveled in the same area. No safe operating procedures had been established to ensure communications between the incoming truck drivers and the front-end loader operators. Additionally, site-specific hazard awareness training had not been provided to the victim regarding the delivery and unloading of the fly ash material.

Corrective Action: Management established safe operating procedures for mobile equipment operators and incoming haul truck drivers bringing raw materials to the materials storage building. The procedures include the use of hand held radios for communication between the front-end loader operator and the haul truck drivers. Cameras and sensors will be installed on the front-end loaders. All mobile equipment operators and haul truck drivers were instructed in these safe operating procedures.

Corrective Action: Management established safe operating procedures for mobile equipment operators and incoming haul truck drivers bringing raw materials to the materials storage building. All haul truck drivers were provided site-specific hazard awareness training which included these safe operating procedures.
