MNMF Fatal 2014-17

- Falling Material
- August 2, 2014 (Montana)
- Sand & Gravel Mine
- Foreman
- 53 years old
- 25 years of experience

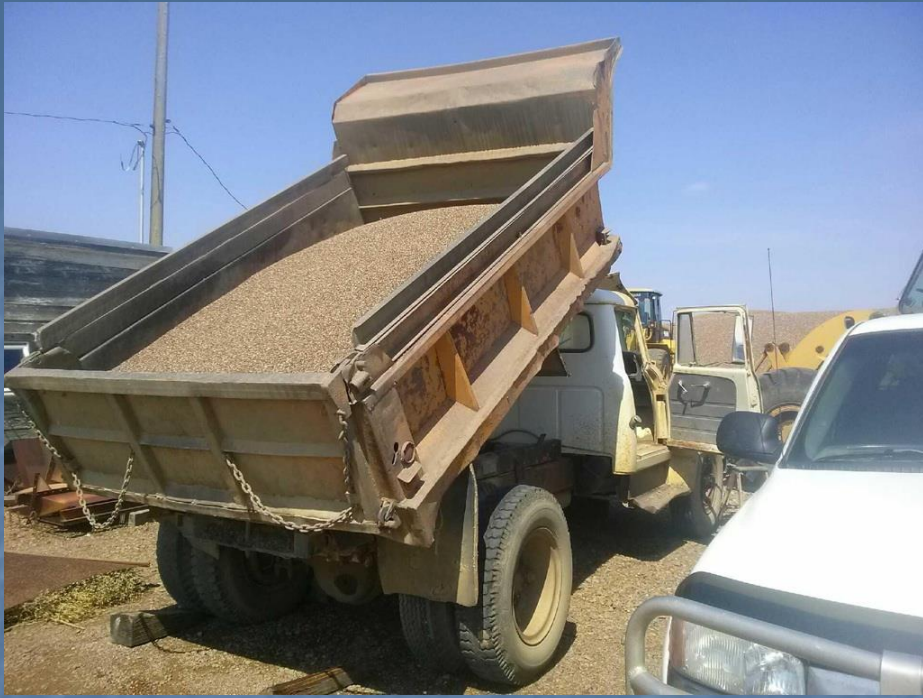
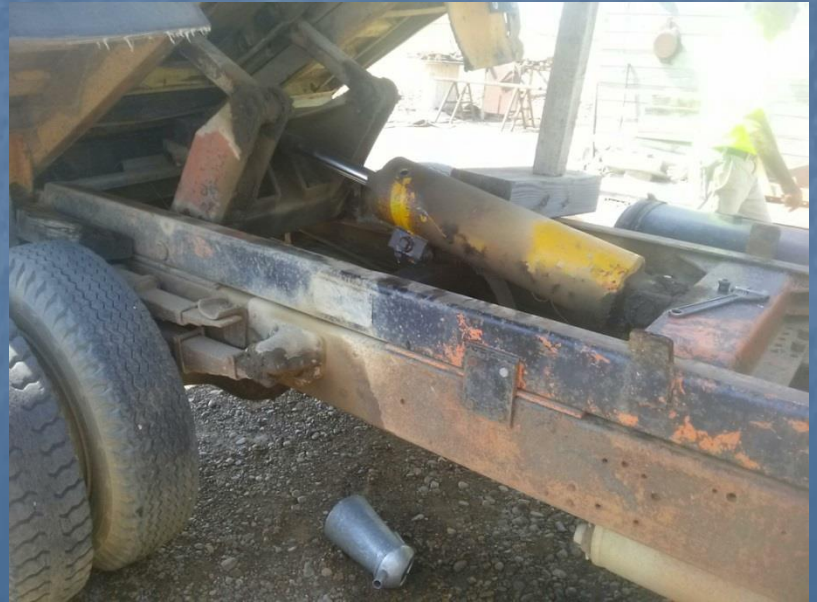
The victim was killed at this operation on August 2, 2014. He was working under the raised bed of a dump truck when a weathered block of wood supporting the load suddenly failed, allowing the bed to fall and pin him. No other miners were working at the mine on the day of the accident. The victim was working alone and was not found until 10 a.m. on August 3, 2014. He was performing maintenance on the truck bed's hydraulic lift system.

The accident occurred due to management's failure to establish procedures to ensure persons could safely perform maintenance on a truck bed in a raised position. The raised truck bed was not secured to prevent accidental lowering when the victim was performing maintenance. The victim was not instructed in the safety and health aspects and safe work procedures of the task of performing maintenance on the truck's hydraulic lift system. Additionally, he was assigned to perform work alone where hazardous conditions existed that would endanger his safety and he could not communicate with others, be heard, or be seen.

Root Cause: Management failed to establish procedures to ensure persons could safely perform maintenance on a raised truck bed. The raised truck bed was not secured to prevent accidental lowering when the victim was performing maintenance. Management failed to ensure the victim received instruction in the safe work procedures of the task of performing maintenance of the truck's hydraulic lift system.

Corrective Action: Management established procedures to ensure raised components of mobile equipment are secured to prevent accidental lowering when persons are performing maintenance. All persons received task training regarding the procedures to be used when working under raised components on mobile equipment.
