MNM Fatal 2015-7

- Powered Haulage
- May 28, 2015 (Nevada)
- Gold Ore
- Truck Driver
- 61 years old
- 2 years of experience

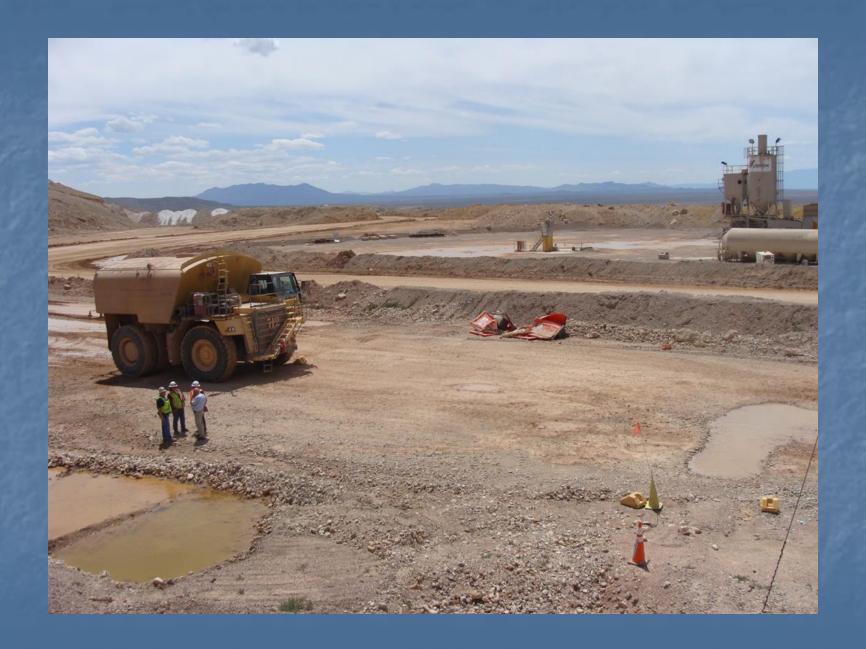
David D. Martinez, truck driver, age 61, was fatally injured on May 28, 2015, when a Komatsu 730E water truck struck a portable toilet that he was using. Martinez went to assist the driver of another water truck already parked at the lower water pipe stand area. When Martinez arrived in his water truck, he parked facing the other water truck. As the other water truck departed the area, the driver turned his truck to avoid hitting Martinez's truck and did not notice that he had struck the portable toilets, where Martinez was located.

The accident occurred due to management's inadequate policies and procedures to ensure the truck driver maintained control of his truck and to place the portable toilet facility in a location where it was compatible with the mining operation and would not be struck by mobile equipment.

- Root Cause: Management policies and procedures were inadequate and failed to ensure that drivers maintained control of mobile equipment. The truck's tire struck the portable toilet without the driver noticing.
- Corrective Action: Management implemented policies and procedures to ensure truck drivers operate mobile equipment safely without striking other objects. Truck drivers were trained on hazards the machine can cause when in and around other equipment and personnel.

- Root Cause: Management policies and procedures were inadequate and failed to place the portable toilet facility in a location where it was compatible with the mining operation and would not be struck by mobile equipment. There was a berm constructed on the West side, or behind the portable toilets, to provide protection from the haul road that was heavily traveled. There were no berms for protection against traffic utilizing the water pipe stand area however.
- Corrective Action: Management implemented policies and procedures to ensure proper placement of portable toilets. Berms or other impeding devices were constructed to protect portable toilets from vehicular traffic.
