MNM Fatal 2015-14

- Powered Haulage
- August 03, 2015 (Nevada)
- Underground Gold Mine
- Jumbo Drill Operator
- 26 years old
- 4 weeks of experience

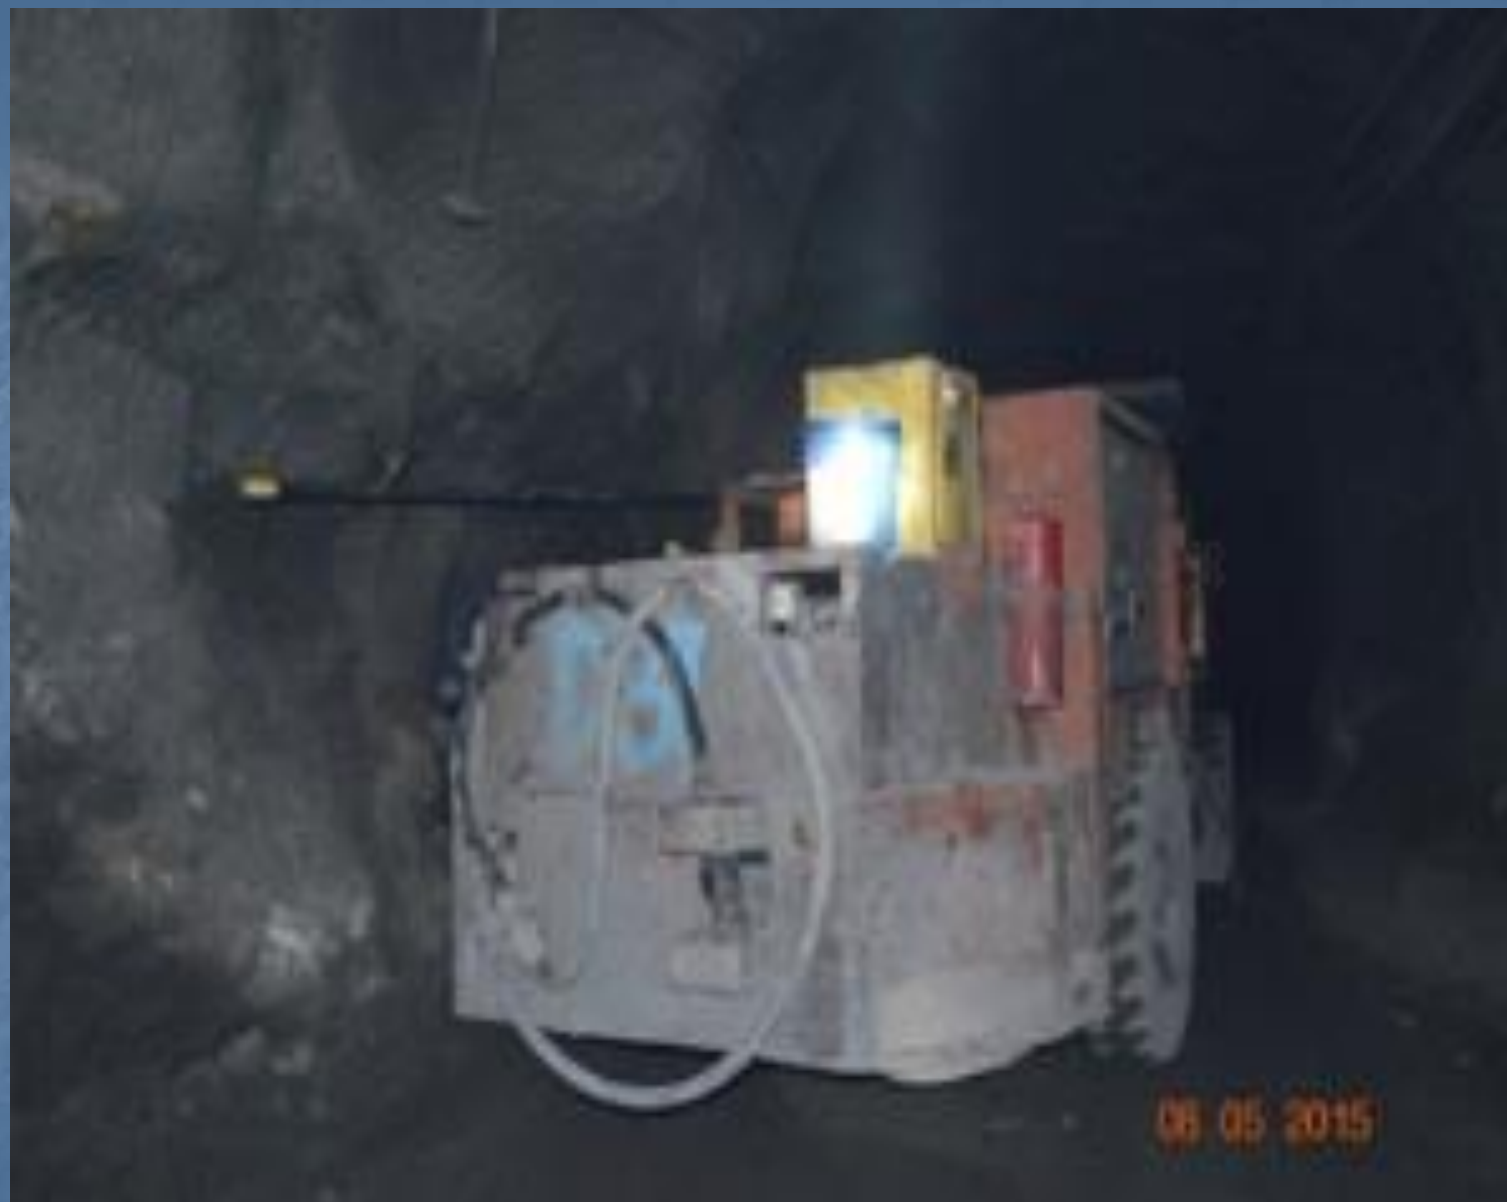
On August 3, 2015, Jason Potter, miner, age 26, was tramming a jumbo rock drill in reverse up a slope when a 13 ½ foot long drill steel came in contact with the rib wall and sprang back striking and killing the victim. The accident occurred due to management's failure to ensure that loading and transporting of materials were done in a safe manner.

Root Cause: Management's policies and procedures were inadequate and failed to ensure that persons loaded and transported materials in a safe manner. The drill steel was transported on top of the jumbo drill and was allowed to extend 2.5 feet beyond the leading edge of the drill. Additionally, the drill steel was not secured in a manner that prevented the drill steel from sliding side to side. This caused the drill steel to strike the rib and then strike the miner.

Corrective Action: Management conducted training for all persons regarding the safe loading and transporting of materials.
