MNM Fatal 2016-12

- Powered Haulage
- September 8, 2016 (North Carolina)
- Crushed & Broken Granite Mine
- Haul Truck Driver
- 58 years old
- 23 years of experience

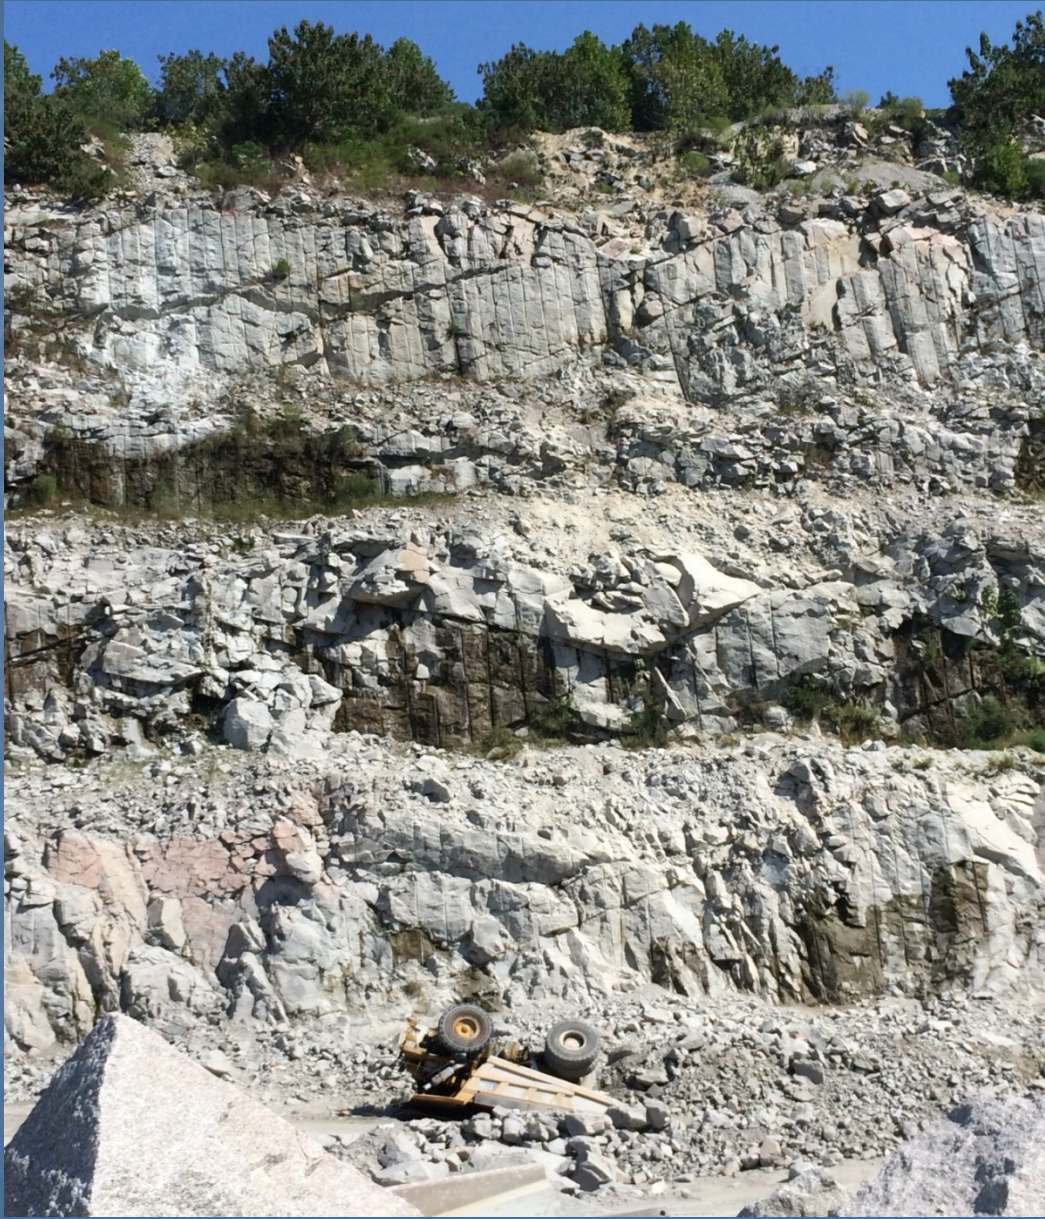
Richard Smith, a 58-year old Haul Truck Operator, was fatally injured on September 8, 2016. The victim was operating a Caterpillar 773E haul truck and was returning to the pit for loading when the truck, traveling down a 9% grade, veered from the right to the left side of the haul road and traveled over the berm at the top of the highwall. The truck landed upside down approximately 201 feet below.

The accident occurred because the mine operator failed to ensure the victim maintained control of the truck and did not ensure seat belts were being used properly.

- Always wear a seat belt when operating a haul truck or mobile equipment.
- Conduct thorough, in depth task training to cover potential hazards.
- Monitor employees regularly to ensure seat belts are worn when operating mobile equipment.

- Emphasize that improperly worn seat belts can NOT provide the proper restraint to necessary to protect equipment operators in hazardous situations.
- Conduct pre-operational checks to identify defects that may affect the safe operation of equipment before being placed into service.

- Observe all speed limits, traffic rules, and ensure that grades on haulage roads are appropriate for haulage equipment being used.
- Maintain control and stay alert when operating mobile equipment.

- Provide and maintain adequate berms and other barriers of mid-axle height.
- Perform safety inspections that include braking systems and seat belts before operating equipment; promptly remove equipment from service if defects affecting safety are found.
